## 3. Derwent Catchment

### 3.1 Derwent Catchment Event Hydrology

## **3.2 Community Impacts - Lilac Way**

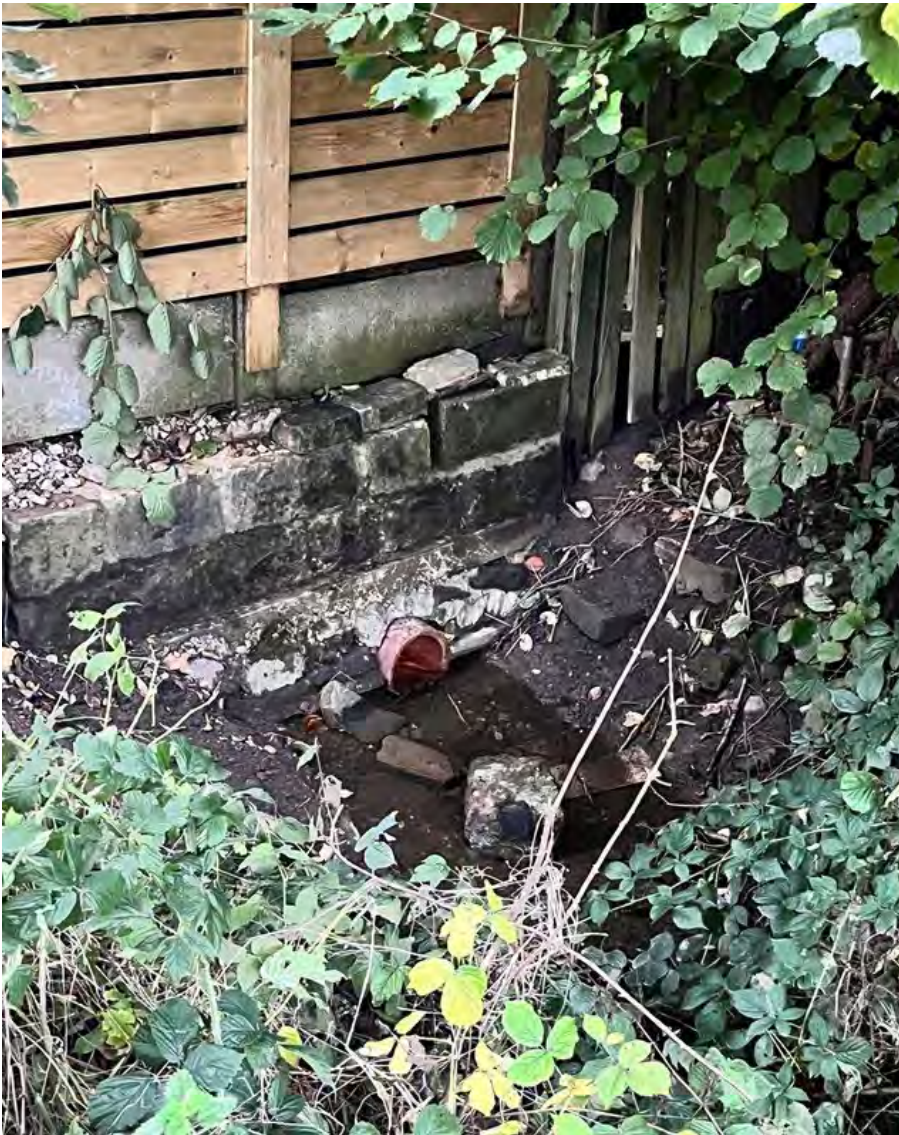
The inlet to this culverted watercourse is small, poorly designed and in poor condition. It can be seen in Figure 3-4 below.

**Figure 3-4: The culvert inlet of the watercourse which flows southwards parallel to Lilac Way.**

North East Derbyshire District Council investigated the flood event which included discussions with residents. They suggested that water could not sufficiently pass through the culvert inlet, and this resulted in water bypassing the culvert and flowing into gardens. This is understandable given the very small size of the culvert inlet. Flood water then continued to flow through the gardens to the rear of the properties, and subsequently entered the properties through doorways where flood water reached depths of 0.6m. The flood water continued to flow south and finally into a large chamber that connects the watercourse and surface water gullies from Lilac Way to the watercourse continuing south of Lilac Way Lane. This chamber is shown in Figure 3-5. North East Derbyshire District Council also noted that many of the residents were unaware of the risk of flooding from the ordinary watercourse and their riparian ownership responsibilities to maintain the watercourse. However, it is acknowledged that a single culvert runs through several properties making coordination essential, and this can be difficult for a group of riparian owners to achieve.

Initial investigations into flooding issues were also undertaken by Derbyshire County Council on the 27th of October 2023. They were made aware that water flowed to a low point and pooled somewhere between no. 1 and 7 Lilac Way, then encroached around the properties and then water entered through the doorways. The initial findings were that the culvert capacity was exceeded.

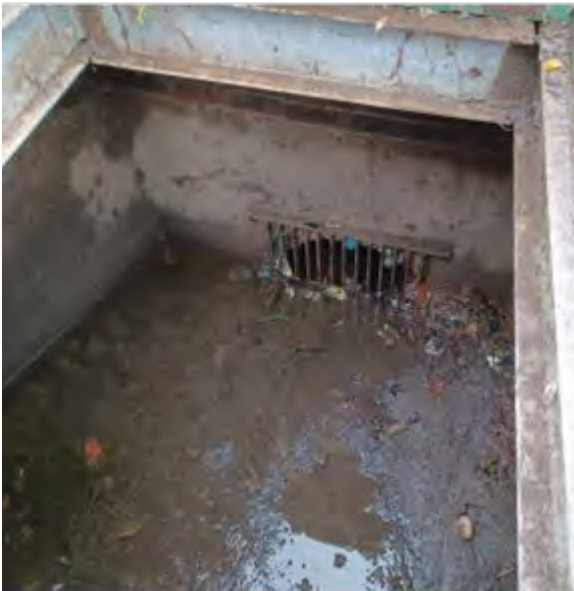
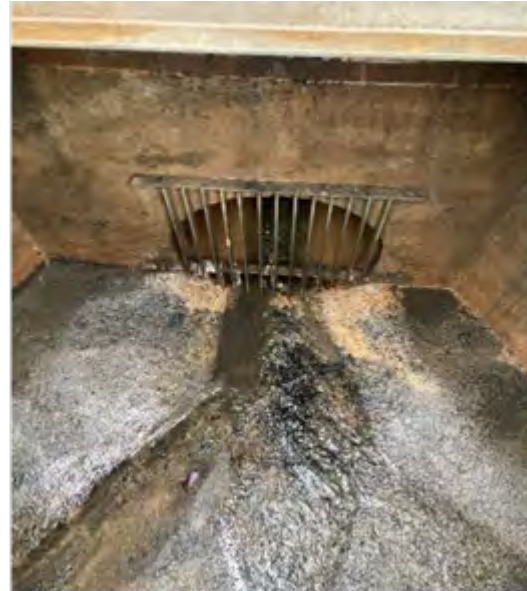
Restrictions within the culvert impeded flow which exacerbated the impacts of flooding. Siltation of a chamber near the downstream end of the culvert was reported, which has subsequently been removed by North East Derbyshire District Council. During the flooding, residents attempted to remove debris from the culvert. The chamber, before and after silt removal, is shown in Figure 3-5 below. It is noted that the siltation is only partial and that the size of the culvert here appears to be much greater than that at the inlet.

Figure 3-5: The picture on the left shows the chamber before cleaning and after de-silting on the right.

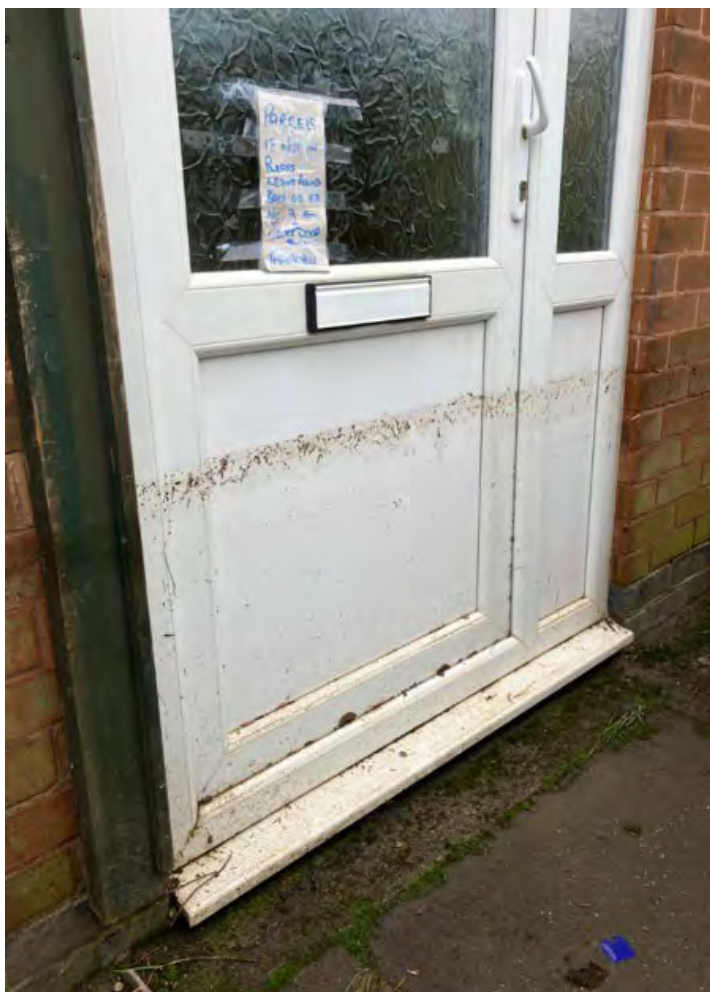
The reported depths of internal flooding reached 0.9m and entered homes via doorways. Figure 3-9 shows the water line on the door of one of the properties, indicating the depth of flooding.

Figure 3-9: Flood water line on property door.

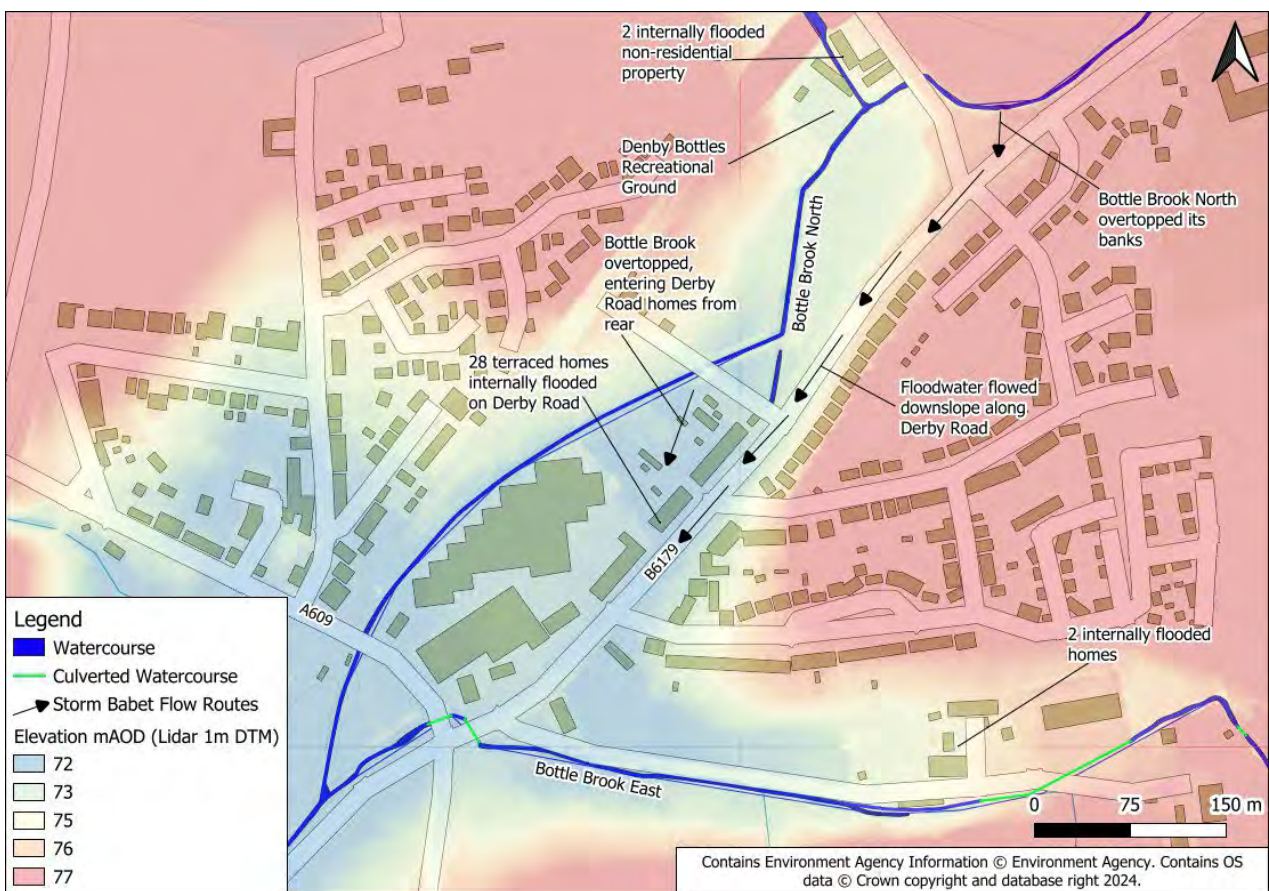
The source of flooding was from Bottle Brook North and Bottle Brook East. Figure 3-24 shows the Storm Babet flood flow routes and ground level at Denby Bottles.

Figure 3-24: Ground level and flow routes at Denby Bottles

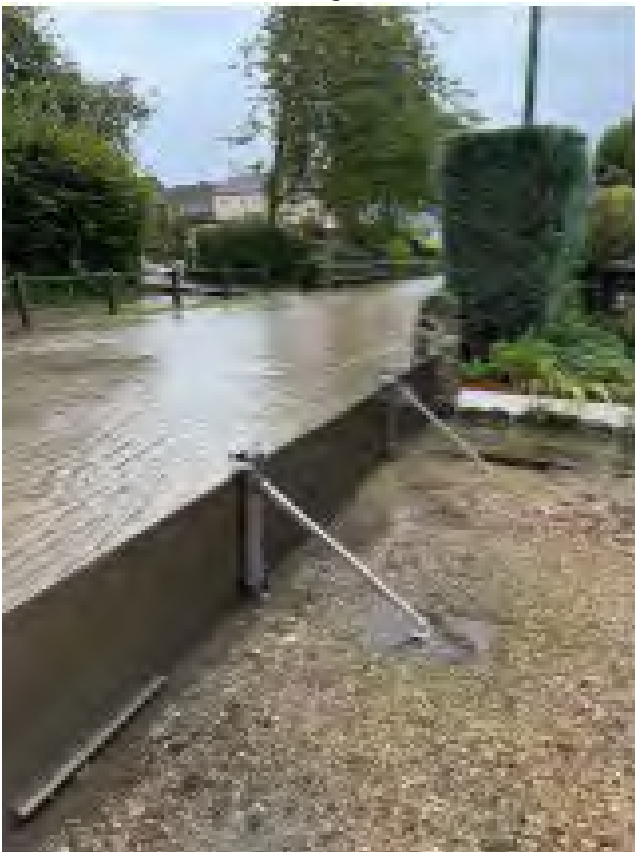
As can be seen in Figure 3-28 the property on Brookside Road that had a demountable flood barrier initially successfully prevented floodwater from Dam Brook from entering the property. On the 20th of October 2023 Dam Brook overtopped and flooded Brookside Road which subsequently resulted in the sewer network being overwhelmed and surcharging. This led to the internal flooding of the property. Figure 3-29 below shows the internal flood water damage.

Figure 3-28: Demountable flood barrier across a driveway prevents flood water reaching a property in Breadsall.

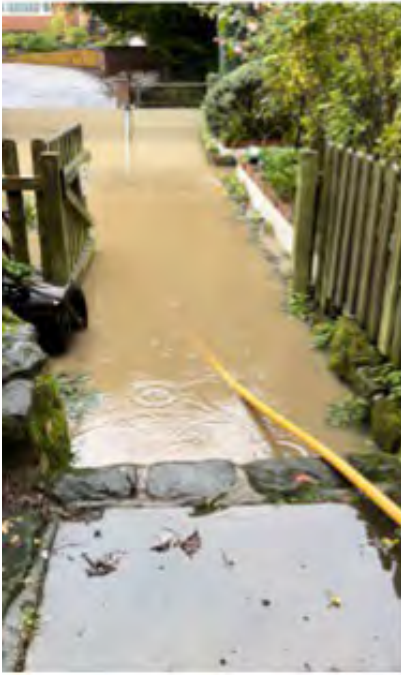
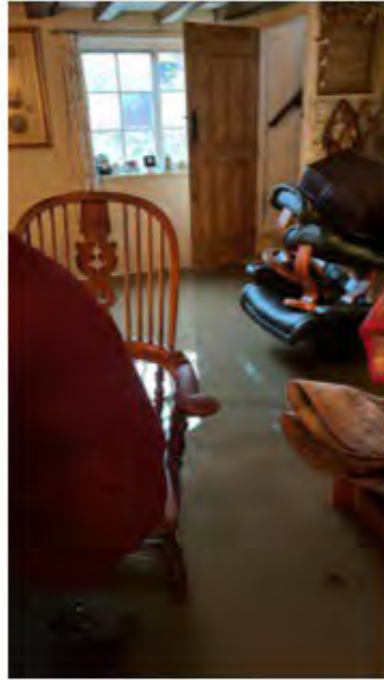
Figure 3-29: Flood water from drainage surcharge (left) and flood water within a property (right).

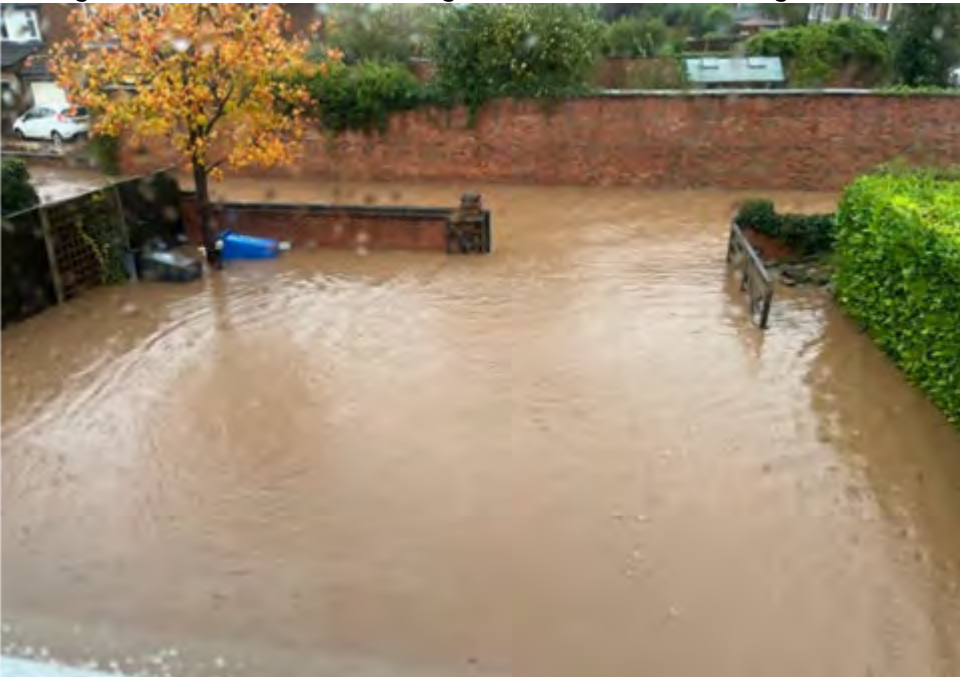
indicates that the culvert under Cole Lane was partially blocked, leading to the water level in Ock Brook to rise upstream (north) of Cole Lane. The Ock Brook then overflowed its banks, with flood water flowing westward along Cole Lane and Collier Lane. Figure 3-32 shows the flooding to Collier Lane.

**Figure 3-32: Flooding to Collier Lane**

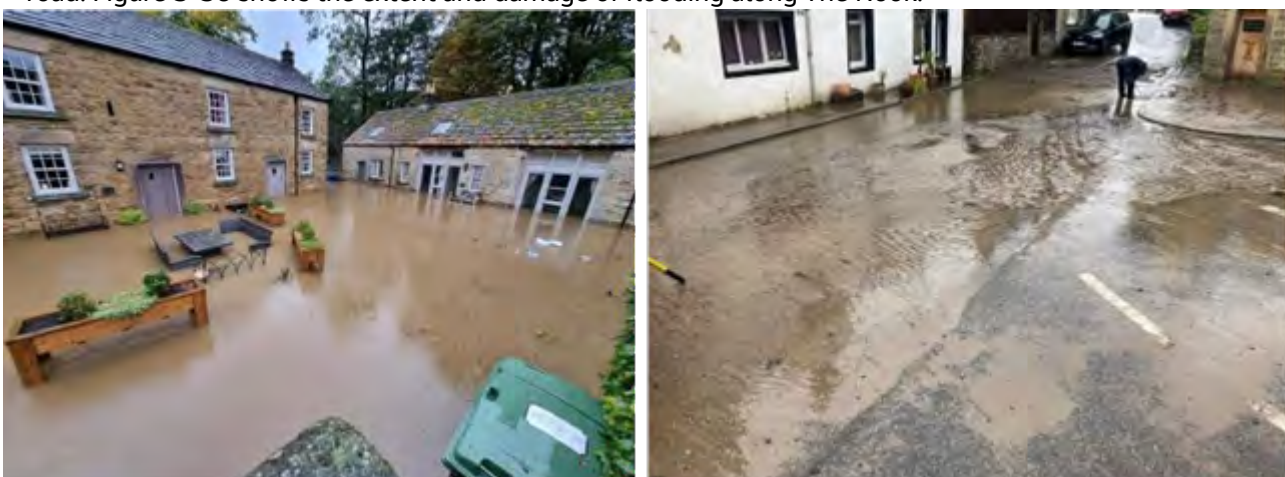
Derbyshire County Council observed flood damage to properties surrounding The Nook and determined that flooding was also related to old mine drainage (soughs) surcharging and flooding properties and the Nook road. Figure 3-36 shows the extent and damage of flooding along The Nook.

**Figure 3-36: Flooding to properties on The Nook (left) and damage caused by flooding to The Nook (right)**

Due to the nature of the steep hillside to the north of the community, surface water runoff is another likely cause of flooding, especially as The Nook is in a low-lying area adjacent to the watercourse. Surface water runoff from the field behind Denman Crescent is reported to be the source of internal flooding to the home which flooded in this location.

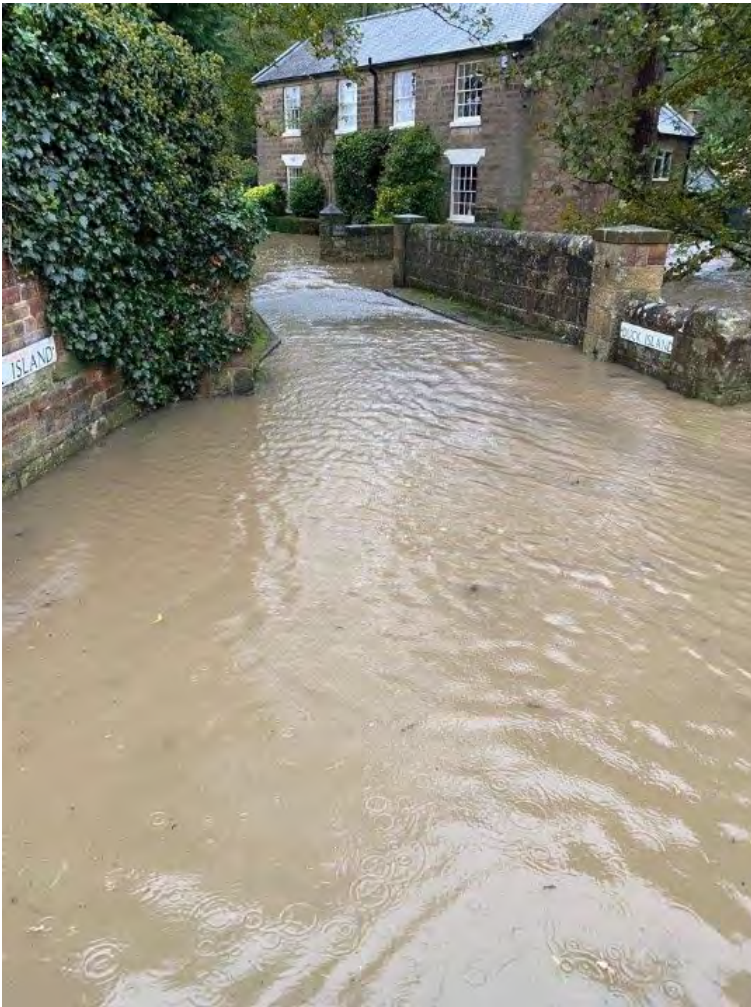
The River Ecclesbourne exceeded its capacity and overflowed its banks and formal defences in several locations through Duffield, which directly caused internal flooding to many of the affected properties.

**Figure 3-40: Flood water flowing over Duck Island Bridge**

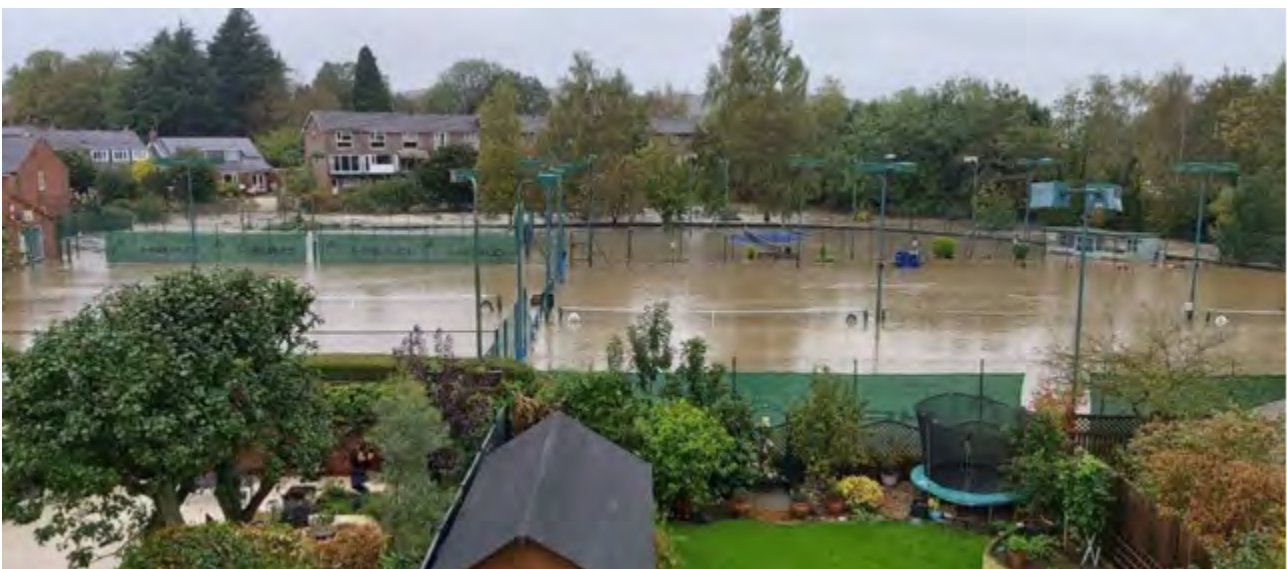
**Figure 3-41: Flooding of Duffield Tennis Courts backing onto properties on Ecclesbourne Avenue**

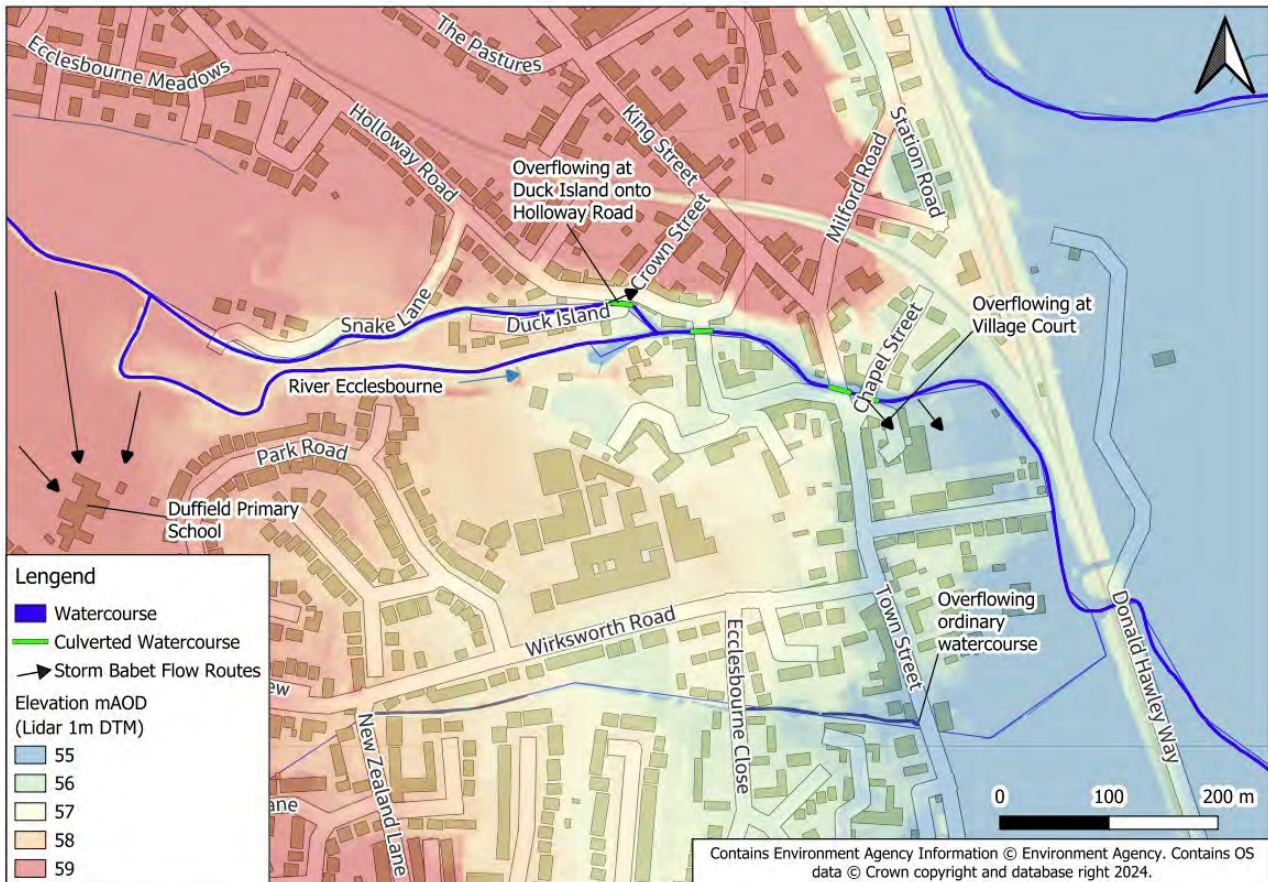
Figure 3-42: Map of Duffield with flooding flow routes indicated with blue arrows.

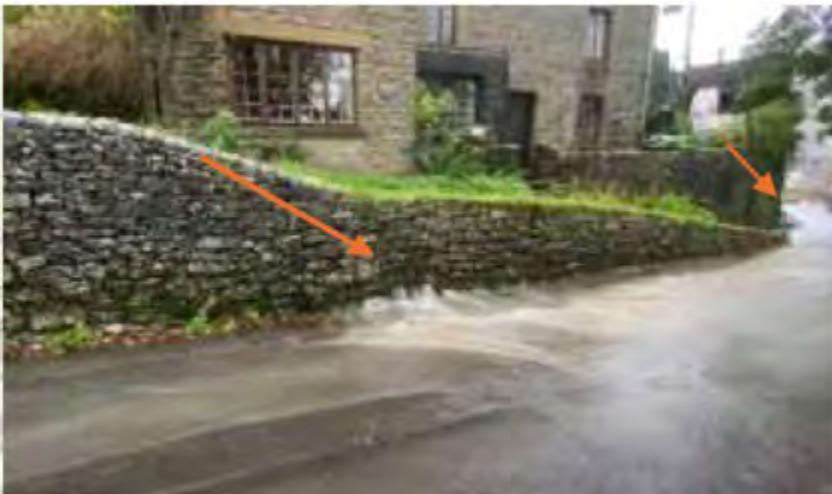
Figure 3-46: Surface water runoff flowing through a drystone wall and onto Brookside.

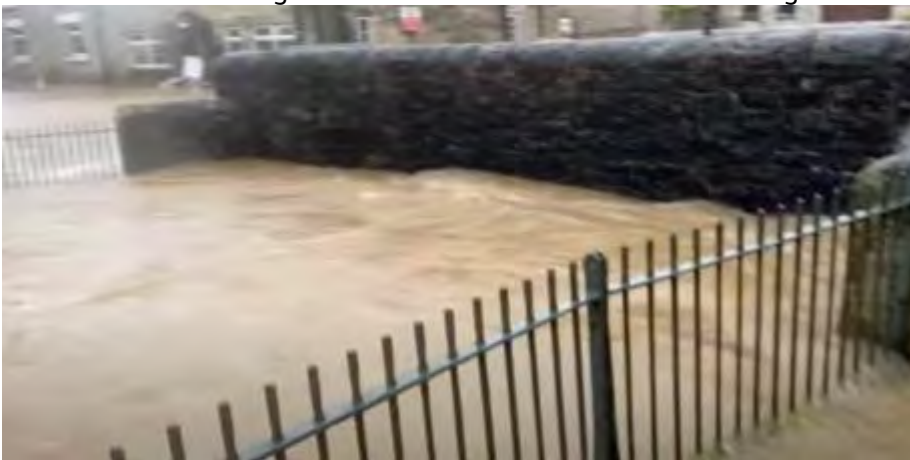
Properties on Church Street suffered internal flooding from the unnamed watercourse that flows to the rear of the properties. Residents reported fast flowing water coming through their properties. Residents opened the doors of their properties to let the water flow through them, to limit structural damage. This flood water from the unnamed watercourse also contributed to flooding on the B6049. Anecdotal evidence reported to Derbyshire County Council stated that the drains on Church Street were visibly surcharging, with manhole covers lifted out of place, posing a safety risk to residents. Severn Trent did not receive any reports of issues in this area during the event. However, during the Section 19 investigation Severn Trent were made aware and are therefore investigating this issue further.

Figure 3-47: Bradwell Brook exceeding its capacity at the Church Street bridge.

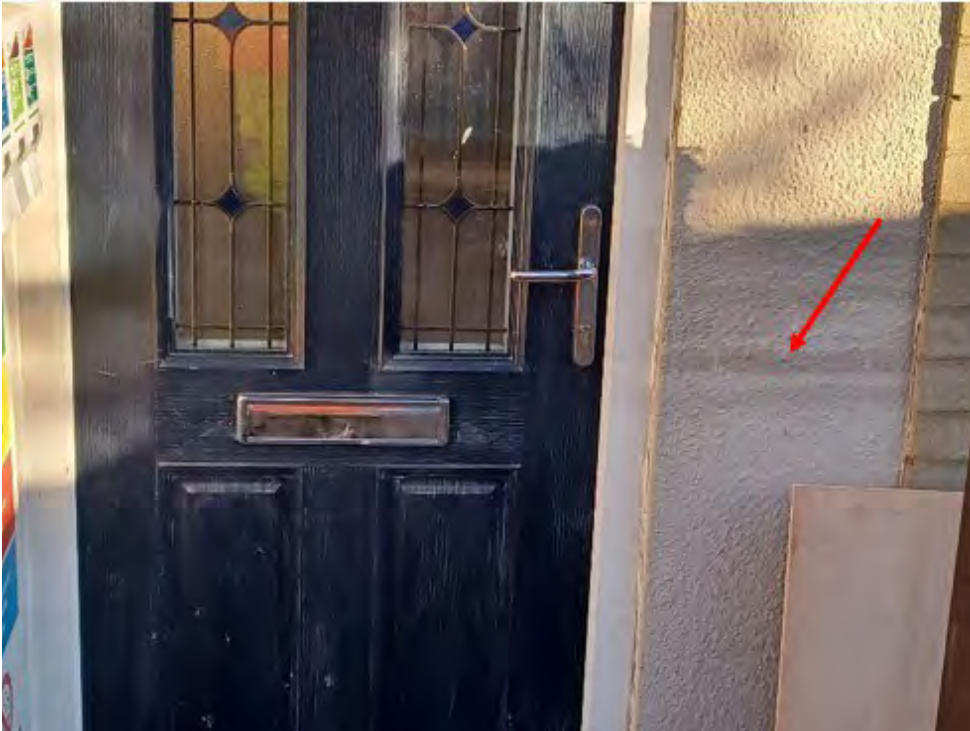
Figure 3-54: Flood water marks about halfway up the door and wall of a property in the community marked by a red arrow.
