4. Don and Rother Catchment

4.1 Don and Rother Catchment Event Hydrology

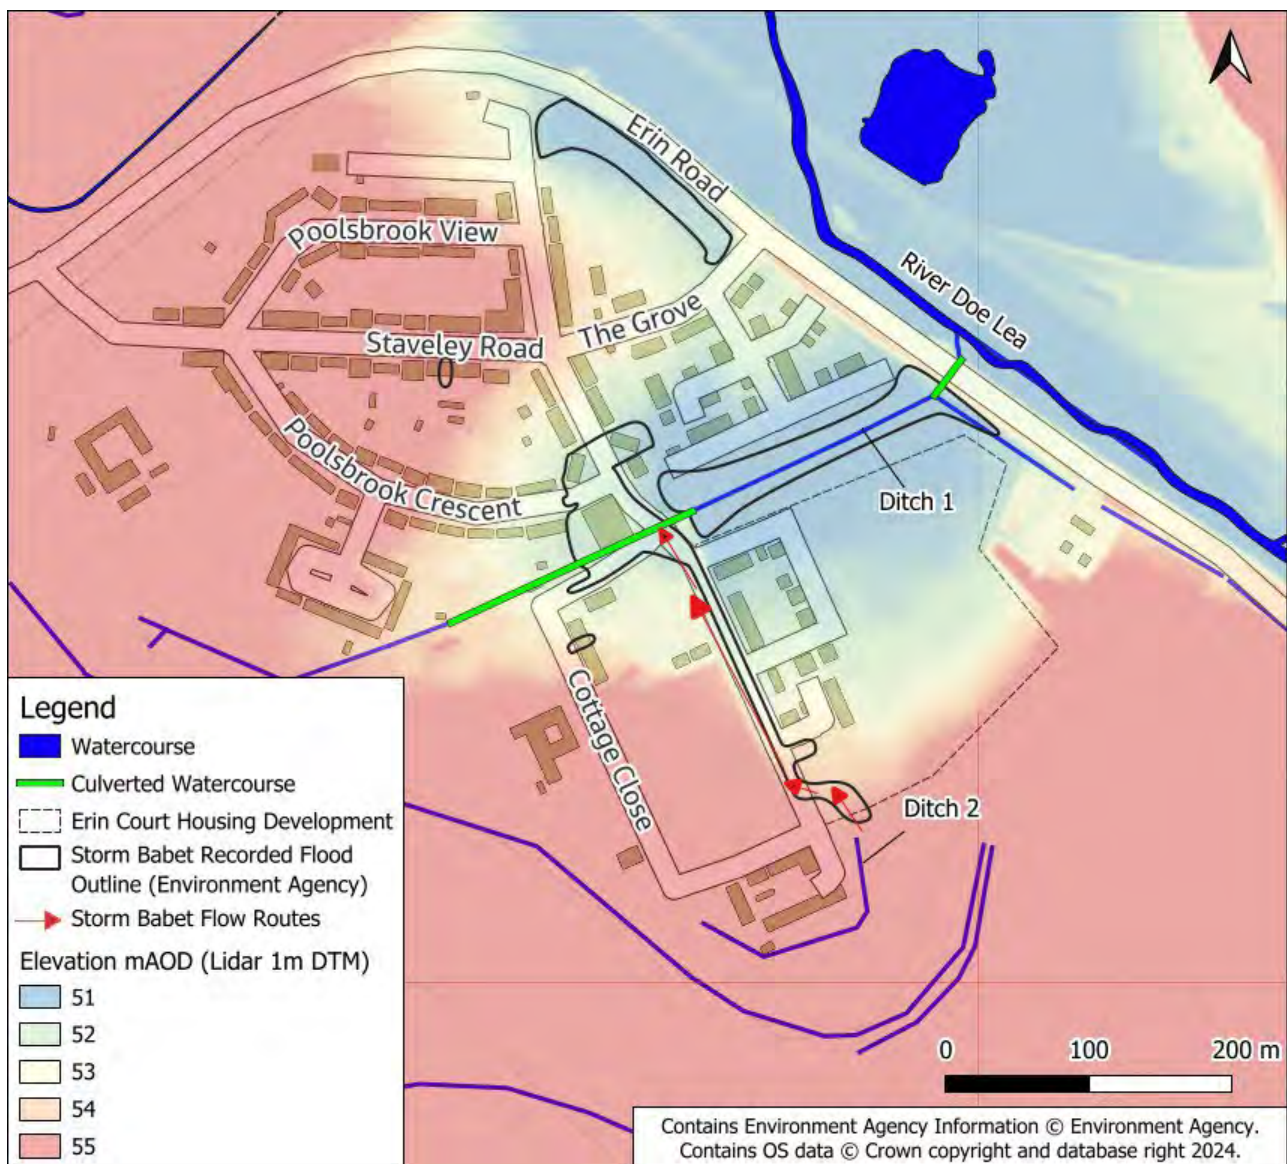
Floodwater flowed from the woodland to the south of Erin Court into the housing development where two homes were flooded internally. This floodwater then flowed downslope along Staveley Road to the low spot, internally flooding the six other properties. It is understood that the floodwater that flowed out of the woodland originated from Ditch 2. Chesterfield Borough Council, as the riparian owner of Ditch 2, have since been investigating the cause of flooding. Investigations are ongoing to understand to what extent a potential blockage could have exacerbated the impact of exceptional weather.

The sewer network discharged at the rear of No. 58 Staveley Road, at the junction of Staveley Road and Poolsbrook Crescent and from the trunk sewer adjacent to the eastern end of Ditch 1 by the A6192. The Yorkshire Water pumping station is shown on Figure 4-2. Yorkshire Water is undertaking an investigation into the potential pumping station failure.

Figure 4-5: Ground level, flooding extent and flow routes at Poolsbrook.

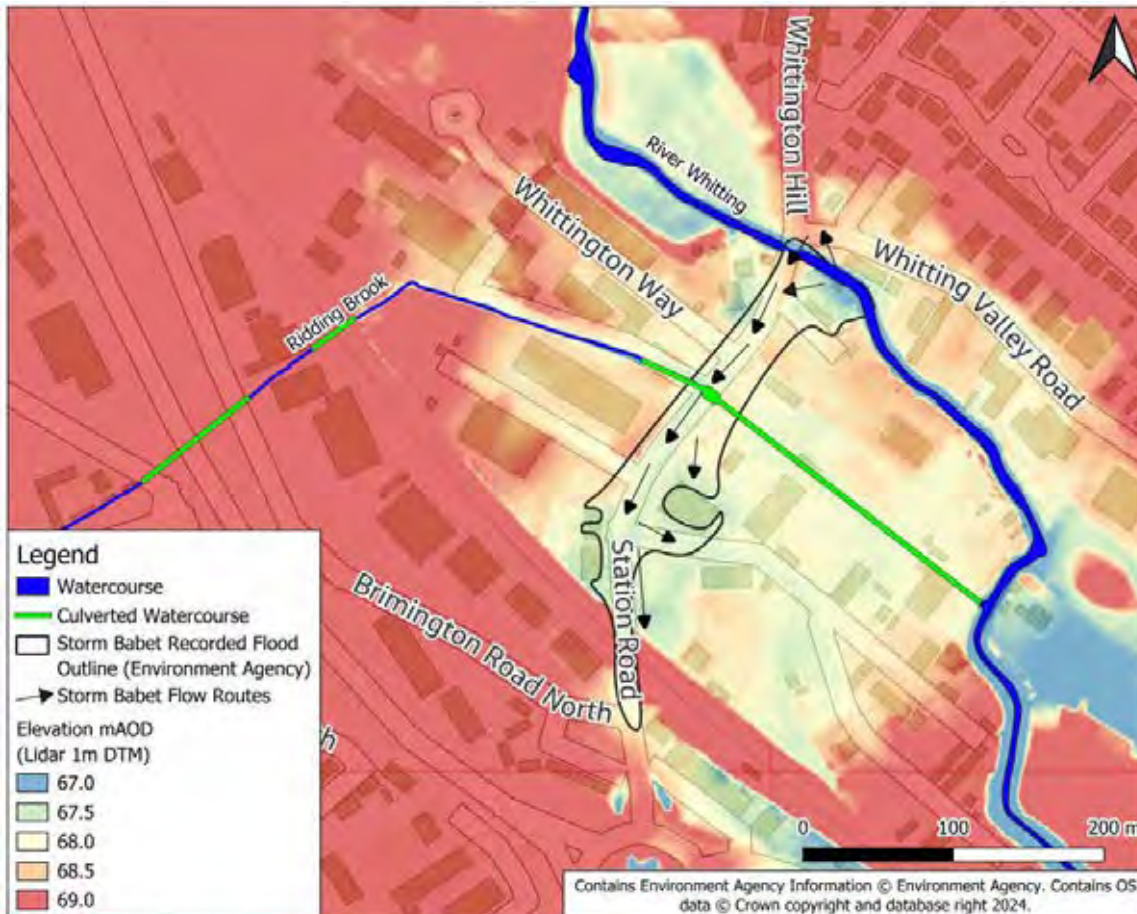
Figure 4-9 shows the flow routes at this community, based on discussions with Chesterfield Borough Council. Hydrology data shows that on the 20th of October, the peak level recorded at the Sheepbridge River Whitting gauge, located approximately 0.9km from the community reached 2.56m; the highest level ever recorded. The gauge indicates that water levels in the River Whitting began to rise on the 20th of October at about midnight, reaching its peak at 2:00pm on the 20th of October.

Figure 4-9: Ground level flow routes at Station Road, Whittington Moor.

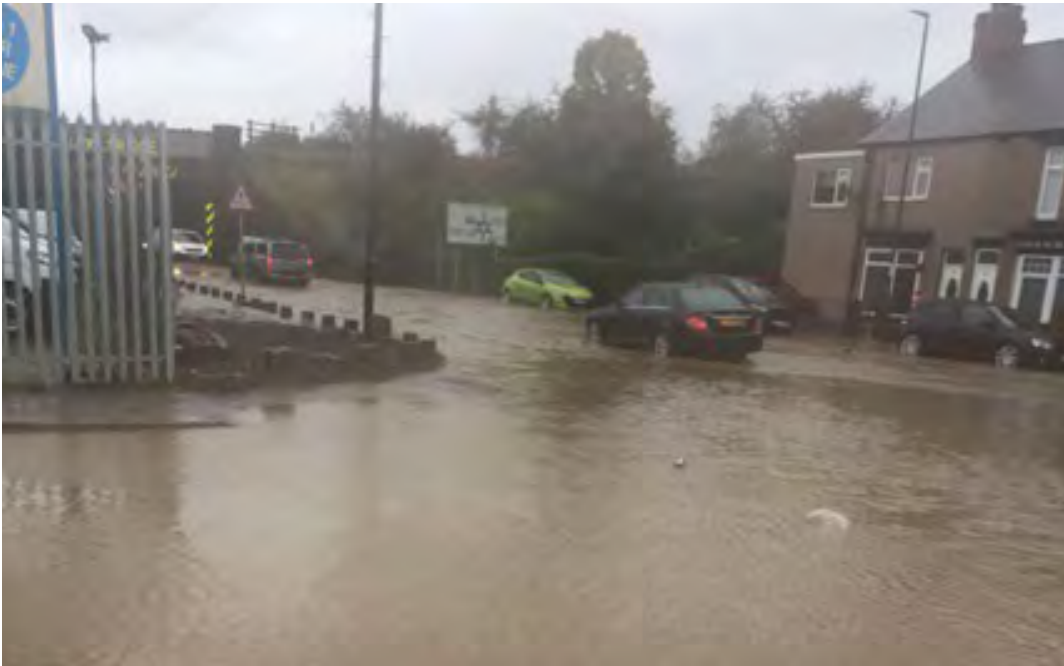
The reported depths of floodwater reached approximately 30cm at the low spot on Station Road, as shown in Figure 4-10. The reported depths of internal flooding reached approximately 50cm, as indicated by a watermark left on one property.

Figure 4-10: Flood water at Station Road low spot on the afternoon of the 20th of October. Photo taken looking south-westwards.

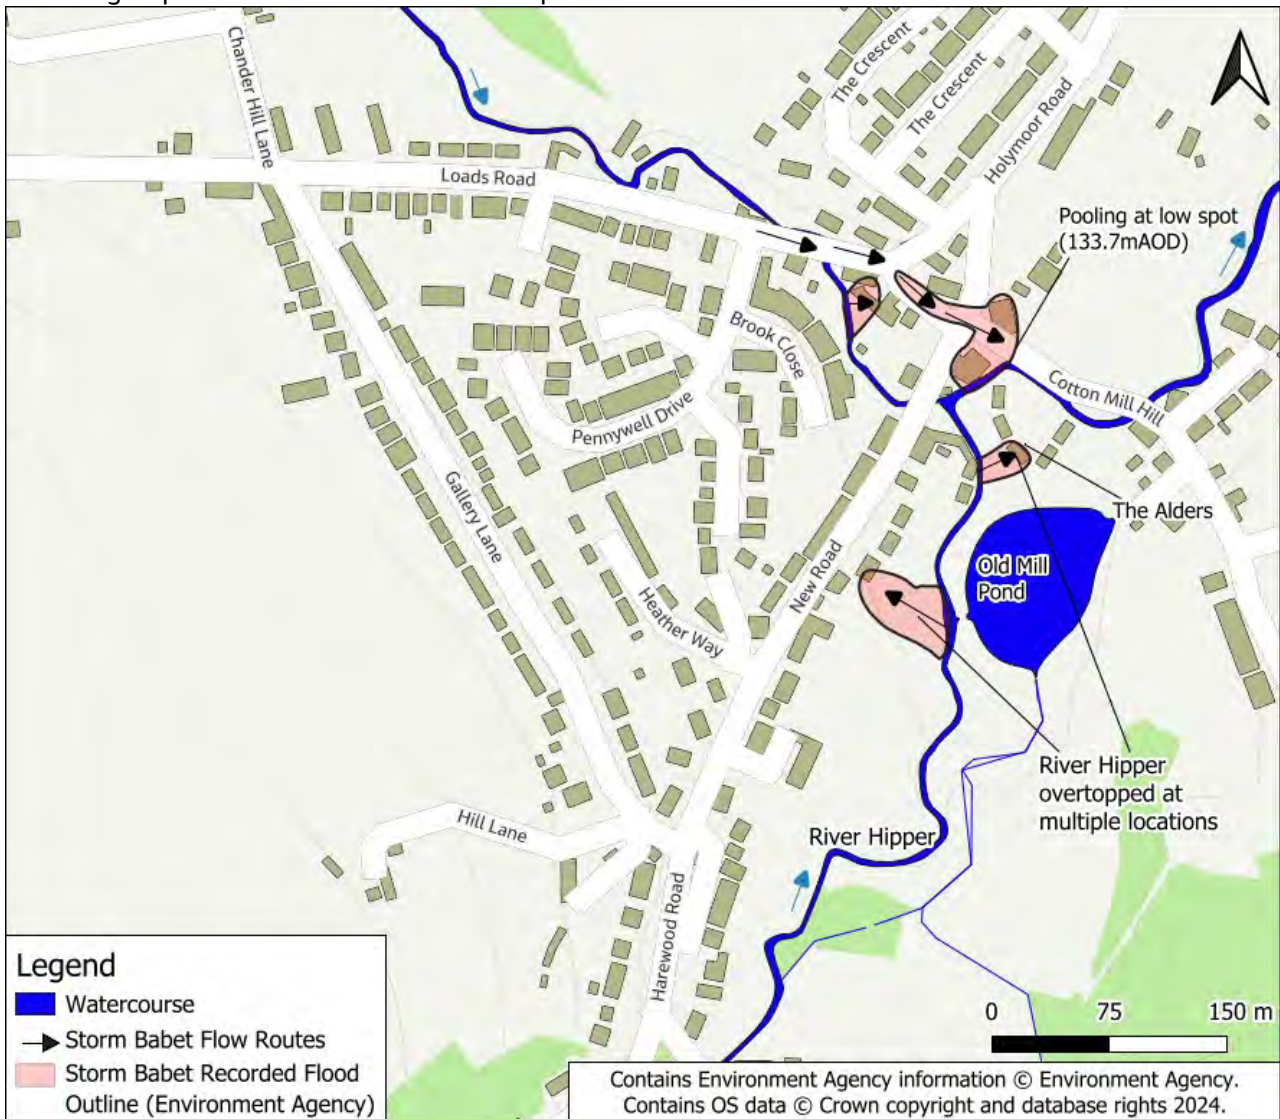
Figure 4-14 shows the assumed flow routes and elevations which will have contributed to the flood extent. Hydrology data shows that on the 20th of October, the peak level recorded at the Holymoorside gauge downstream of Loads Road bridge on the River Hipper, reached 1.58m; the highest level ever recorded. The gauge indicates that water levels in the River Hipper began to rise on the 20th of October at about midnight, reaching its peak twelve hours later at 12:00pm.

Figure 4-14: Flood extent and flow routes at Holymoorside.

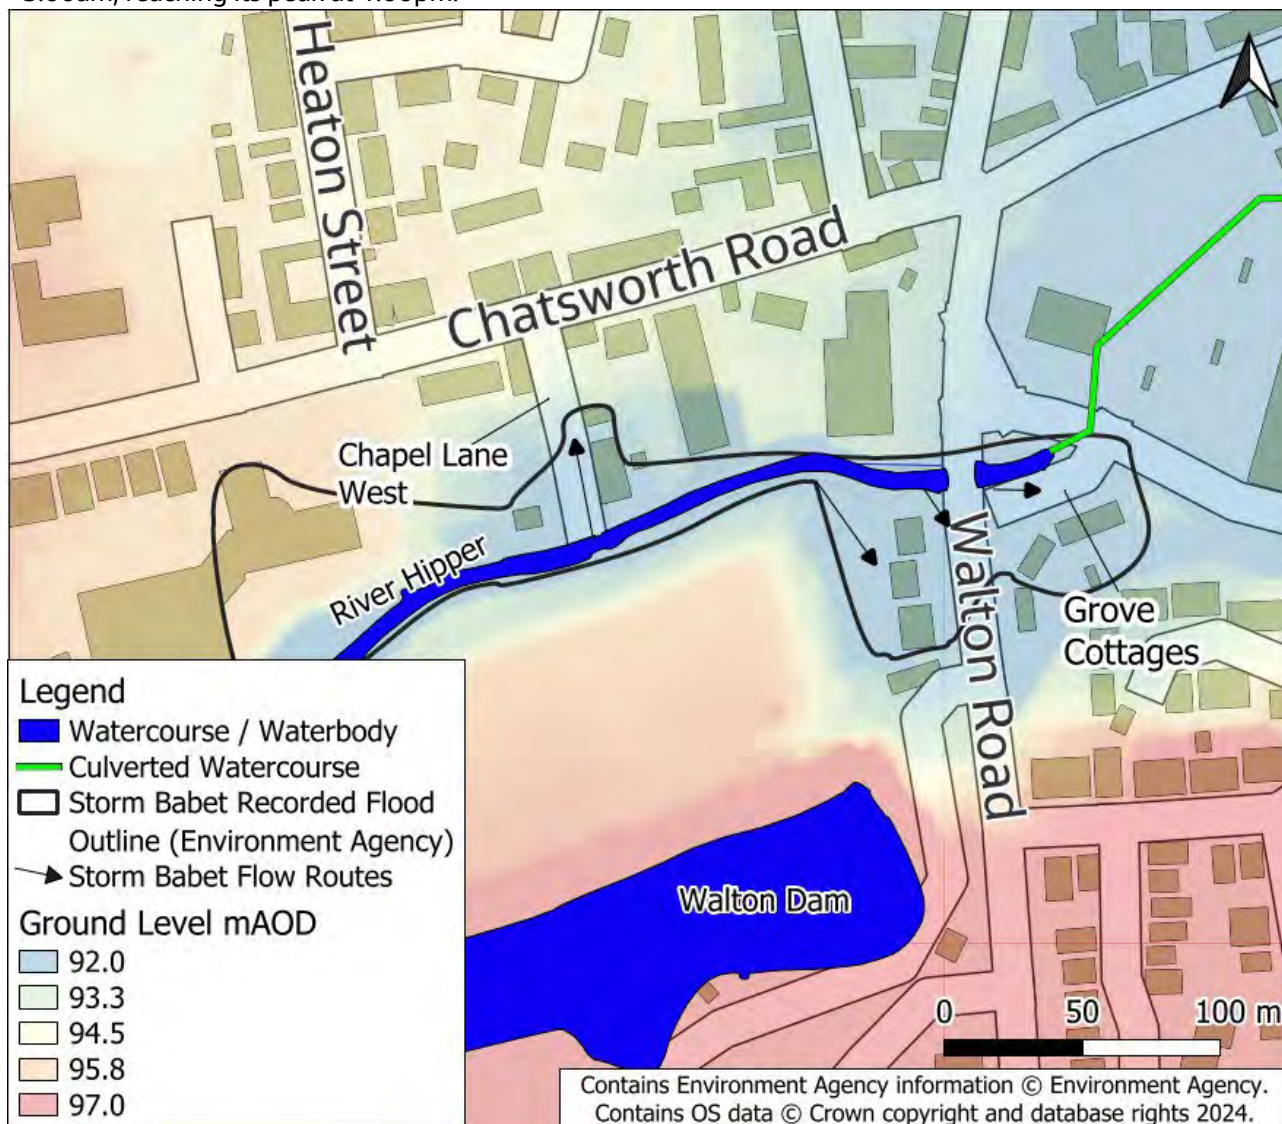
located approximately 20m upstream of Walton Road bridge, reached 3.59m; the highest level on record. The gauge indicates that water levels in the River Hipper began to rise on the 20th of October at about 3:00am, reaching its peak at 1:00pm.

Figure 4-18: Ground level and likely floodwater flow routes during Storm Babet at the Chatsworth Road West community.

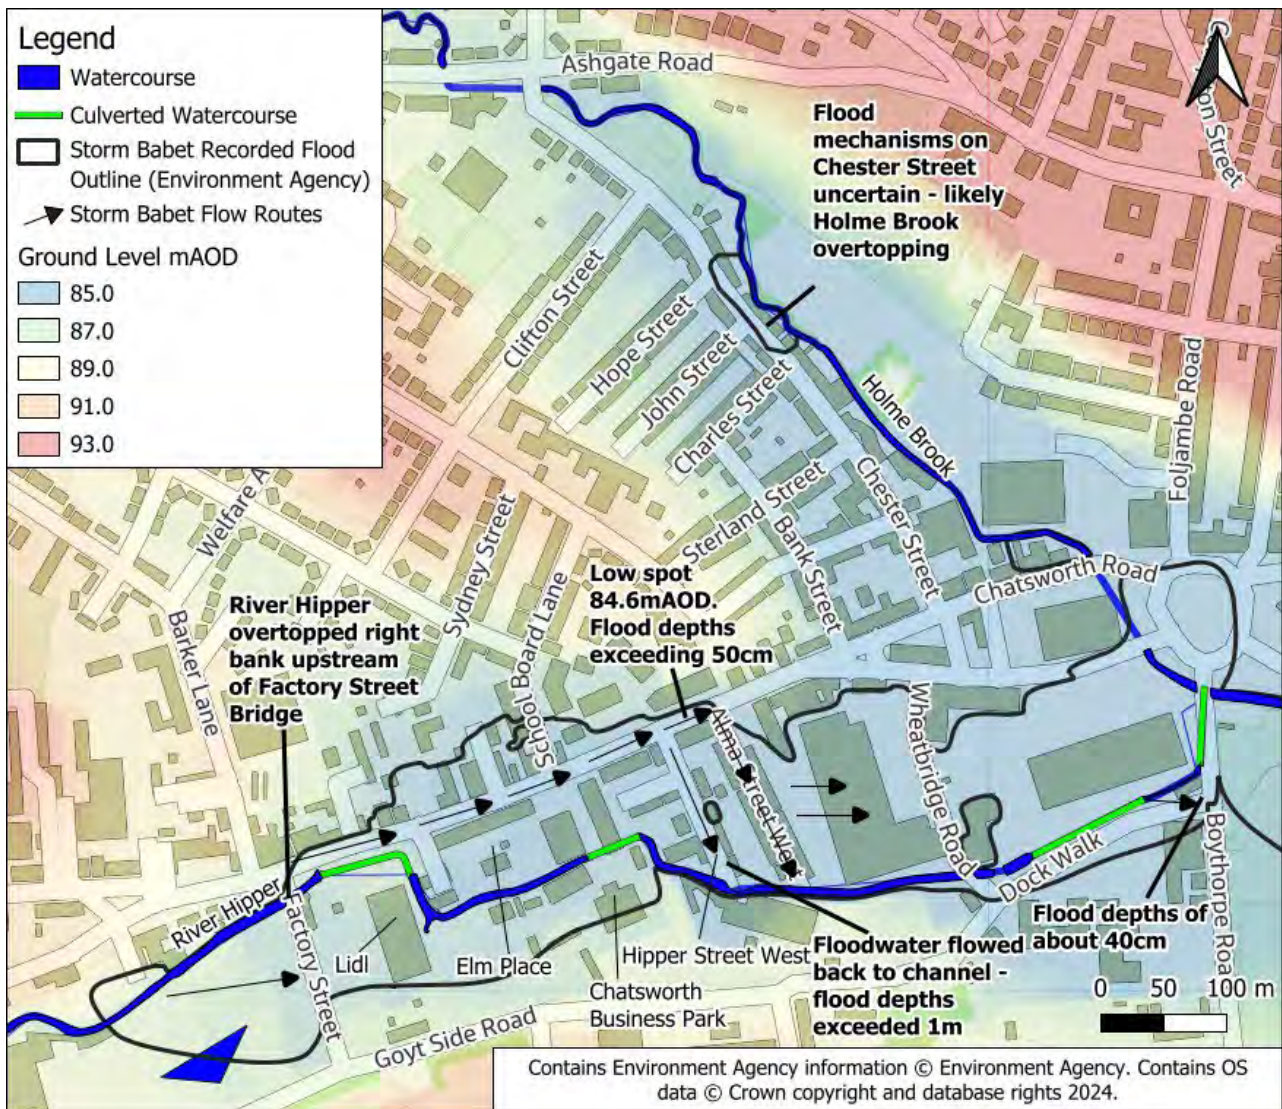
The Chesterfield Ashgate gauge is located on Holme Brook by Purbeck Avenue bridge, approximately 1.5km upstream of where Holme Brook joins the Hipper and shows that on the 20th of October, the peak level recorded reached 1.6m; the second highest level ever recorded. The gauge indicated that water in Holme Brook began to rise on the 20th of October at about 2:00am, reaching its peak at 1:00pm.

Figure 4-22: Ground level and Storm Babet flow routes at the Brampton community.

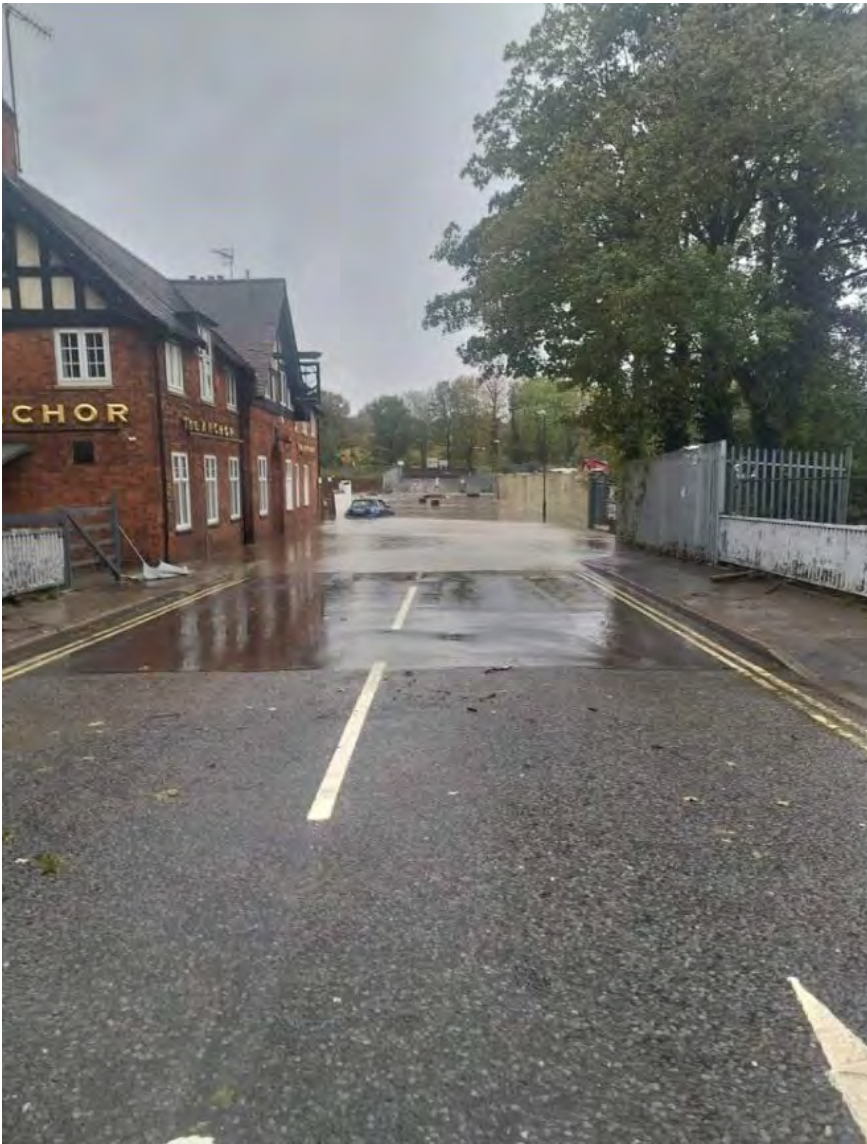
The River Hipper overtopped near the derelict brownfield site upstream of Factory Street, inundating this site before flooding Factory Street and the Lidl car park. Properties on Chatsworth Road, upstream of the Factory Street bridge, are not reported to have internally flooded. Factory Street bridge was surcharged, as is evidenced by Figure 4-23, taken after water levels had receded somewhat. The figure shows debris caught in the bridge rails on either side of the road. A public house was internally flooded on Factory Street, shown in Figure 4-23 to be submerged south of the River Hipper. Media evidence indicates that the flood depth at the entrance to Lidl, which is a low spot-on Factory Street, likely exceeded 0.5m.

Figure 4-23: Flooding of low spot on Factory Street. Photograph taken from immediately north of Factory Street bridge.

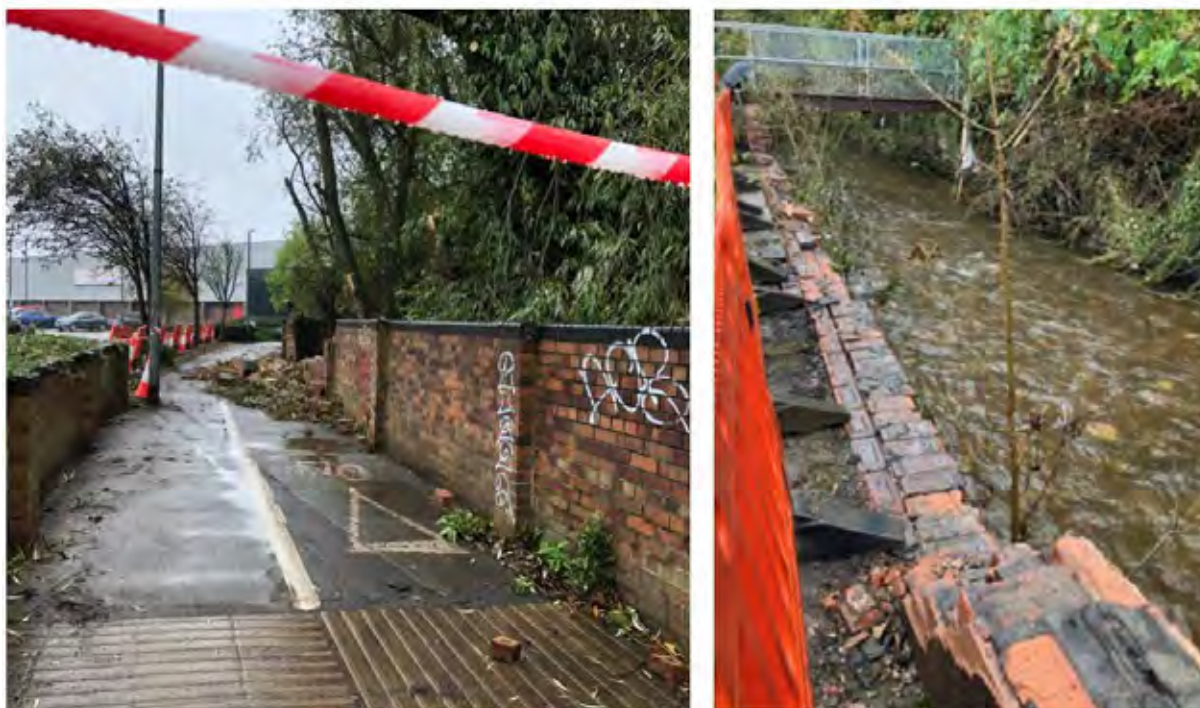
River channel exceedance within this community caused numerous instances of infrastructure damage. For example, the overtopping of Holme Brook and River Hipper caused a riparian owned brick wall to collapse adjacent to West Bars roundabout and just upstream of the culvert immediately west of Boythorpe Road, respectively. The damage sustained to a red brick wall during Storm Babet is shown in Figure 4-24 below. The area is taped off and cones have been placed around the section that has collapsed.

Figure 4-24: Collapsed walls as a result of the overtopping of Holme Brook (left) and the Hipper (right).

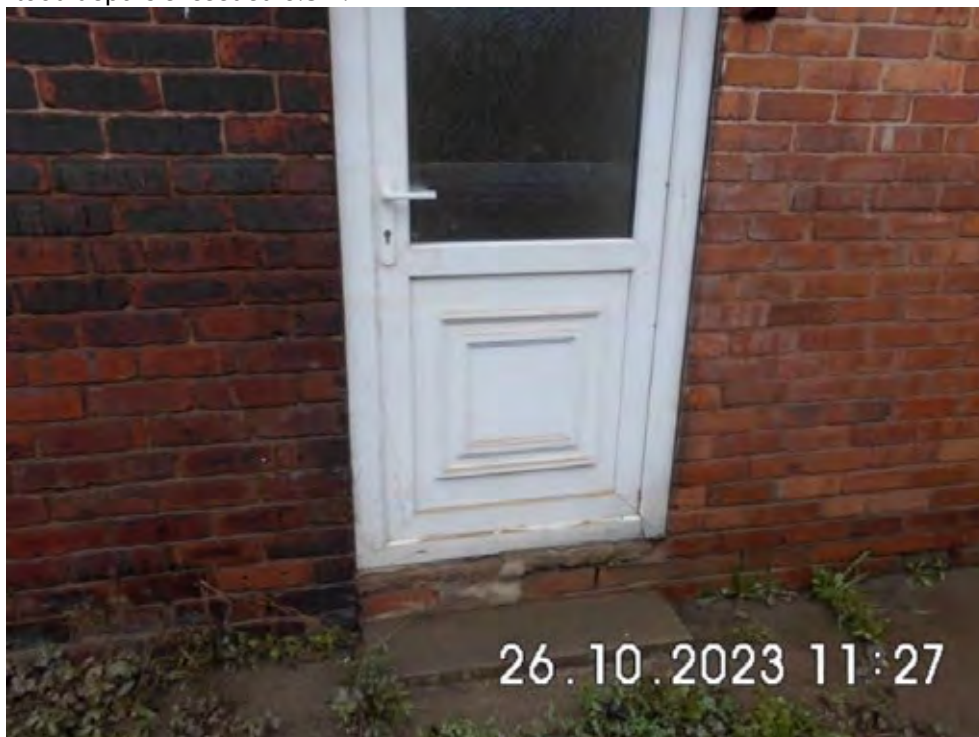
Figure 4-28: Water mark on the rear door of a property on Hawthorne Street.

Residents on Hawthorne Street reported that floodwater also overtopped the embankment at the south-east end of the street. Sherwood Street residents reported floodwater to have initially originated from a manhole, and that floodwater then entered the rear gardens of Sherwood Street homes from the Rother by infiltrating through the wall rather than by overtopping it (i.e., penetrated through the flood wall to the north-east of Sherwood Street). Note, however, that post-event asset surveys conducted by the Environment Agency did not detect any infiltration. The initial route of floodwater entering homes on Sherwood Street was reported to be through property air bricks and subsequently through the floor.

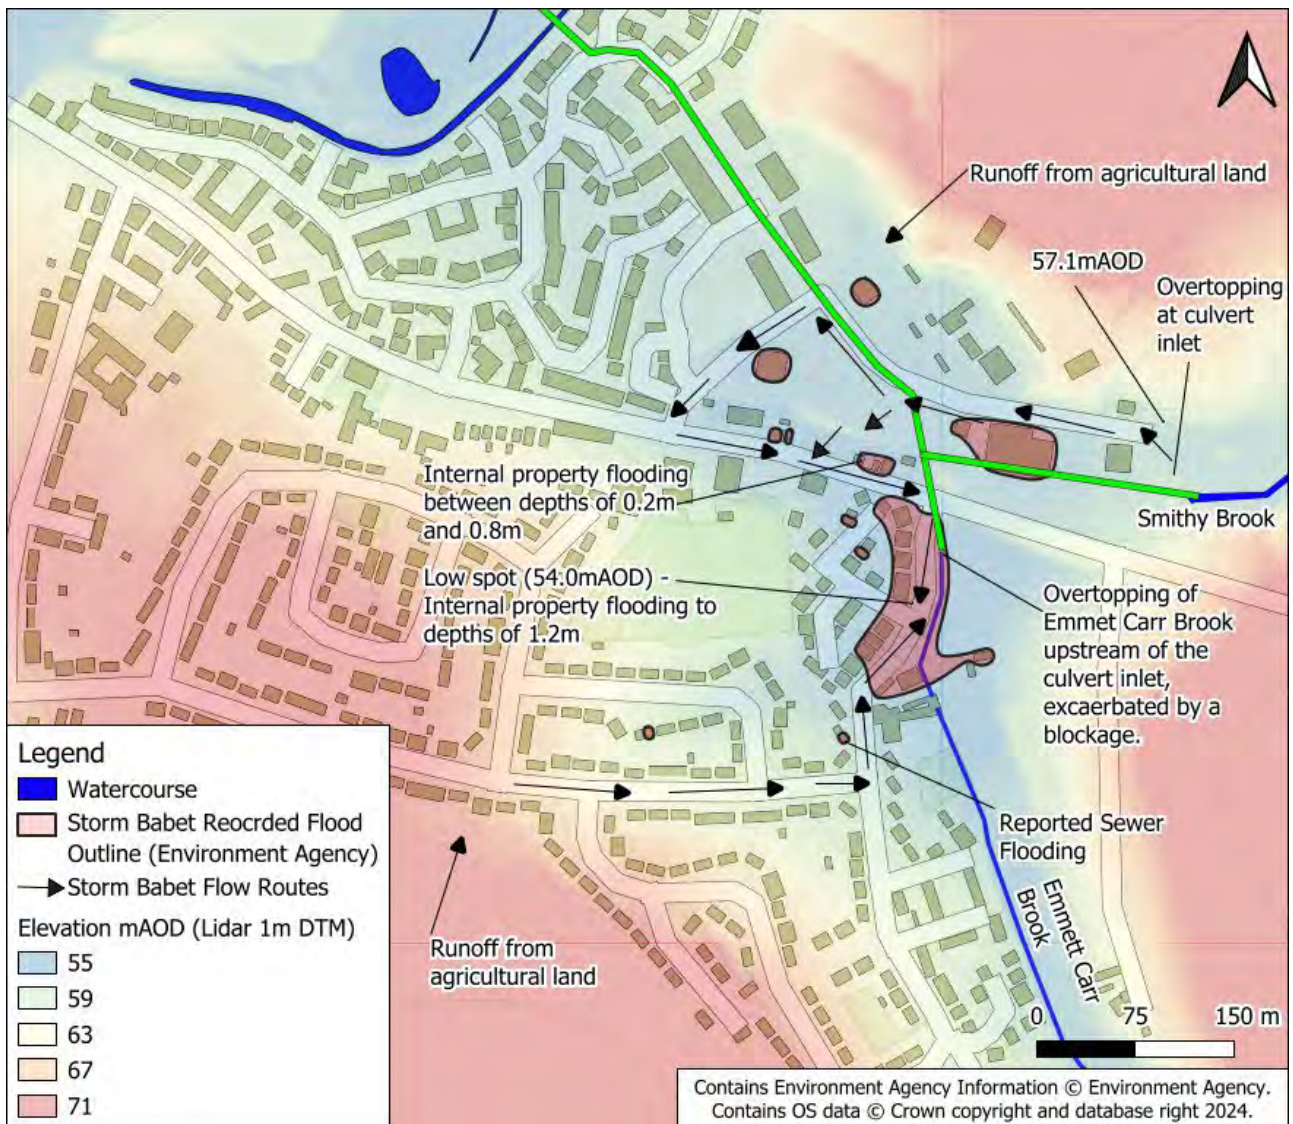
Figure 4-32 shows the flood extent, mechanisms and flow routes that occurred at Renishaw. It is clear that in addition to the exceptional rainfall, the flooding was also caused by culvert blockages at the inlet of both Smithy Brook and Emmett Carr Brook culvert inlets. Flood depths of up to 1.5m outside and 1m inside properties were reported.

Flow routes traversed westwards along Smithy Brook Road after having overtopped at the Smithy Brook culvert inlet. Overflowing is also considered to have occurred upstream of the Emmet Carr Brook culvert inlet. Both instances are noted as being exacerbated by culvert blockages. Smithy Brook flood water is shown to join Sheffield Road and the Emmet Carr Brook floodwater. Internal flood depths are thought to have reached depths of 0.2m to 0.8m on Sheffield Road, and upto 1.2m in a property on Emmet Carr Lane.

Figure 4-32: Ground level and Storm Babet flow routes at Renishaw.

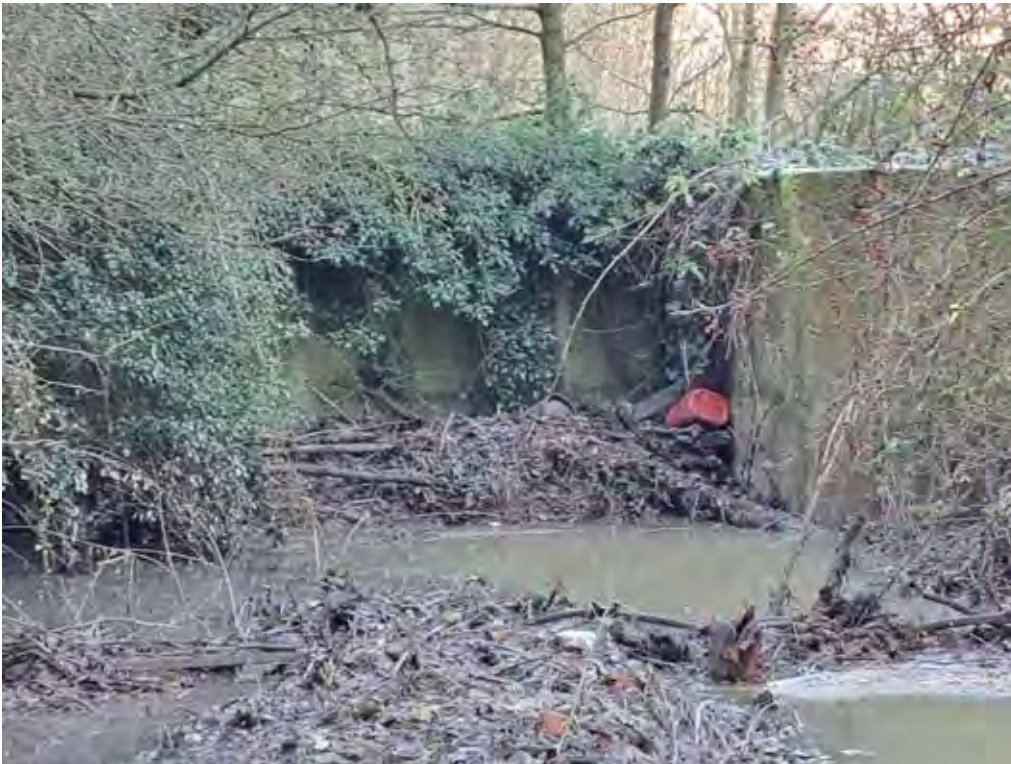
Figure 4-33: Debris blockage at Smithy Brook culvert inlet (upstream of Smithy Brook Road).

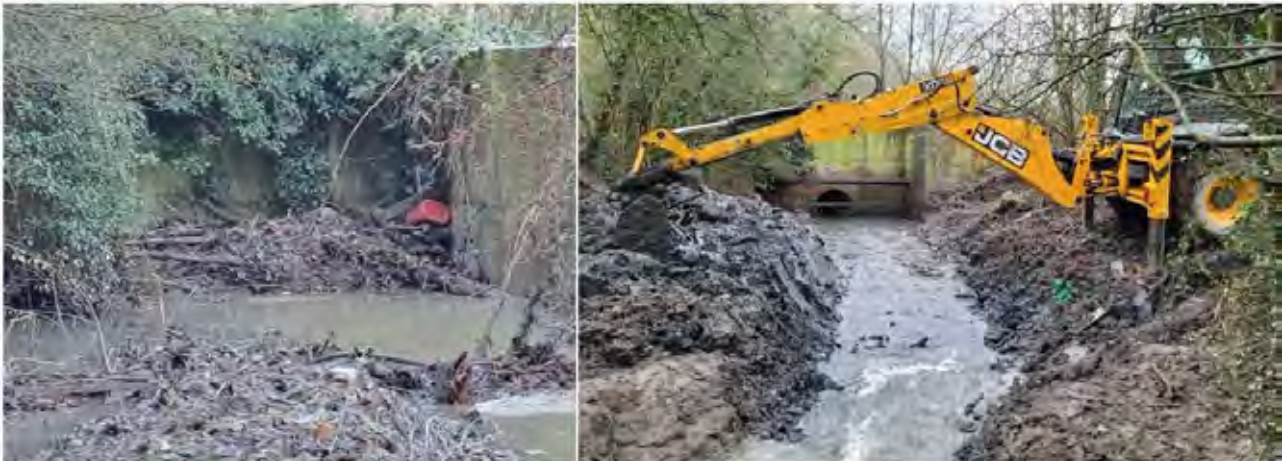
Figure 4-34: Smithy Brook culvert prior (left) and post (right) trash screen clearance.

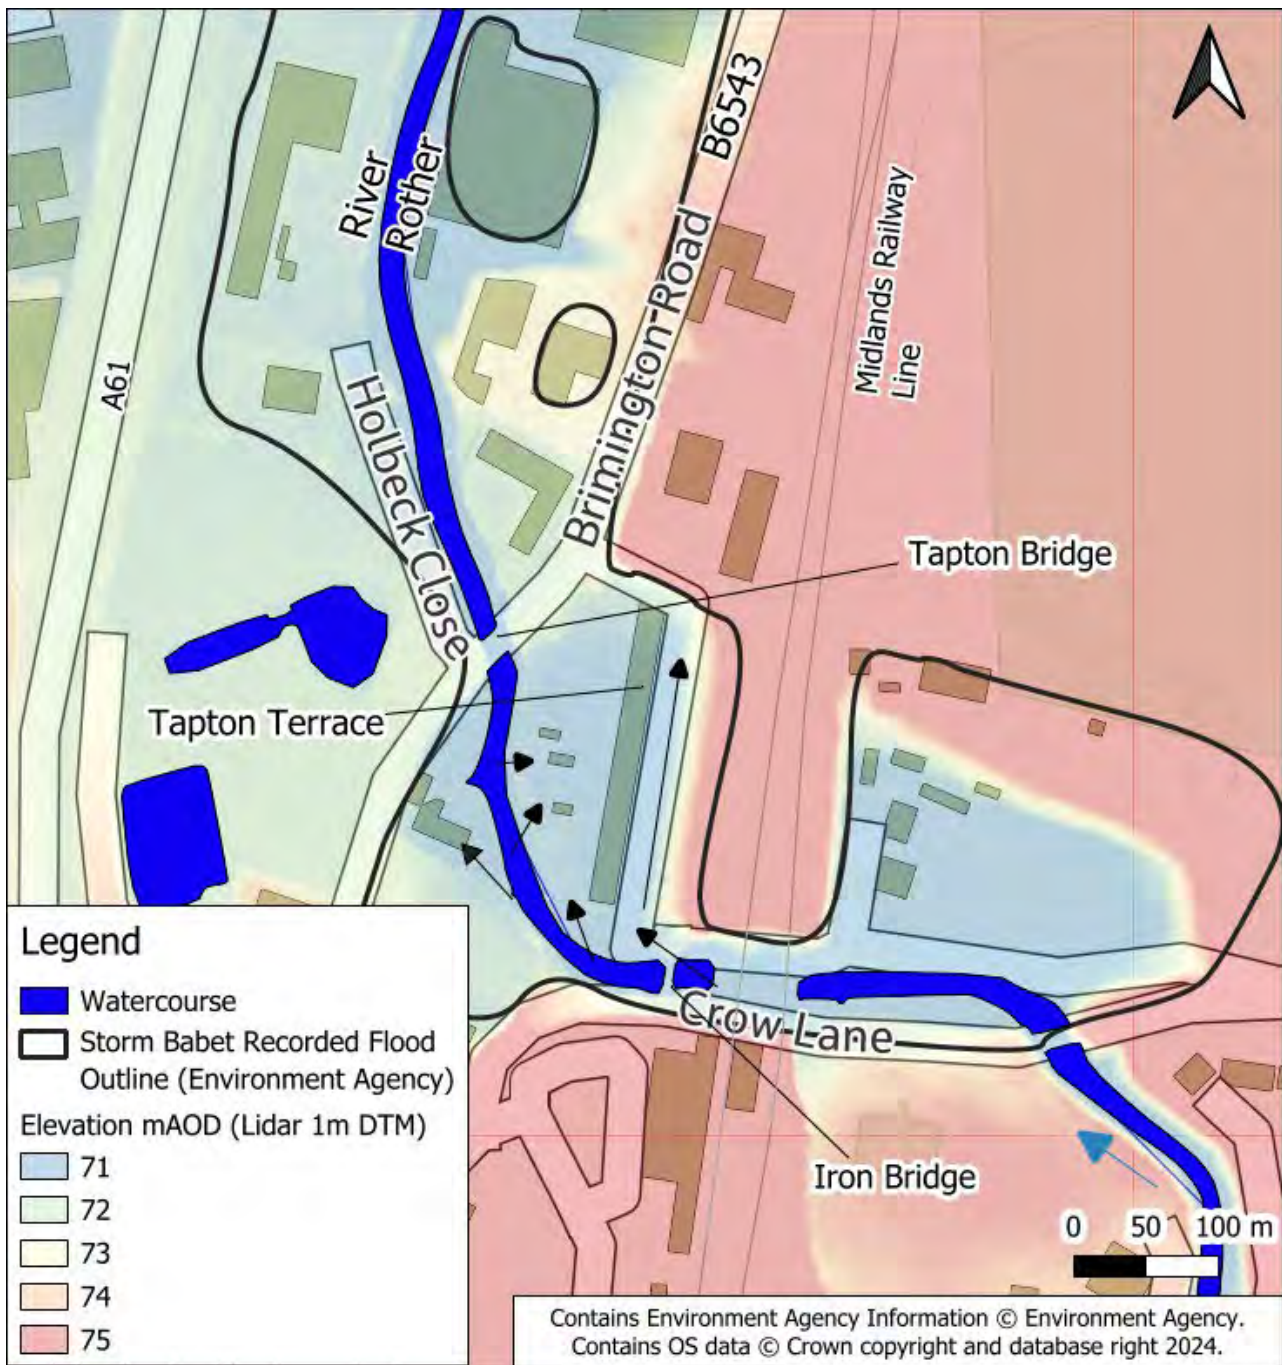
Figure 4-38: Ground level and Storm Babet flow routes at Tapton Terrace.

Investigations are ongoing to determine the impact of Tapton Bridge on restricting flow in the River Rother. Initial flooding near Tapton Terrace occurred at the low spot of the west bank of the river, impacting a non-residential property. River levels then exceeded the low spot on the east bank of the river, impacting the rear of all twenty-six homes, before flooding from the front, down to Tapton Bridge. Flooding reached depths of 1.5m in some properties, which would exceed the design standards of external PFR measures. Flooding of such depths represents a hazard to members of the public.

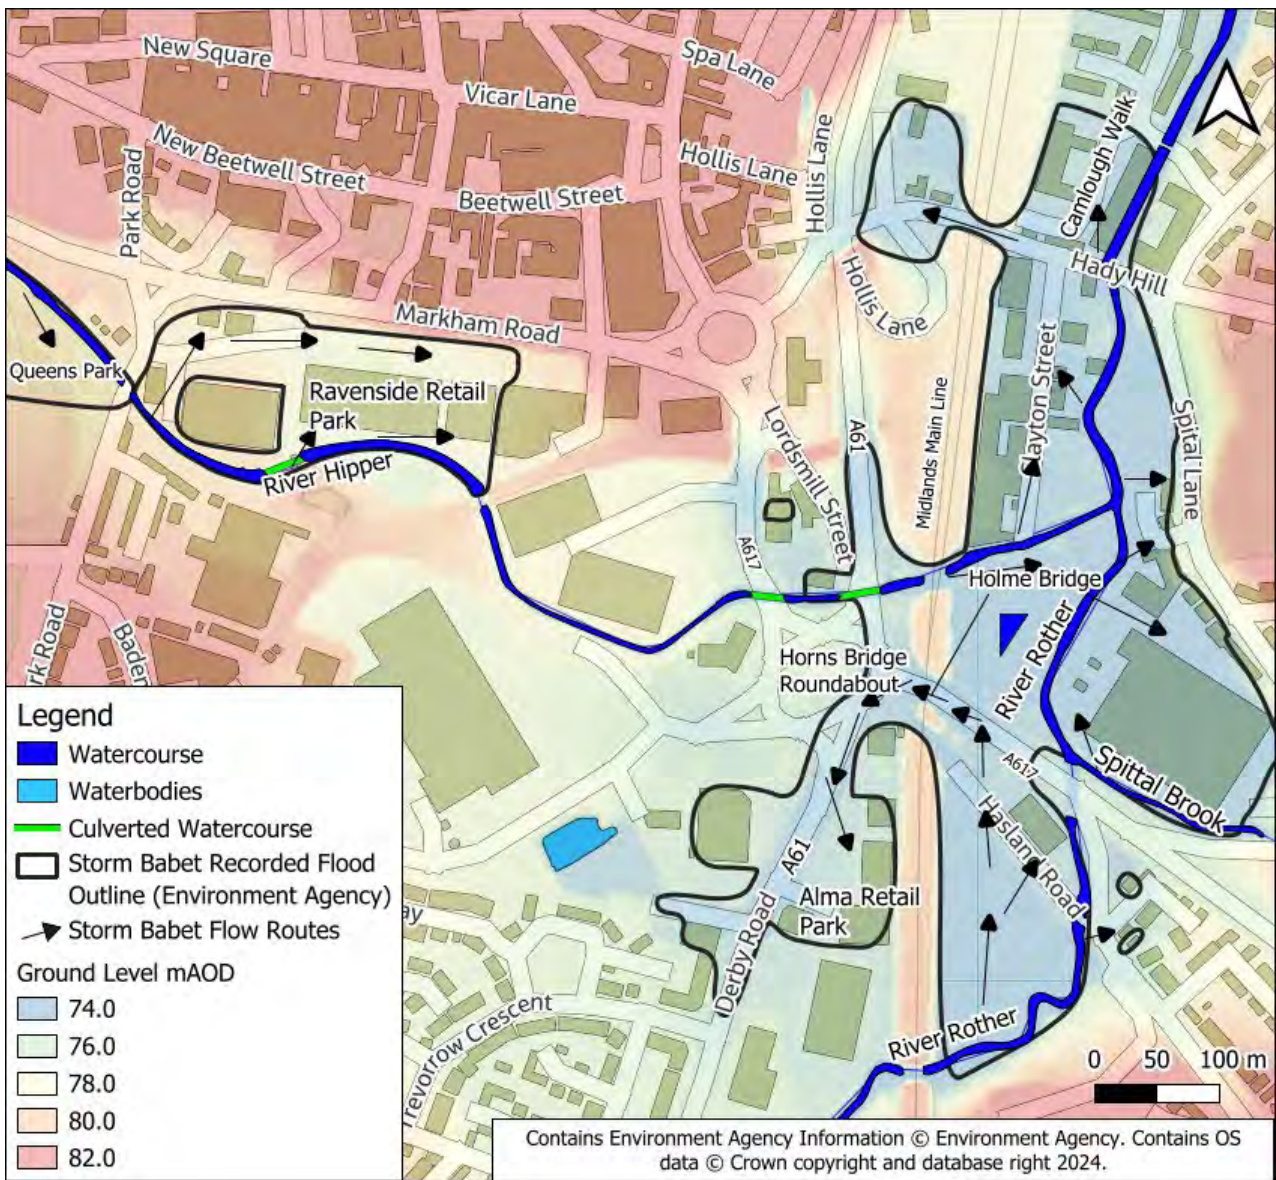
Flooding at this community was mainly caused by the River Rother, the River Hipper and Spital Brook exceeding their channel capacity. There is evidence to suggest that sewer systems were also overwhelmed in some areas of this community, which is likely to have contributed to flooding. Surface water runoff also likely exacerbated flooding in some areas, although the extent of floodwater contribution from sewer and surface water sources is unclear.

Figure 4-42: Ground level and Storm Babet flow routes at Central Chesterfield.

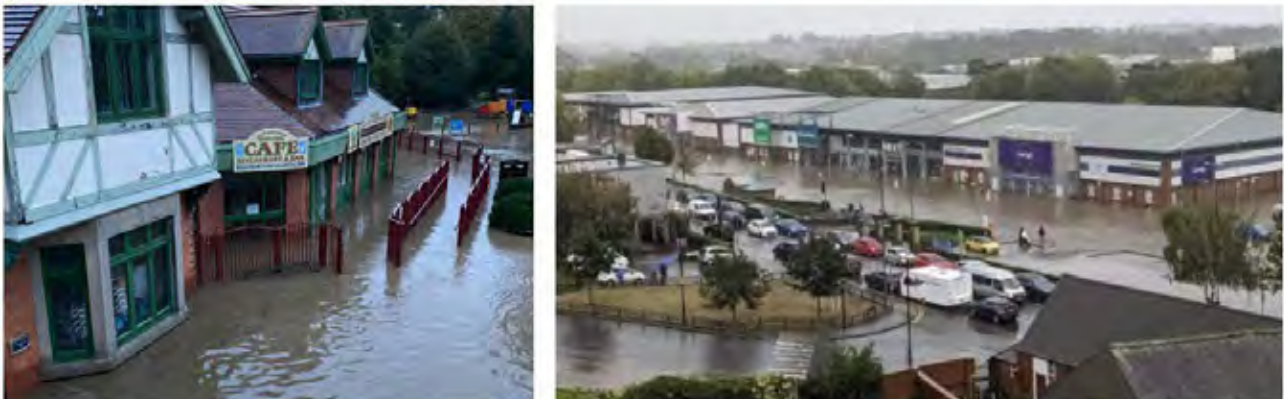
Figure 4-43: Left - Flooding at a business within Queens Park. Right - Flooding on the northern side of Ravenside Retail Park.

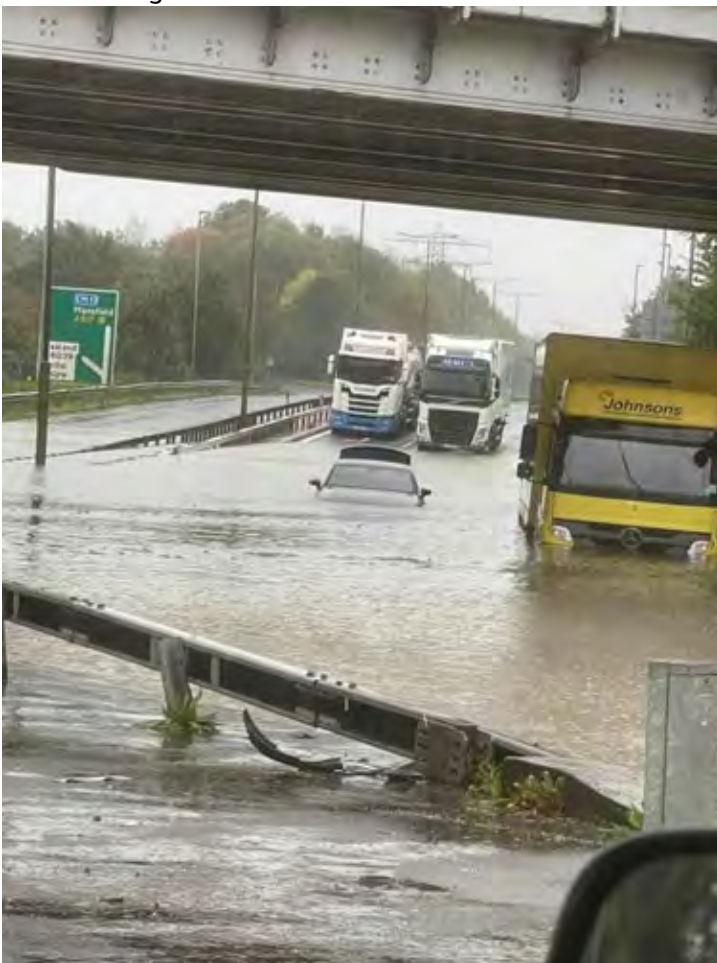
Flooding at this community had a substantial impact on infrastructure in the vicinity of Horns Bridge. Numerous roads were impassable due to excessive flood depths, including all arms of Horns Bridge roundabout. Watermarks on railings and signposts at the roundabout indicate water depths reached about 0.5m. The A617, to the south-east of Horns Bridge roundabout, was flooded to depths exceeding 0.5m at its low spot. The cause of flooding here is understood to have been a combination of river, sewer, and surface water sources. Floodwater overflowing the River Rother near to the A617 is understood to have flowed from both north and south directions towards the low spot on the A617. Additionally, a sewer passes beneath the rail embankment at this location, which has a history of being overwhelmed. During Storm Babet, floodwater surcharged from the manhole on the A617, contributing to the flooding there. In addition, surface water is likely to have contributed to flooding at this location due to the local topography. Flooding at the low spot is shown in Figure 4-44.

Figure 4-44: Flooding on the A617 at the low spot beneath the railway underpass at Horns Bridge. Photograph taken from Horns Bridge Roundabout.

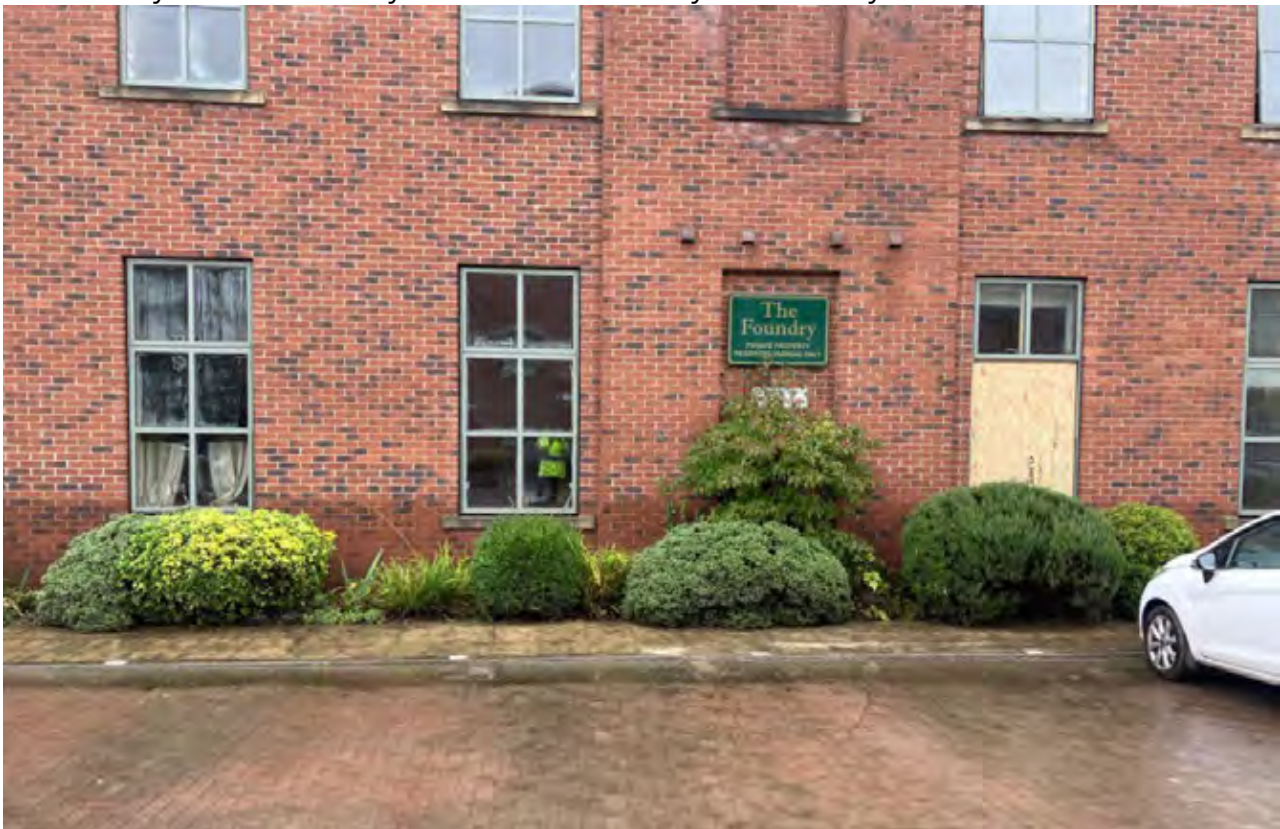
The River Rother overflowed its west bank at Hady Hill. Hady Hill slopes westwards from the Hady Hill bridge to a low spot beneath the East Midlands Main Line, which crosses Hady Hill about 100m west of the River Rother. The Foundry and Markham Quay are apartment blocks located on Camlough Walk, just north of Hady Hill and west of the River Rother. Markham Quay is located on the west bank of the River Rother, while The Foundry is about 50m further west but at a similar elevation. The ground floor of both these buildings suffered internal flooding, as did three businesses on Hady Hill between the River Rother and the railway underpass. Although the dominant flood source was from the River Rother overflowing, reports of sewage at The Foundry and Markham Quay indicate that the sewer system was likely to have been overwhelmed.

Figure 4-45: Photograph of watermarks reaching over 0.5m on The Foundry building, Camlough Walk taken in the aftermath of flooding.

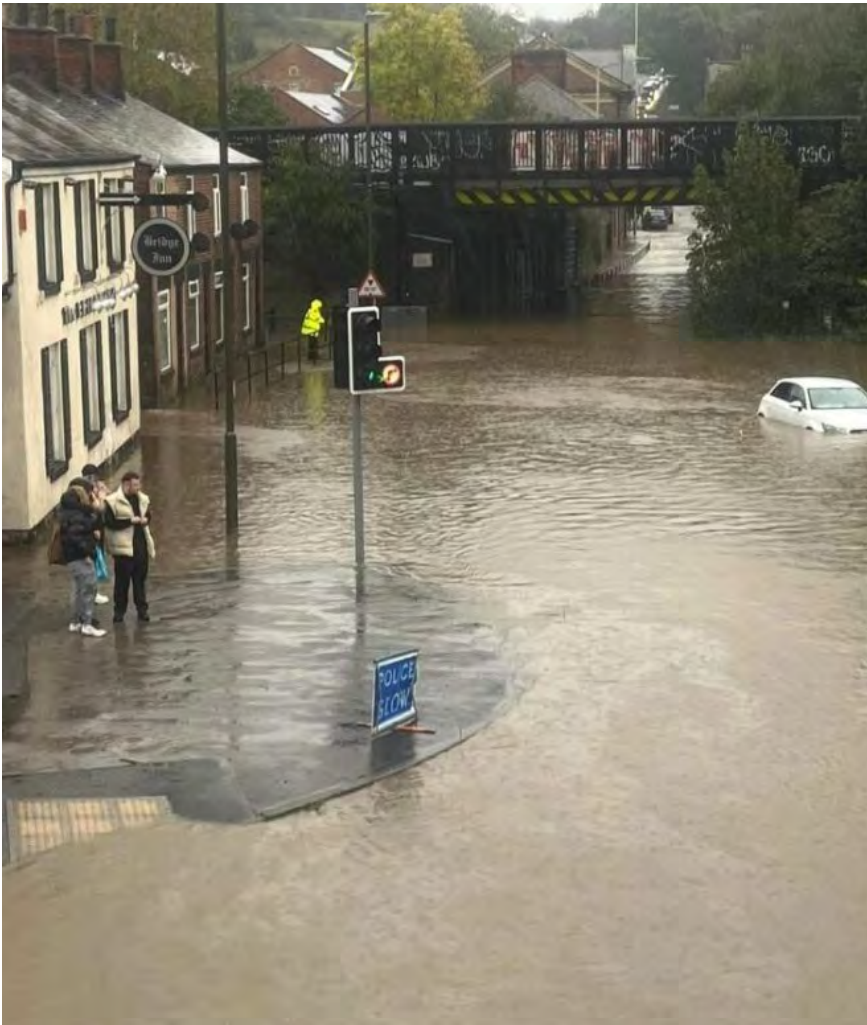
Figure 4-46: Flooding on Hollis Lane, facing eastwards towards Hady Hill.
