4. Don and Rother Catchment

4.1 Don and Rother Catchment Event Hydrology

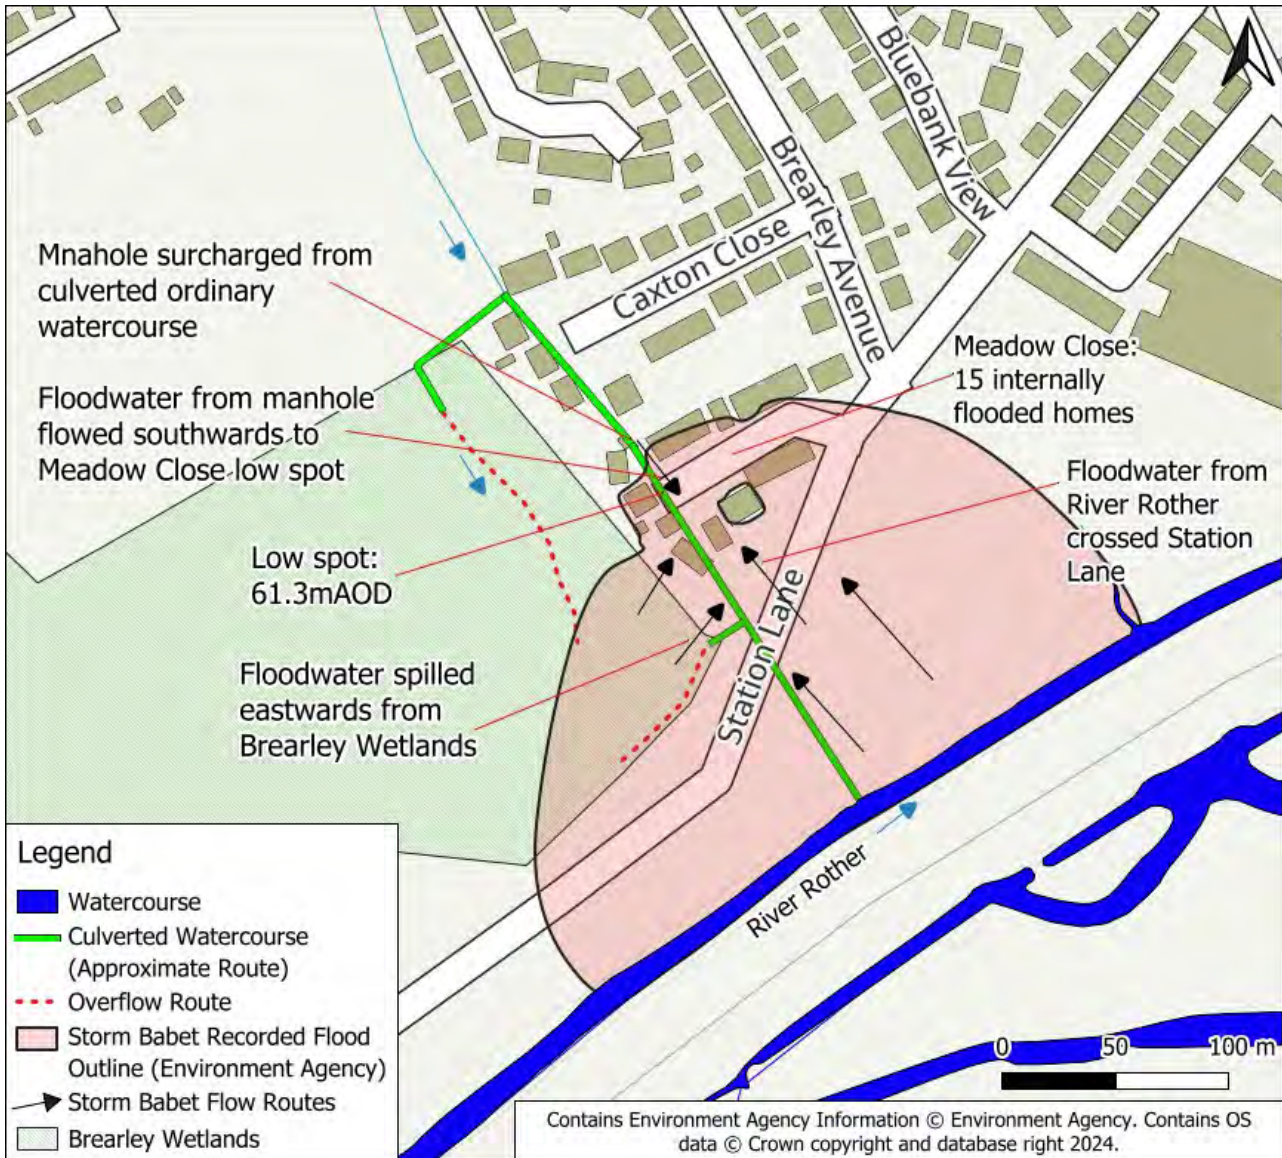
Figure 4-50: Flow pathways and annotated flood mechanisms of Storm Babet flooding in the vicinity of Meadow Close. Source: Derbyshire County Council Flood Team.

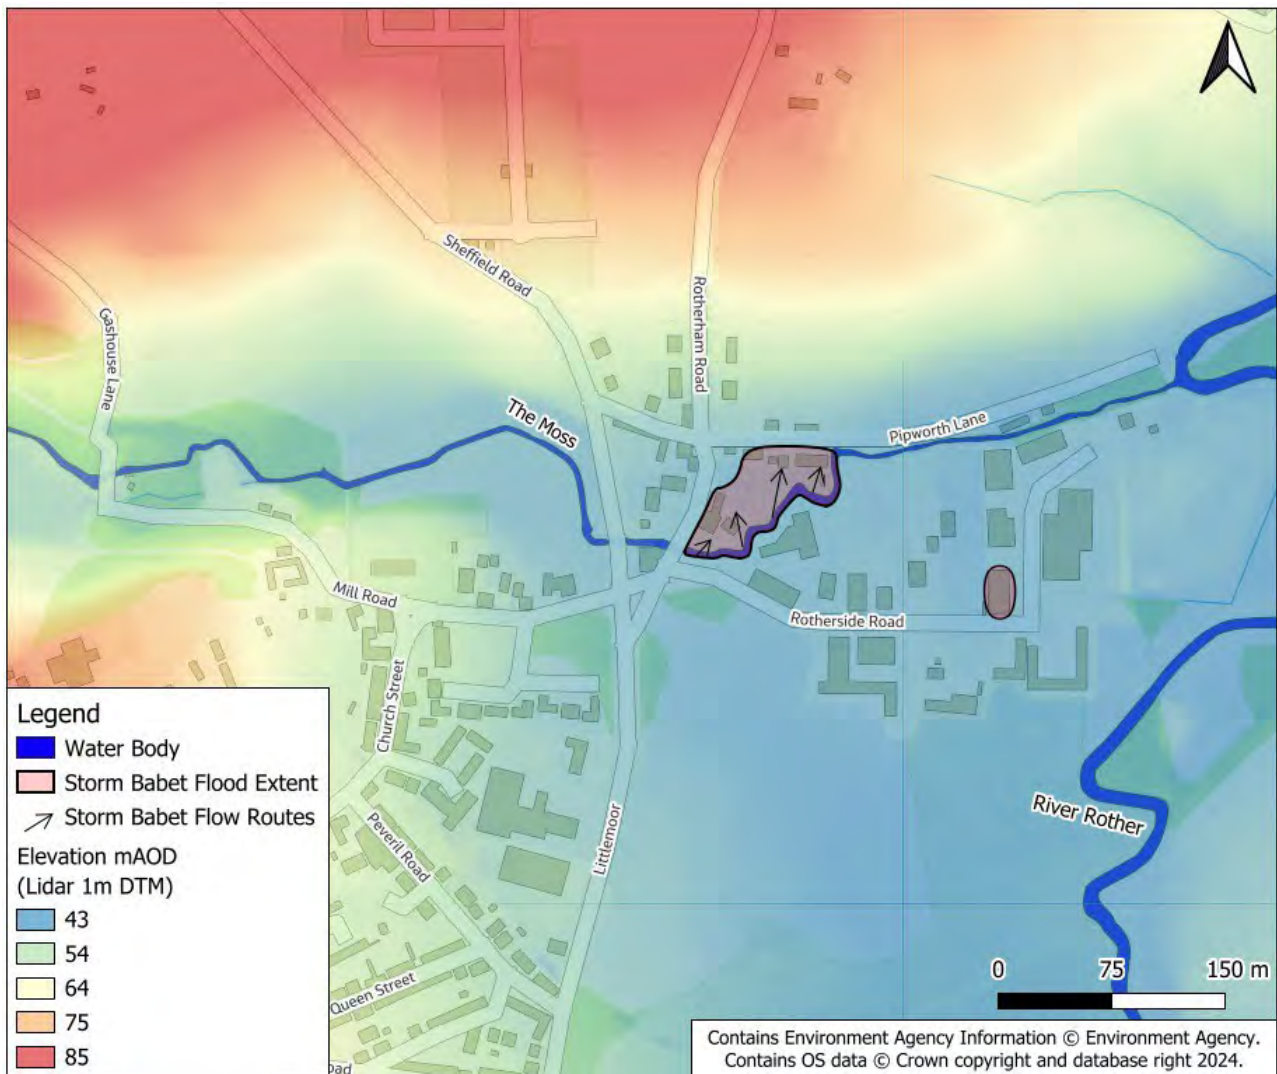
Figure 4-54: Ground level and Storm Babet flow routes at Eckington.

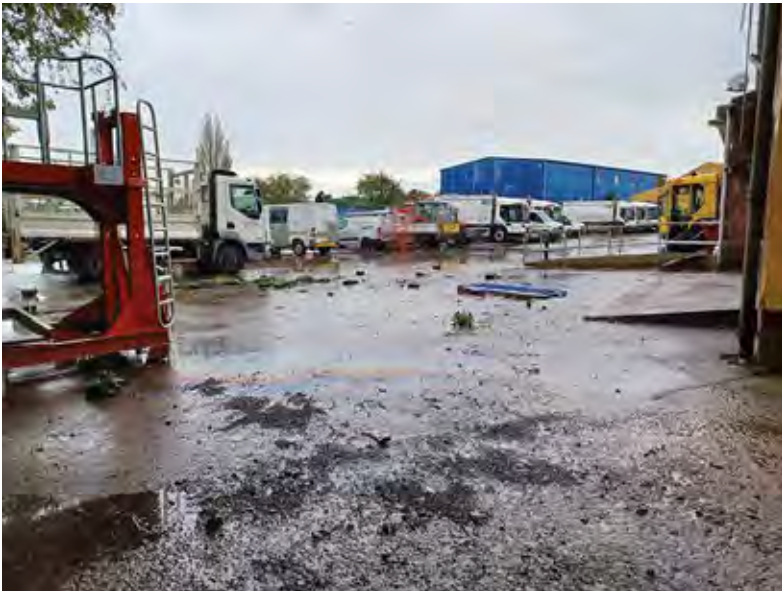
Following the flooding, residents reported through the National Incidents Reporting System (NIRS). NIRS allows the public to report environmental incidents such as flooding to the Environment Agency. In this case residents reported that trees around Pipworth Lane had fallen and were blocking The Moss. While these incidents were recorded in the days following Storm Babet, concerns were raised about the potential for the blockages to inflict further damage and flooding to the community. Within one of the reports, a resident notes that flood water was around 0.6m deep as a result of Storm Babet on the 20th of October.

Figure 4-55: Eckington Depot affected by flooding because of Storm Babet.

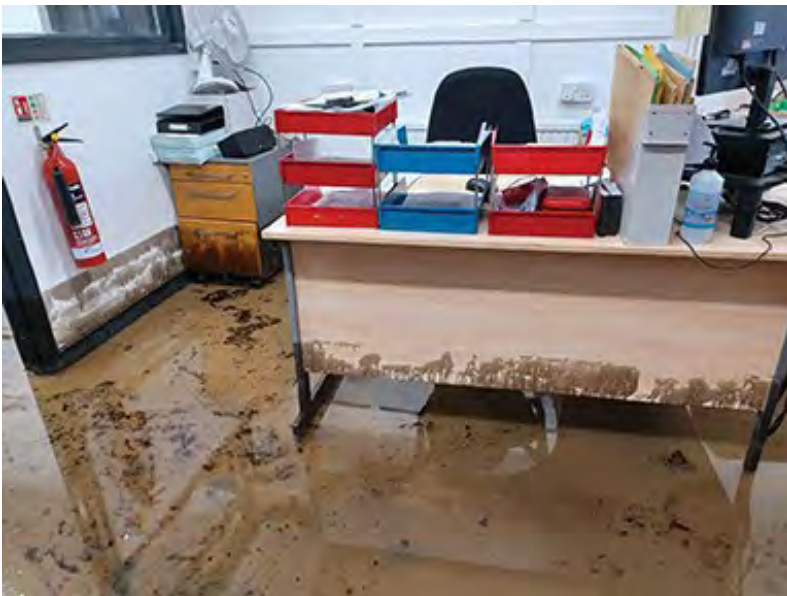
Figure 4-56: Interior of Eckington Depot affected by flooding because of Storm Babet.
