5. Dove Catchment

5.1 Dove Catchment Event Hydrology

5.2 Community Impacts – Ashbourne

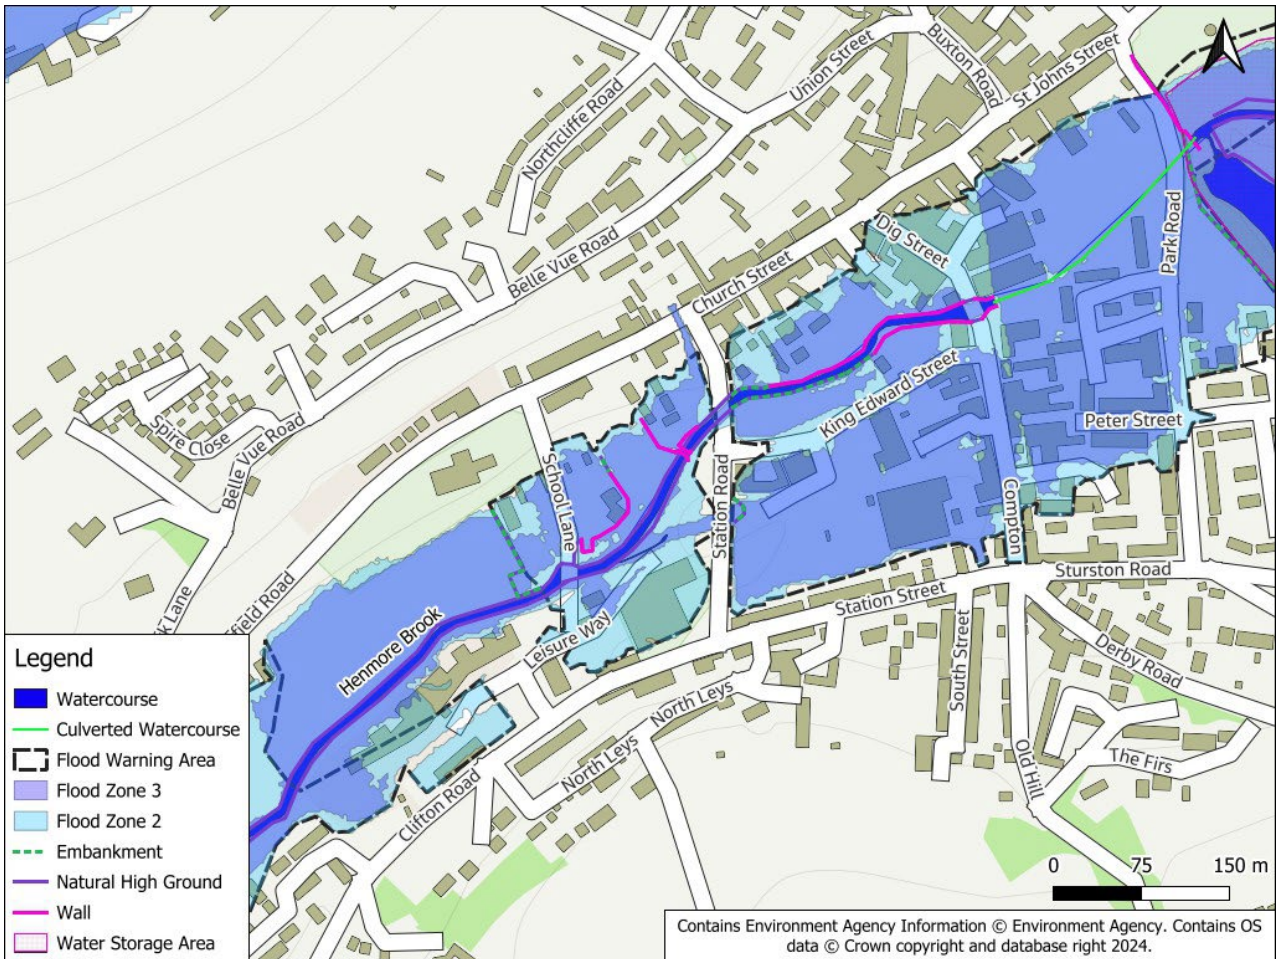
Figure 5-3: Flood Risk Management Arrangements and flood zones within Ashbourne.

The Flood Map for Planning (<https://flood-map-for-planning.service.gov.uk/>) shows that all of the flooded homes within this community are in Flood Zone 2 and 3, see Figure 5-3. Areas in Flood Zone 2 have between a 1% and 0.1% AEP of river flooding. Areas within Flood Zone 3 have a greater than 1% AEP of flooding from rivers.

The Ashbourne Flood Storage Reservoir (FSR) built in 2014 in Ashbourne Park is approximately 550m upstream of the flooded properties. It was designed to store water during flood events and provide 1% AEP SoP to the properties downstream in Ashbourne. The reservoir is maintained by the Environment Agency and is considered to be in good condition. Figure 5-3 shows all the flood risk management arrangements described above.

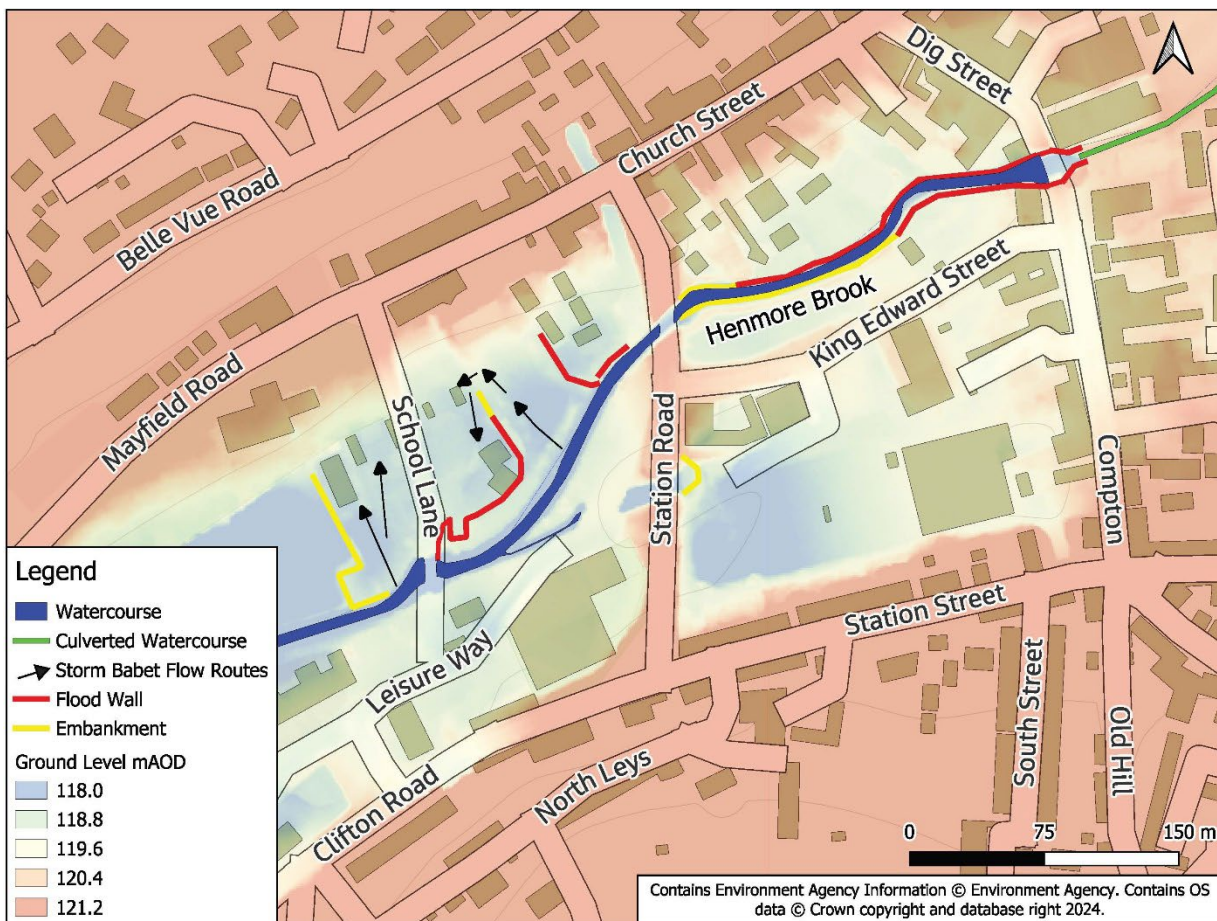
Figure 5-5: Ground level and Storm Babet flow routes at Ashbourne.

The primary source of flooding affecting all of the properties within this community was from the Henmore Brook. Figure 5-5 shows the assumed flow routes and elevations which will have contributed to the flood extent.

The three residential properties on Coachmans Close flooded as flood water flowed over the embankment to the north of the properties. The flood defence wall to the east and south of Coachmans Close overtopped along its length. This led to internal flooding of the properties to a reported depth of 0.5m.

The ten residential properties on School Lane were internally flooded to a depth of up to 15cm. Flood water overtopped the banks of Henmore Brook and a wall that retained high ground. Water flowed in a northwards direction along School Lane and entered the Almshouses courtyard, where flood water entered the properties through the doorways. Flood levels exceeded the previous 1% AEP design standard in this location and at Coachmans Close. The embankment protecting the Almshouses did not overtop, but it was purposefully lowered, following Storm Babet's peak, to let water drain back out from the flooded area when it became trapped. This has now been reinstated.

St Oswald's Church Hall flooded as a result of flood water flowing over and around the embankment to the south of the car park. When in the car park, water became trapped, leading to internal flooding of the hall to a

In the short term, they plan to raise the lowest sections of the flood defences around Coachmans Close to have a consistent level all along the defence wall that matches the current crest level. The embankment will also be raised to match the height of the coping stones on the defence wall. These works are planned for summer 2024. De-silting and removal of vegetation from School Lane bridge are also scheduled for 2024.

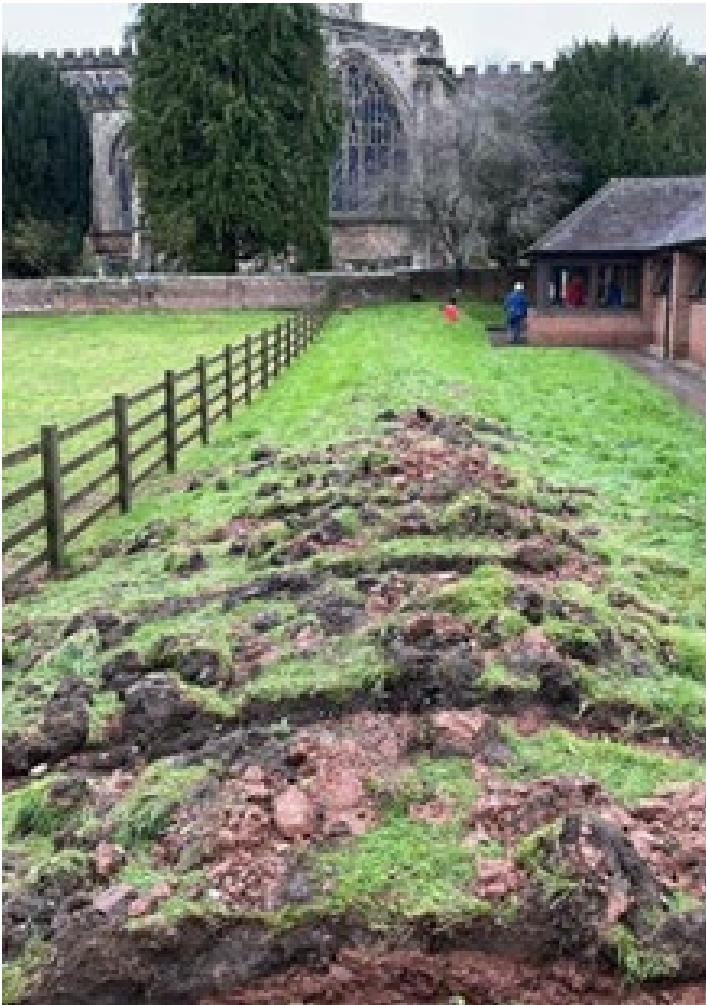
reported depth of 23 cm. Figure 5-6 shows that channels were excavated through the top of the flood embankment to allow flood water to drain away from the church hall. These were excavated around 3:00pm on the 20th of October.

Figure 5-6: Channels were excavated into the flood embankment to the west of St Oswald's Church Hall to allow water to escape.

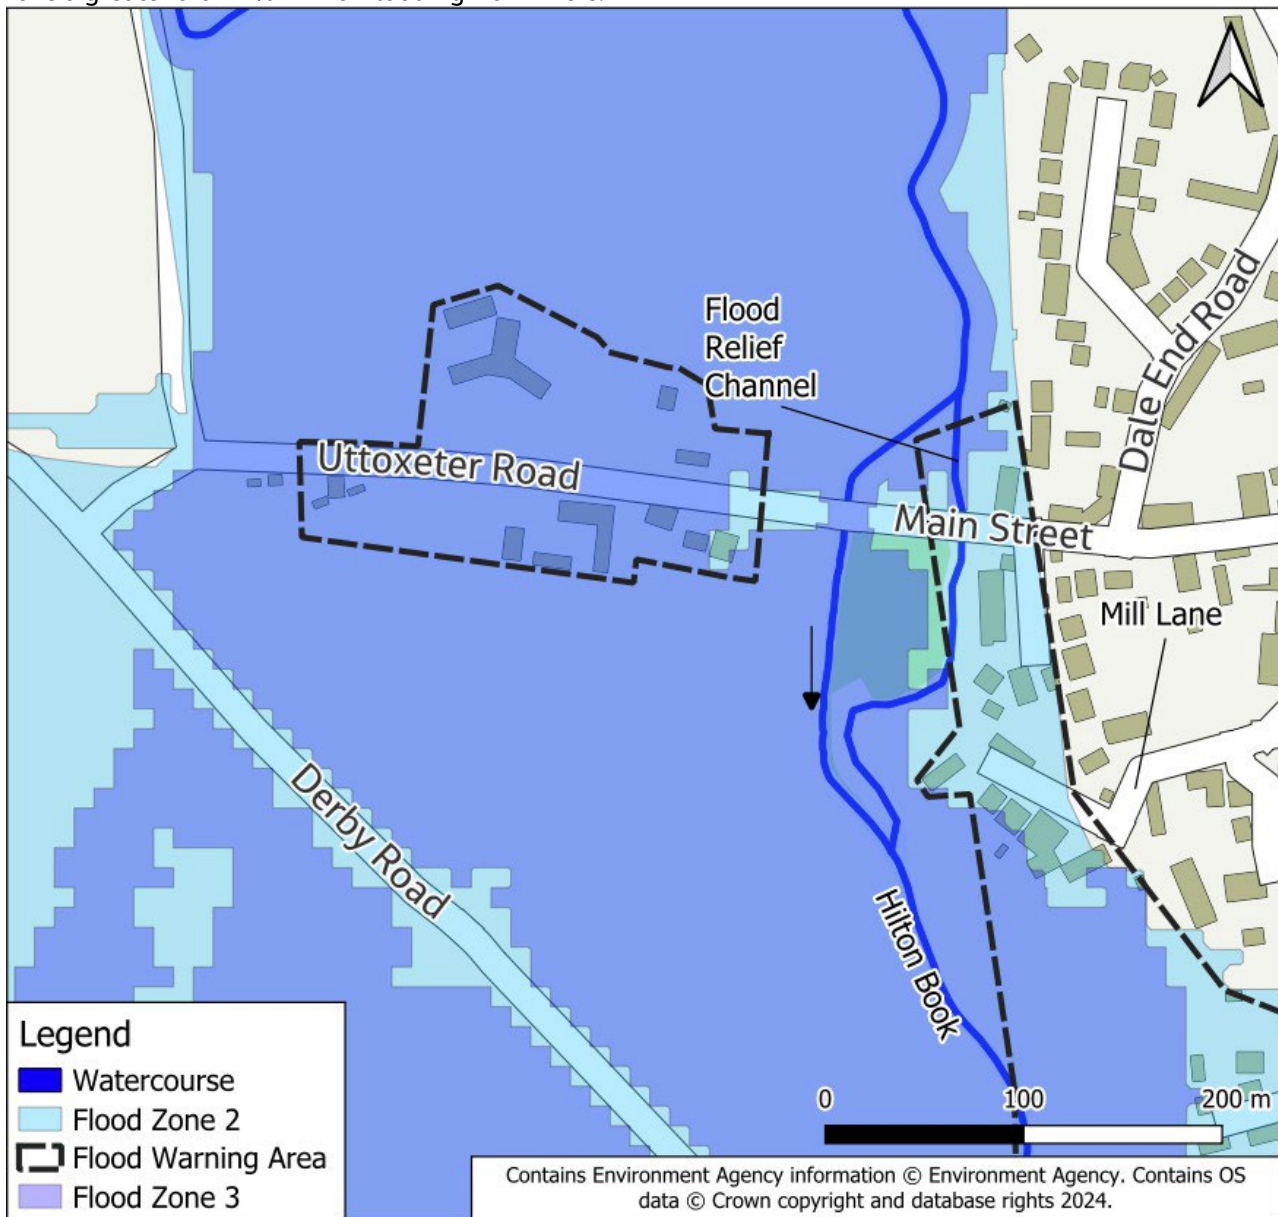
Figure 5-8: Flood Zones and flood risk management arrangements in place at the Hilton community.

The Flood Map for Planning (<https://flood-map-for-planning.service.gov.uk/>) shows that the majority of the flooded properties within this community are in Flood Zone 2 or Flood Zone 3, as shown in Figure 5-8. Areas in Flood Zone 2 have between a 1% and 0.1% AEP of river flooding and Flood Zone 3 means the properties have a greater than 1% AEP of flooding from rivers.

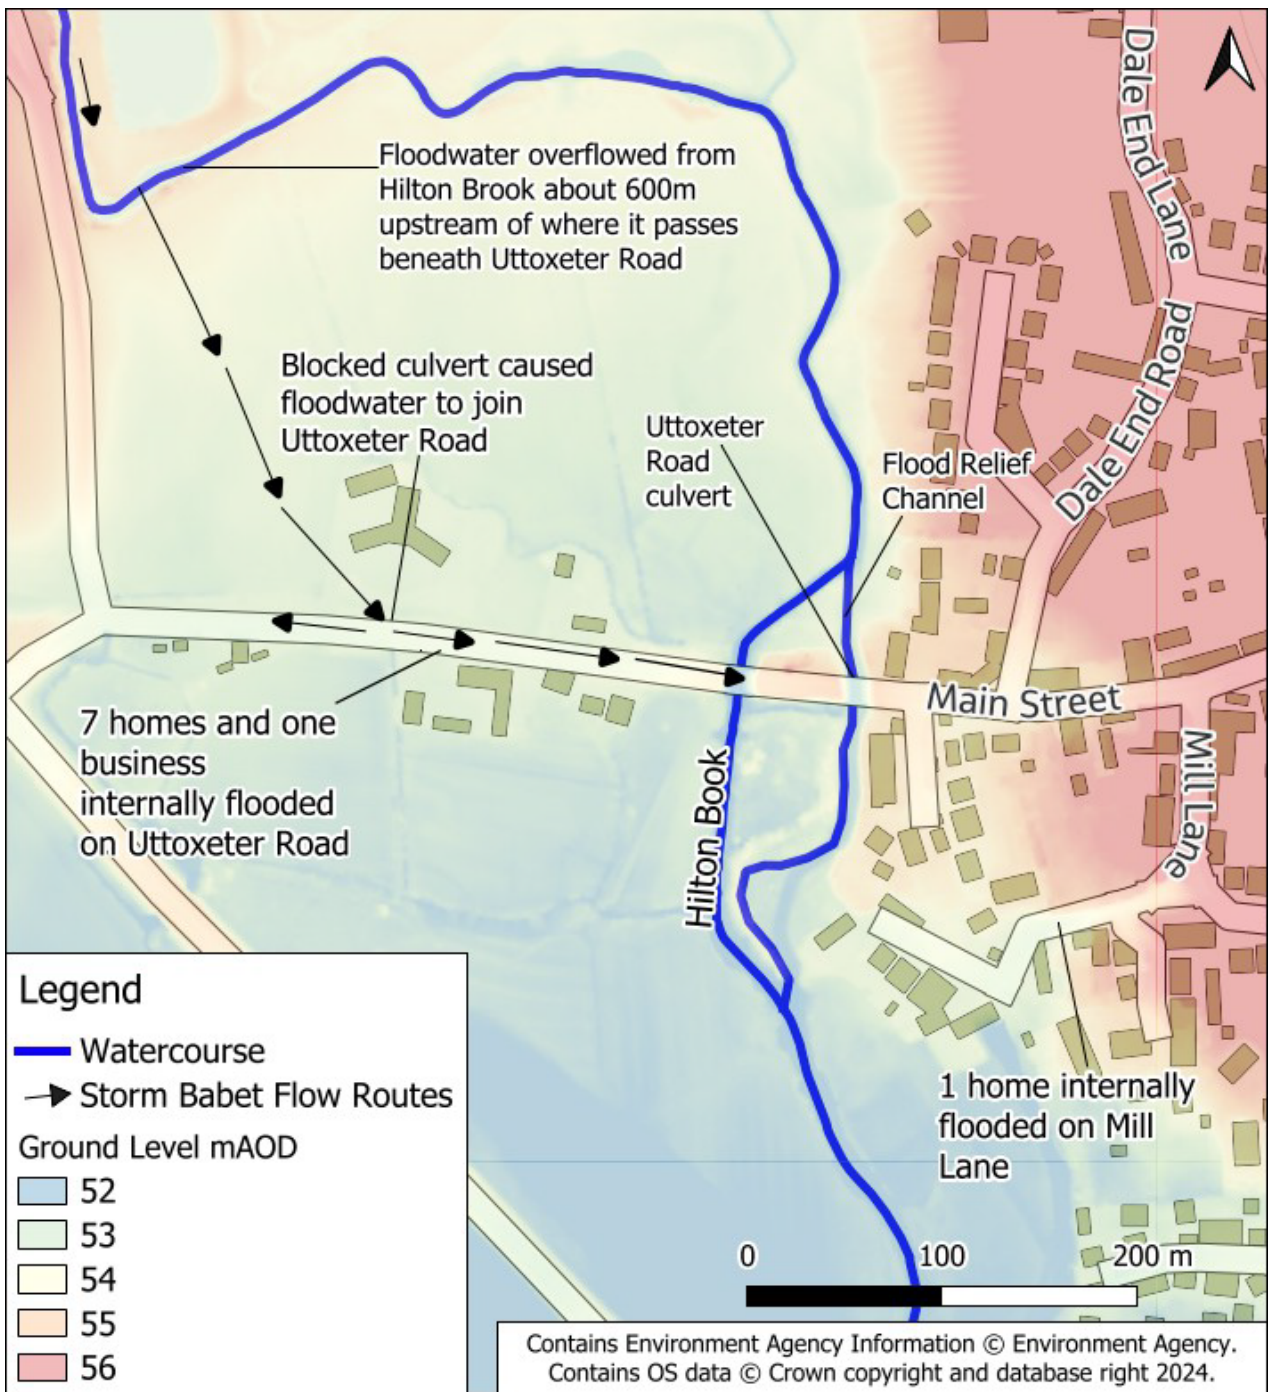
Figure 5-10: Ground level and Storm Babet flow routes at Hilton.

The primary source of flooding affecting all properties within this community is assumed to be from Hilton Brook due to overflowing upstream of Hilton village and flooding Uttoxeter Road.

It was reported by a councillor from South Derbyshire that the Hilton Brook culvert beneath Uttoxeter Road was blocked. This resulted in the channel overtopping upstream of the culvert inlet. Floodwater then flowed onto Uttoxeter Road and downslope westwards, internally flooding seven properties on Uttoxeter Road. Figure 5-10 shows the ground level and Storm Babet flow routes at Hilton.

The Environment Agency have subsequently discussed the flooding with a local District Councillor and as requested inspected the Hilton Brook around the flooded properties. The Flood Relief channel was found to be operating as designed. The Environment Agency determined there may be an opportunity to redirect floodwater, that escapes further upstream away from property, back towards the Hilton Brook channel which would reduce the chances of property flooding in the future. Investigations are underway to determine the feasibility of these adaptations..
