6. Idle and Torne Management Catchment

6.2 Community Impacts – Clowne

6.2.3 Storm Babet Incident Details

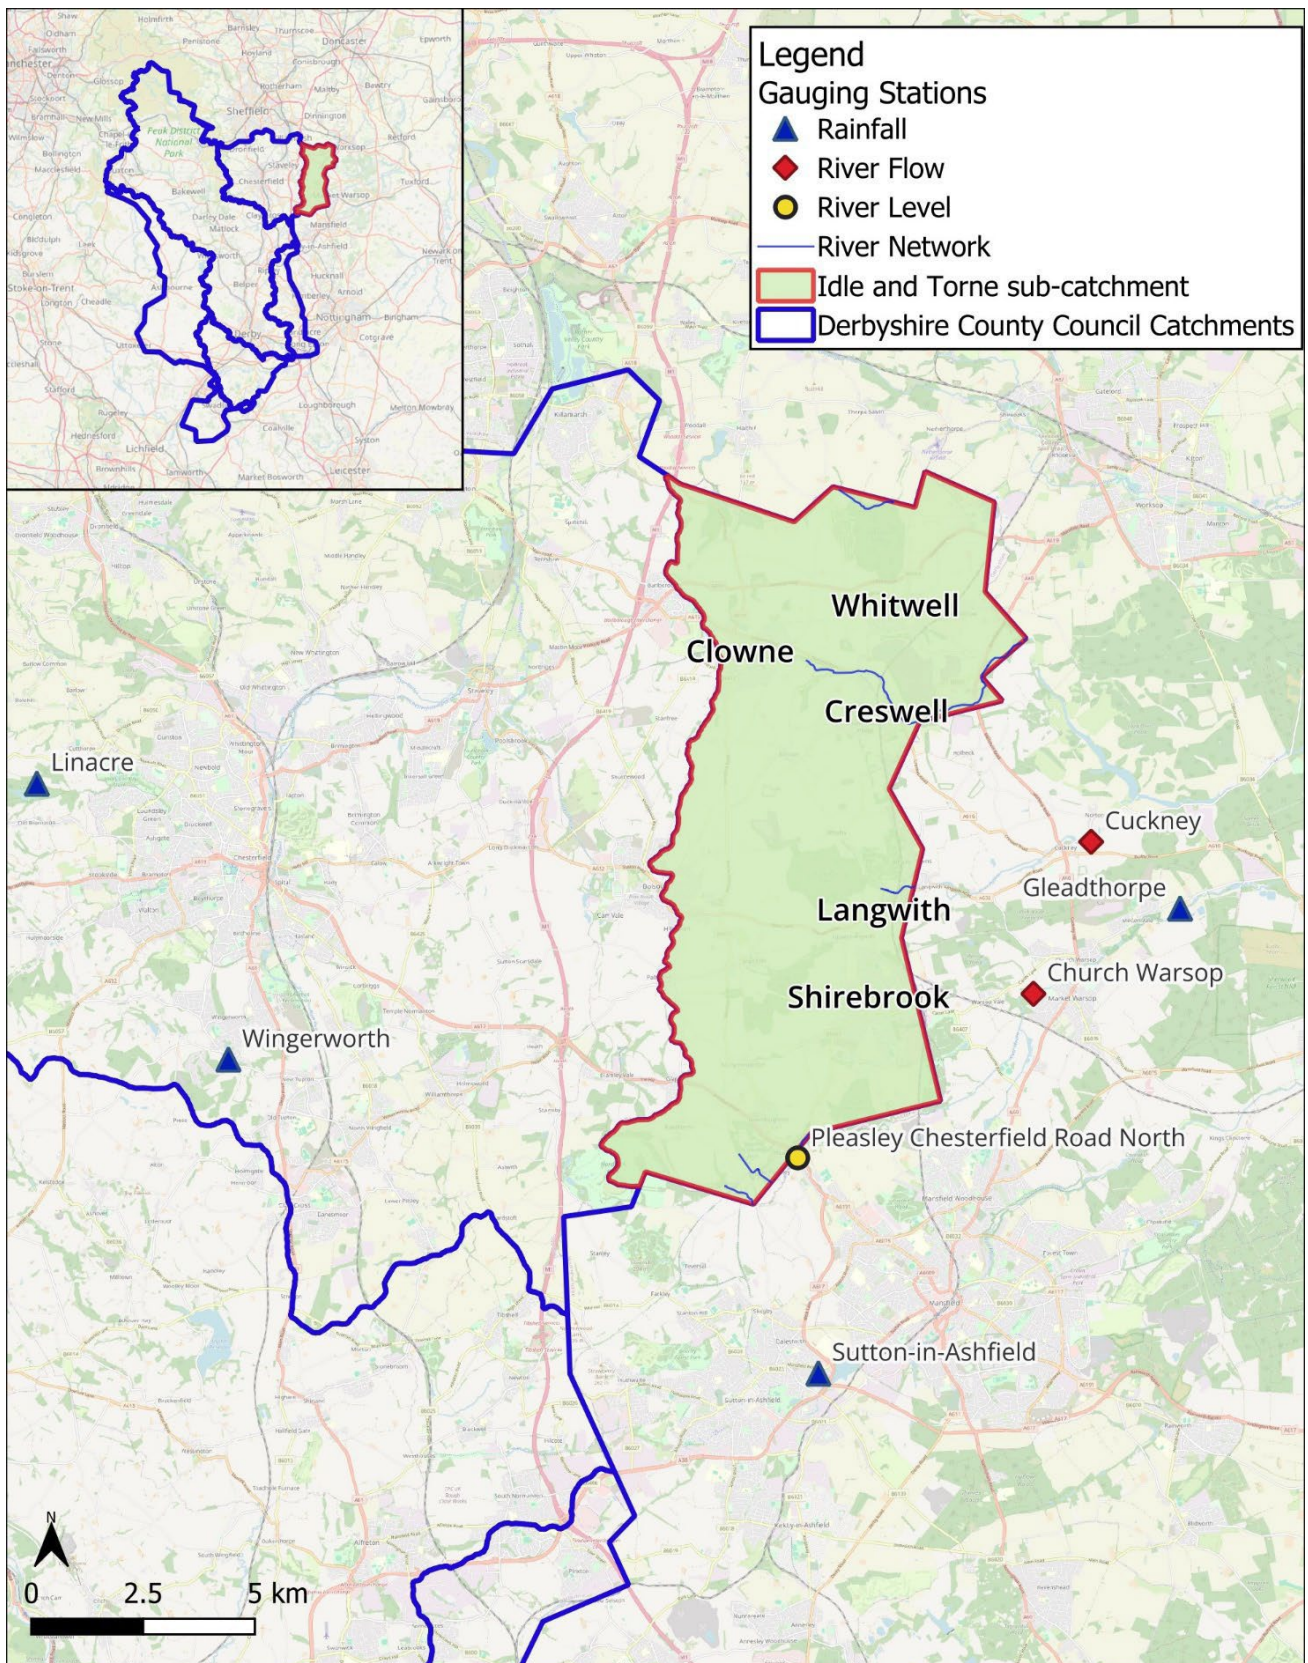
Figure 6-1: Catchment extent and rainfall, river flow and river level gauges.

Figure 6-1 indicates the sub-catchment extent in respect of the Derbyshire area, in addition to the rainfall, river flow and level gauges used for the hydrological analysis of this sub-catchment. It is noted the majority of these stations are outside the sub-catchment boundary referred to in this report. However, they are within the wider Idle and Torne catchment and will be representative of the hydrology within the reports sub-catchment.

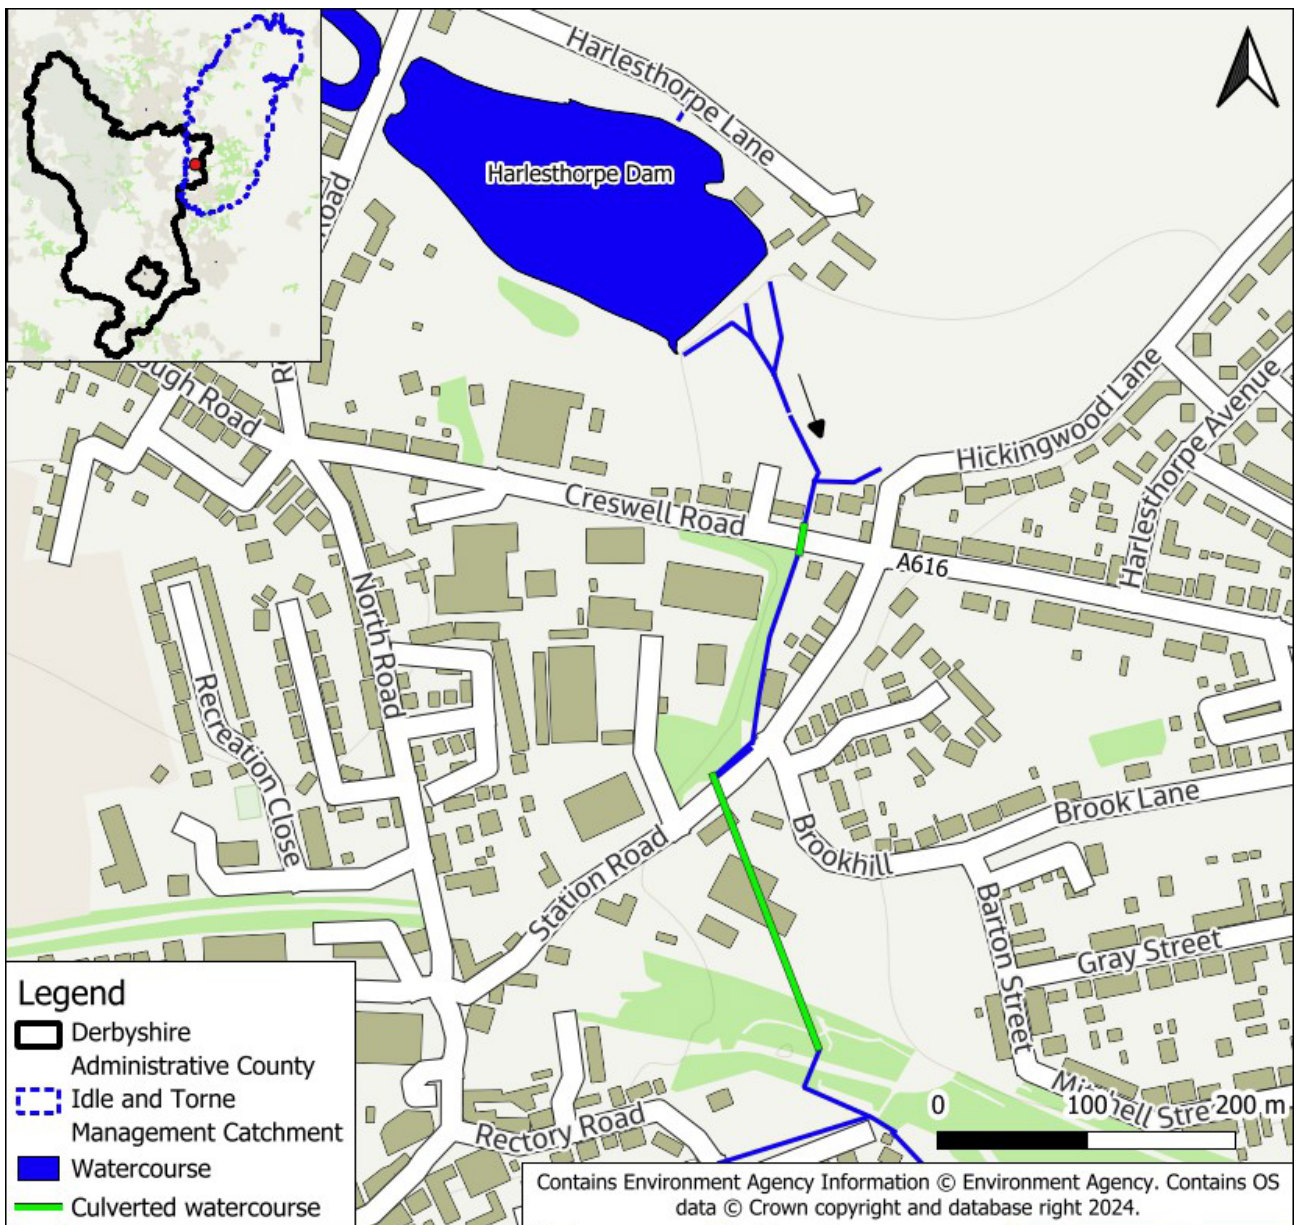
Figure 6-2: Overview map of Clowne community.

Seventeen residential properties and one commercial property to the north of Clowne village centre suffered internal flooding as a result of Storm Babet. Figure 6-2 below shows an overview of the community. The community is adjacent to an unnamed ordinary watercourse which originates to the north-west of Clowne and flows through Harlesthorne Dam before flowing southwards through the community. Most of the flooded properties are to the east of the watercourse.

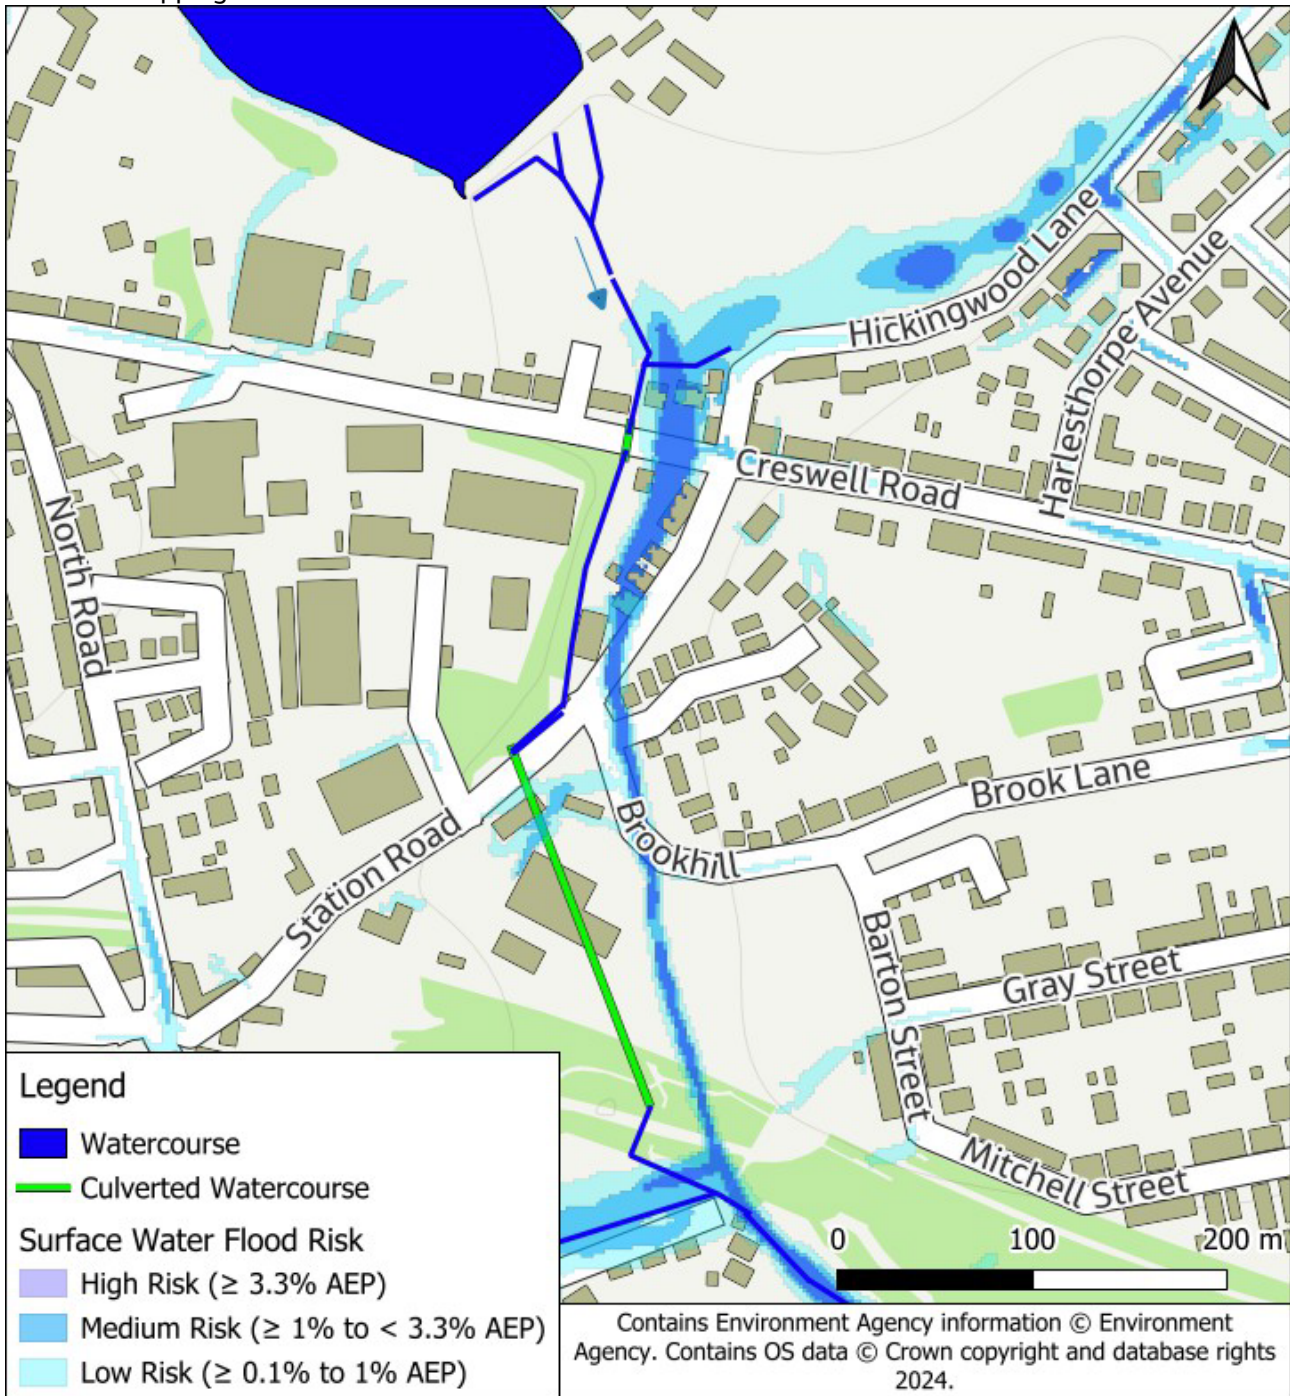
Figure 6-3: Map showing the chance in any given year of flooding from surface water at Clowne (Source: Long Term Flood Risk Map).

However, some homes on North Road have a high risk of surface water flooding, based on the Long Term Flood Risk Map (<https://check-long-term-flood-risk.service.gov.uk/postcode>). High risk is defined as greater

than 3.3% AEP of flooding. Figure 6-3 shows the surface water flood risk for the community based on the national mapping referred to above.

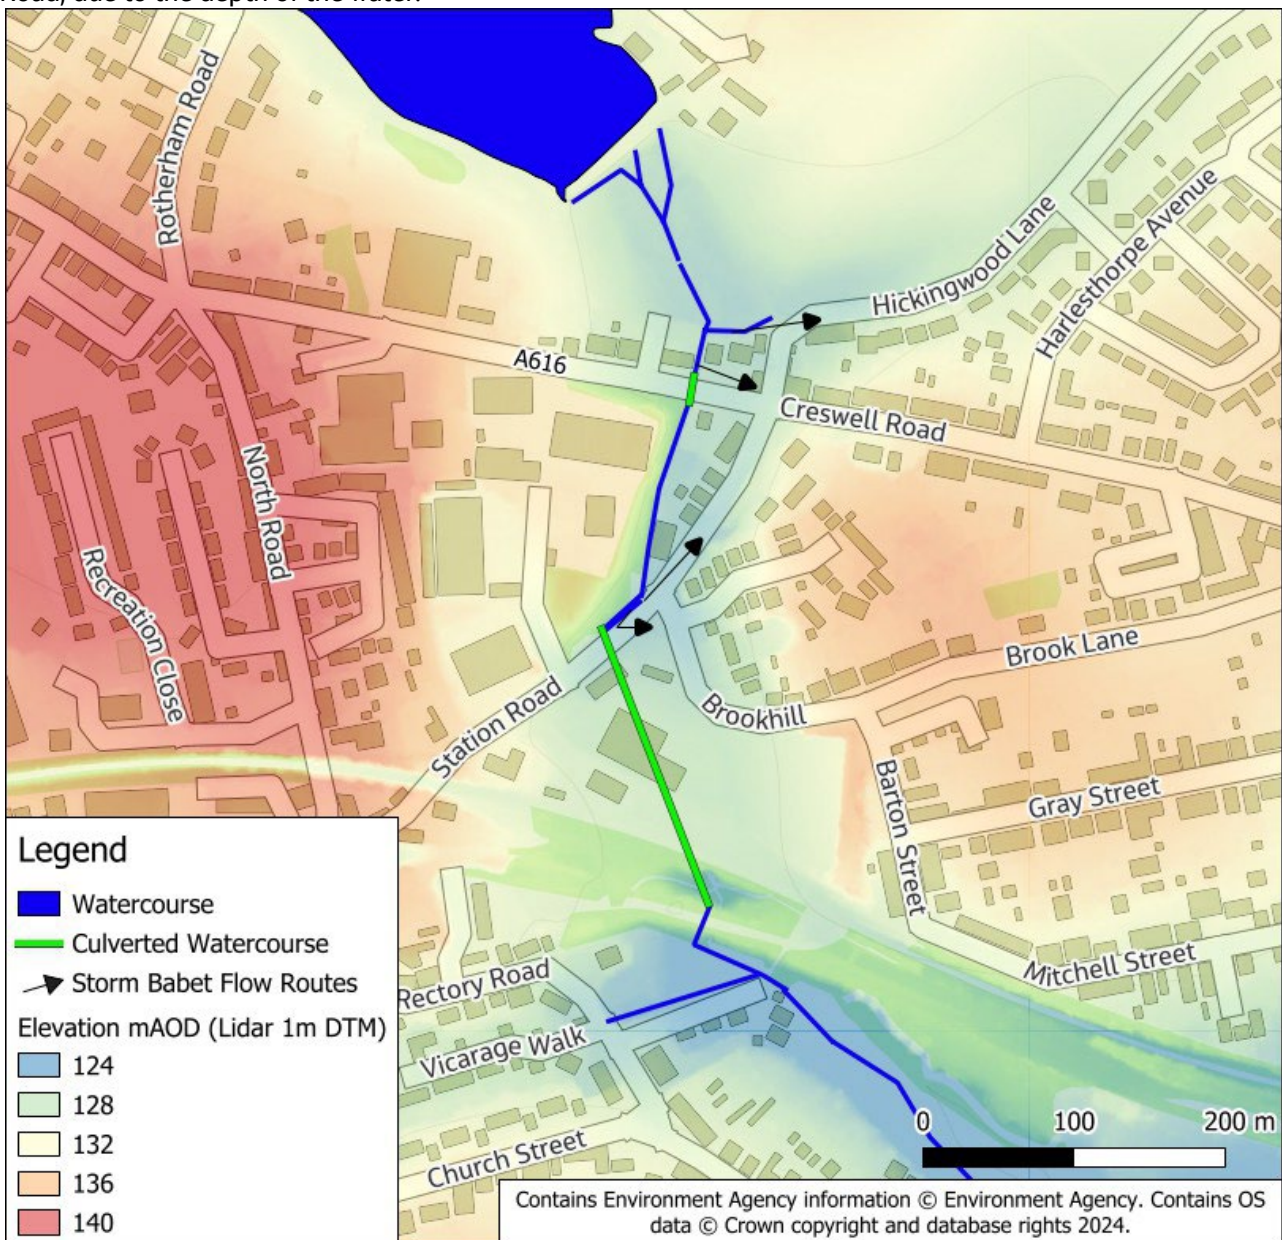
Figure 6-4: Ground level and Storm Babet flow routes at Clowne.

Figure 6-4 indicates the local topography and flow routes during Storm Babet. The primary source of flooding affecting all of the properties within this communities was from the ordinary watercourse. Flooding may have been exacerbated by the culvert under Station Road and the A616 (Creswell Road) being overwhelmed.

The flooding was exacerbated by surface water run off due to saturated ground north of Hickingwood Lane. The surface water then flowed towards the watercourse and increased levels. There are also a number of road gullies along the A616 (Creswell Road) and Station Road that discharge into the watercourse. Details received from the residents suggest that the flooding issues arose from the gullies being unable to discharge to the watercourse.

It has been reported that the flooding caused several garden walls to collapse at properties along Station Road, due to the depth of the water.
