## 7. Trent Lower and Erewash Catchment

### 7.1 Trent Lower and Erewash Event Hydrology

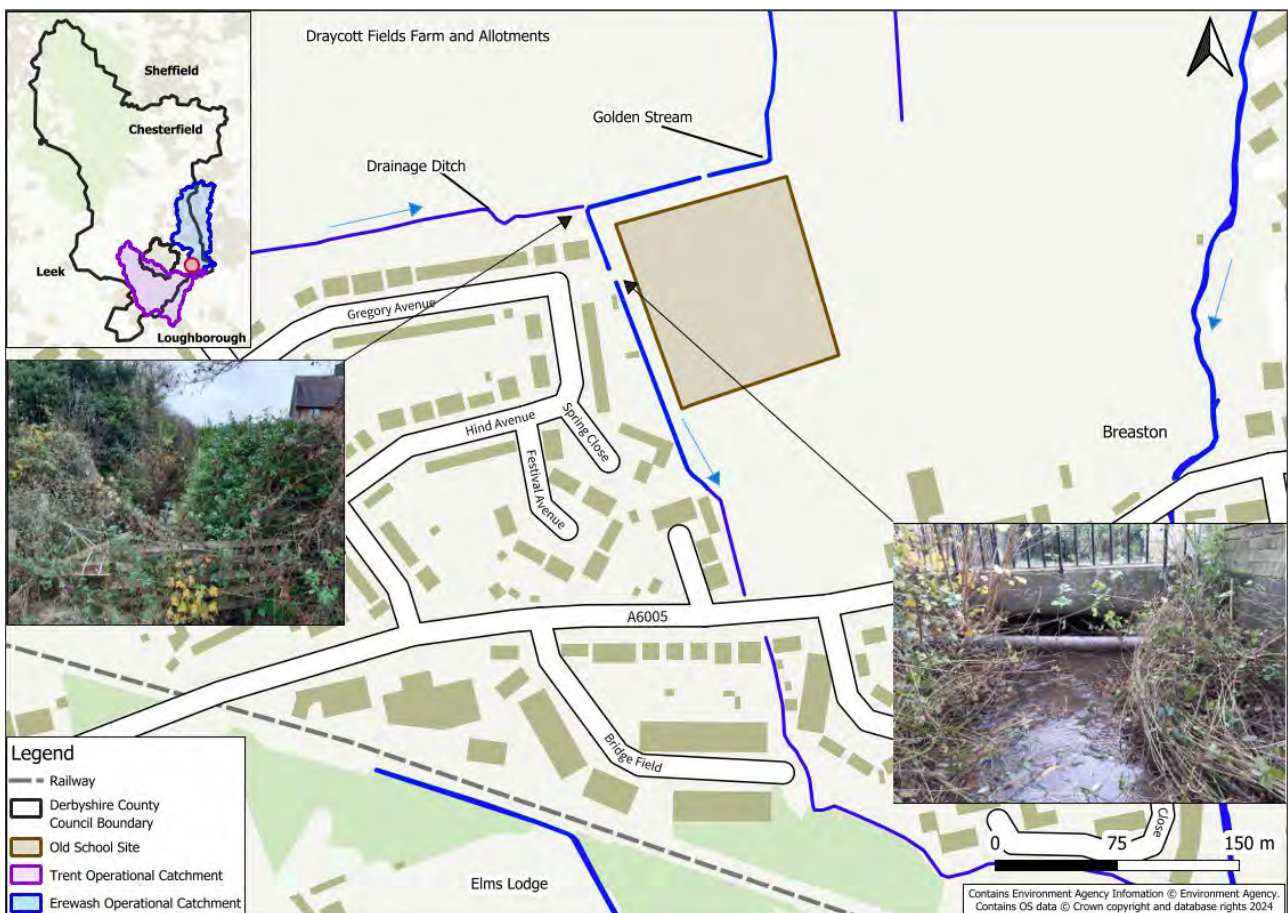
Figure 7-5: Location of features which exacerbated flooding within the Breaston community.

Residents have reported a lack of maintenance along the drainage ditch between Gregory Avenue and Johnson's Meadow, and along Golden Stream. It was reported that maintenance has not occurred for numerous years prior to Storm Babet. The riparian zone, stream banks and in-channel area in these stretches of watercourse became extensively overgrown with vegetation, see Figure 7-5. The stream collects runoff from fields to the north. During Storm Babet, the ability of the ditch to convey water is likely to have been restricted by this vegetation. Together with the high flows, this resulted in the overtopping of banks of the Golden Stream and the flooding of back gardens of neighbouring houses.

A box culvert on the Golden Stream located east of the east end of Gregory Avenue has been identified as receiving irregular maintenance. Maintenance along Golden Stream would include the removal of vegetation and debris to ensure the channel is clear for water flow. In addition to this, a pipe across the channel obstructs flow, see Figure 7-5. When combined with overgrown vegetation, the culvert became obstructed, causing the back-up of flow, resulting in the overtopping of banks. This water ended up in the road and flowed southwards. Videos provided from residents show this water flowing from Gregory Avenue, into Hind Avenue, and then into both Spring Close and Festival Avenue.

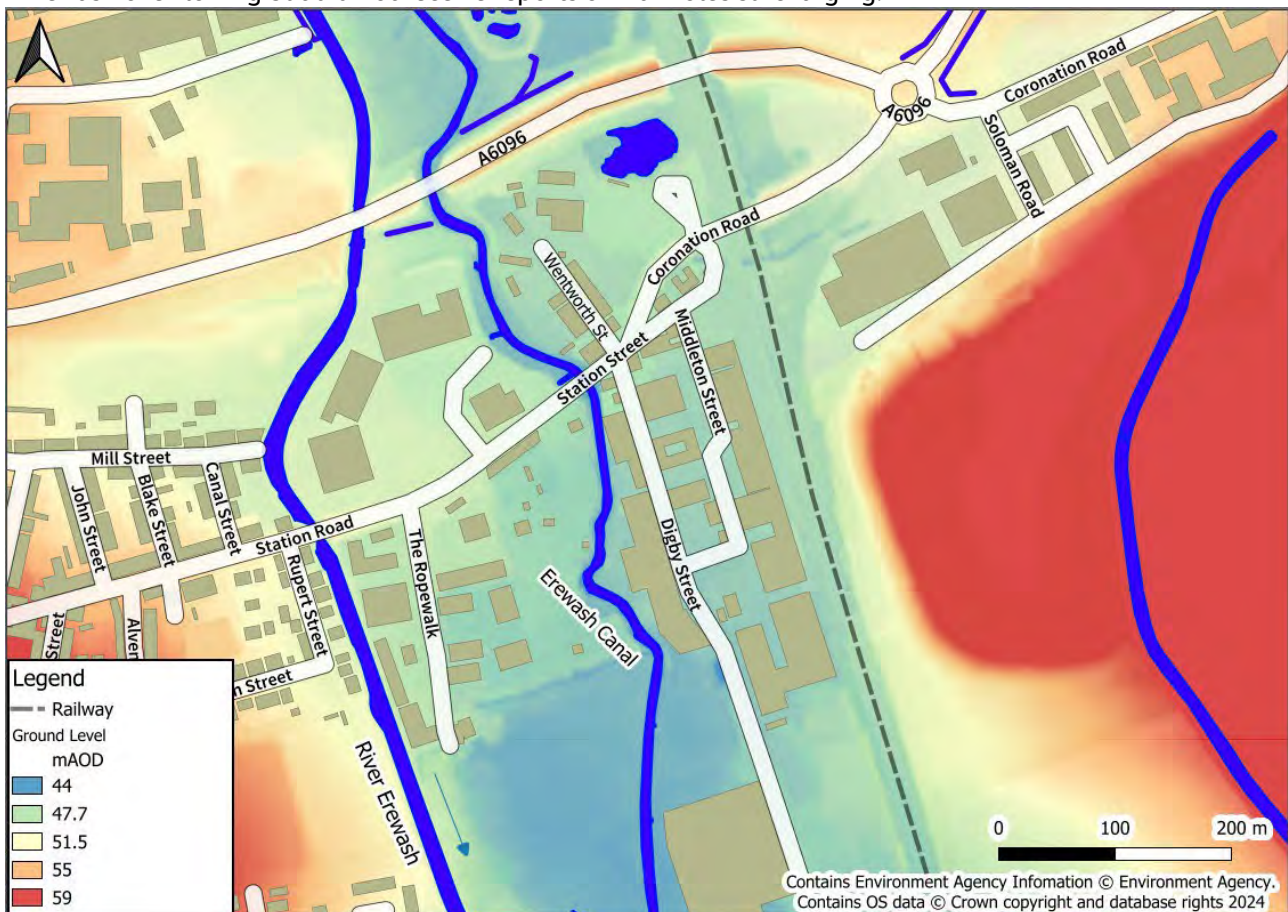
Figure 7-9: Topography at Ilkeston.

Station Street, Wentworth Street and Digby Street all experienced surface water flooding. Figure 7-9 shows that these streets are situated at a lower elevation than the rest of the community, with neighbouring fields sloping towards Digby Street. This flooding caused impacts to the road network and the internal flooding of businesses and homes. There were complaints issued that street gullies were not clear for flow. Residents believe that blocked drains were the cause for flooding along Digby Street, although this has not been substantiated as the cause of the flooding. The properties on Station Road, experienced flooding to their basements, and there were anecdotal reports of floodwater coming up through the floor of properties and rising up through drains. Severn Trent received reports of flooding along Station Road due to the River Erewash overflowing but did not receive reports of manholes surcharging.

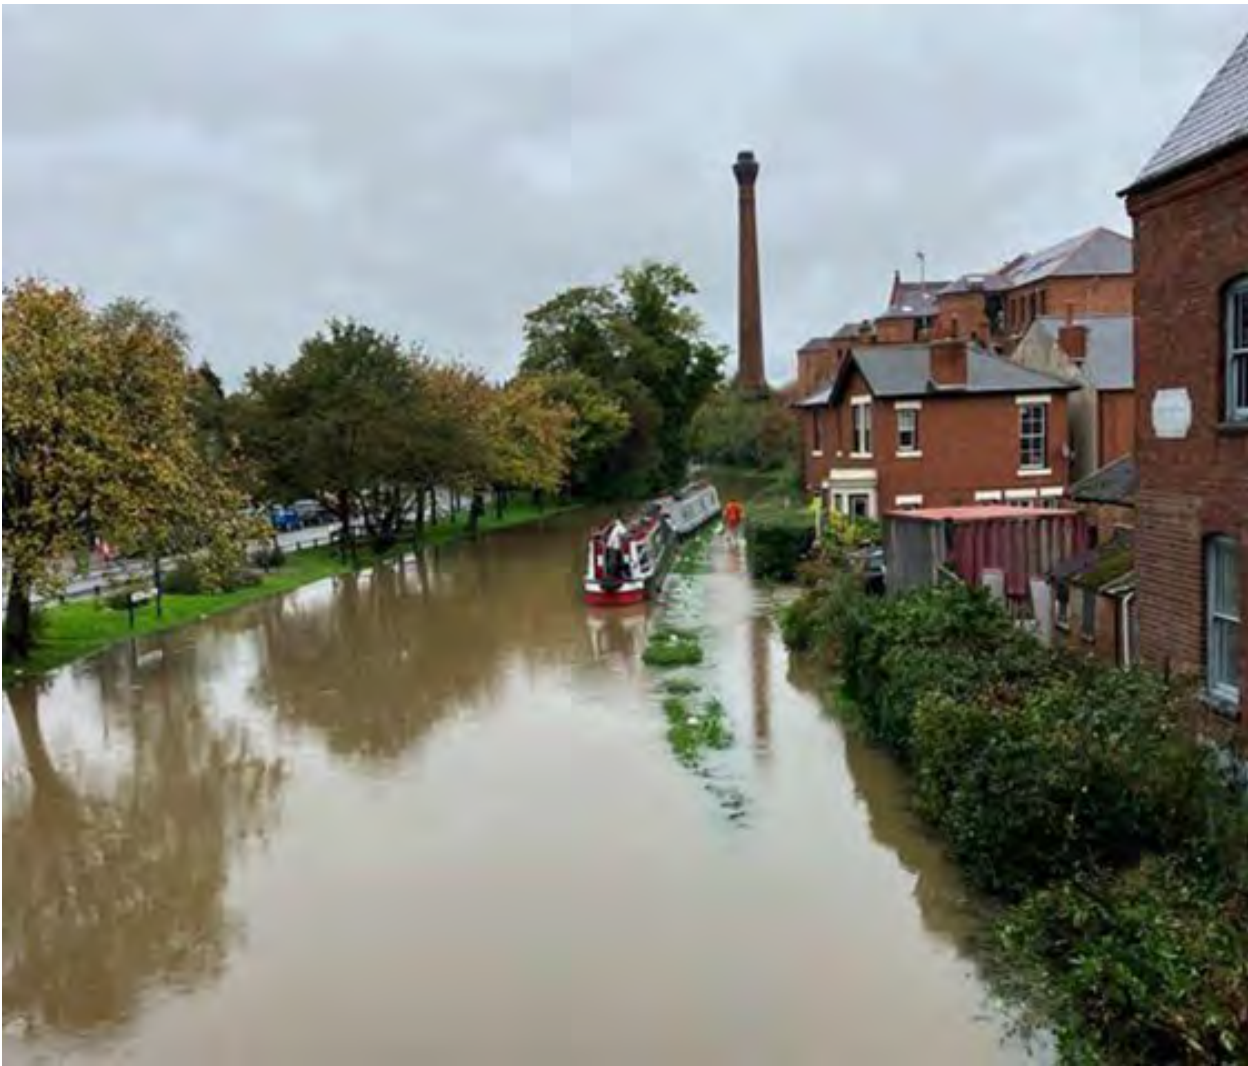
The River Erewash overtopped its banks and flowed into the Erewash Canal north of Gas Street, opposite Brookfield Mews. The defences north of Gas Street tie into the railway embankment. The Environment Agency acknowledge they do not know the porosity of this embankment and that this needs further investigation. It is also likely that a connection between the Erewash Canal and the River Erewash opened a flow path via the canal which led to flooding of properties. There were also other river-canal interactions upstream during this event at Langley Mill and other rural areas, making it possible that the canal was already elevated before the River Erewash overtopped at this location. These factors caused water levels in the canal to rise, creating a secondary flow path for the flood water, which flowed south across the community. The onset of flooding was reported to be very quick. The volume of water caused significant property damage, with several properties' floors being lifted by the force of water. Figure 7-13 below shows flooding from the canal, which was caused by the River Erewash overflowing into the canal. The photograph was taken from Station Road looking north along the canal.

**Figure 7-13: Flooding of the Erewash Canal: The River Erewash overtopped, and fluvial flood water entered the Erewash Canal which acted as a conduit for the flood flow.**

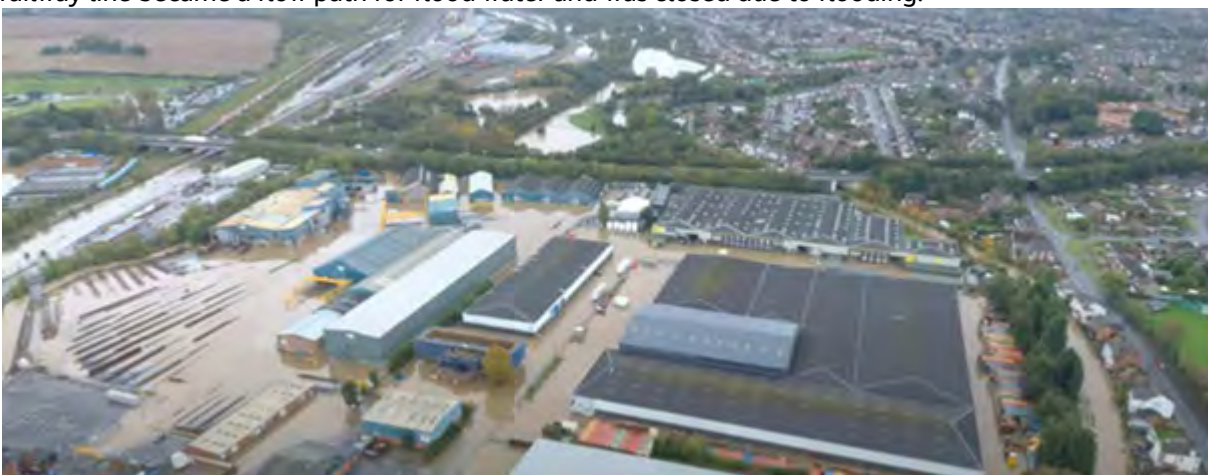
The flood defence wall on the west bank of the River Erewash, opposite Megavaux, overtopped, with the wrack marks 0.3m above the crest level of the defence wall. Overflowing at this location led to flood water flowing westward across the community and to the south, across Station Road. This led to flooding of the industrial park, south of Station Road. The east bank defence wall also overtopped in this location, leading to flood water flowing in a southward direction across Station Road, towards the business park and railyard. Figure 7-14 below shows flooding to the south of Station Road and the railyard to the left of the image. The railway line became a flow path for flood water and was closed due to flooding.

**Figure 7-14: An aerial photograph looking south flooding to the industrial estate and railyard south of Station Road caused by the River Erewash overflowing.**

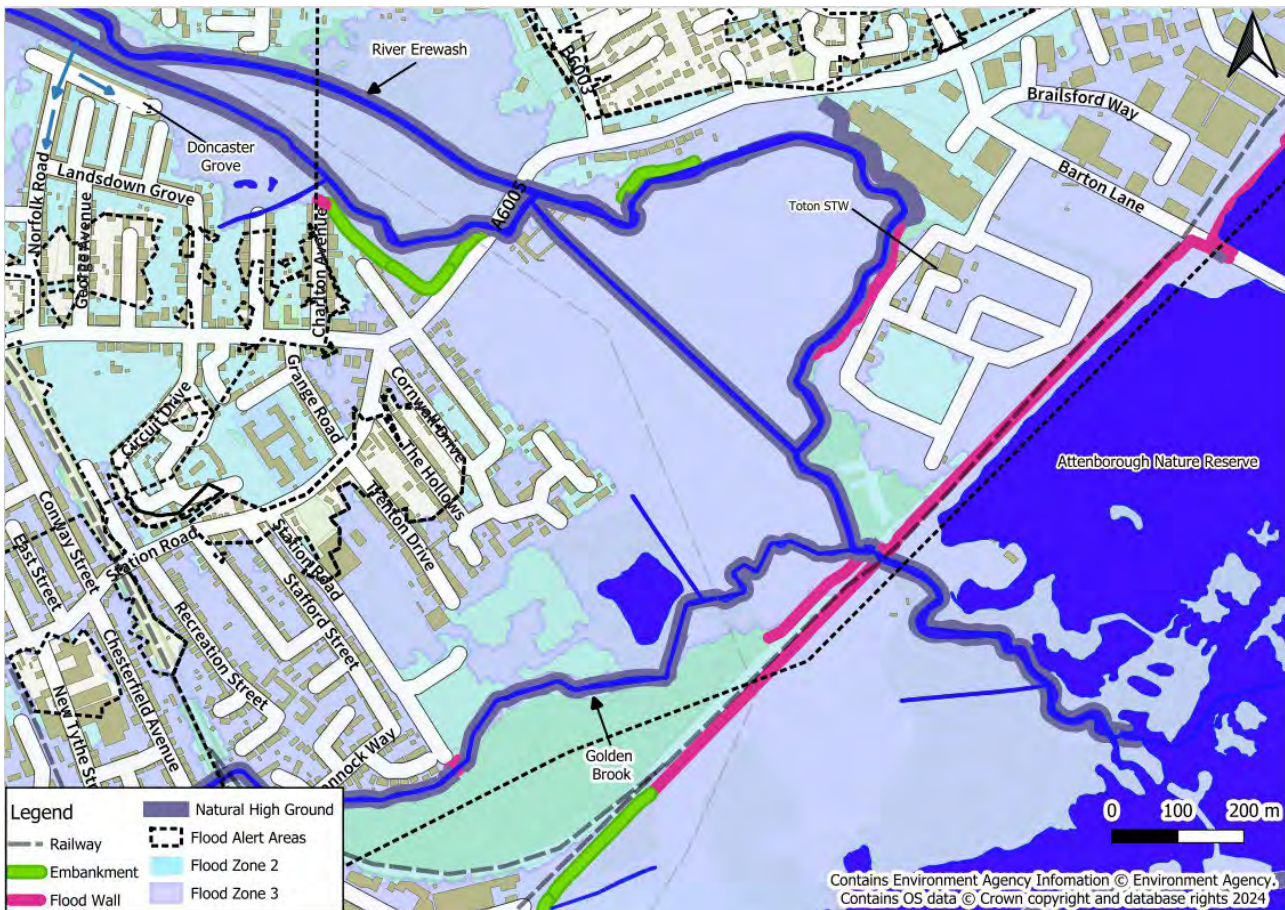
Figure 7-17: Flood Zones, assets and flow routes from the River Erewash entering the community via Doncaster Grove

Figure 7-17 shows the flow routes from the River Erewash overflowing and initially joining Doncaster Road.

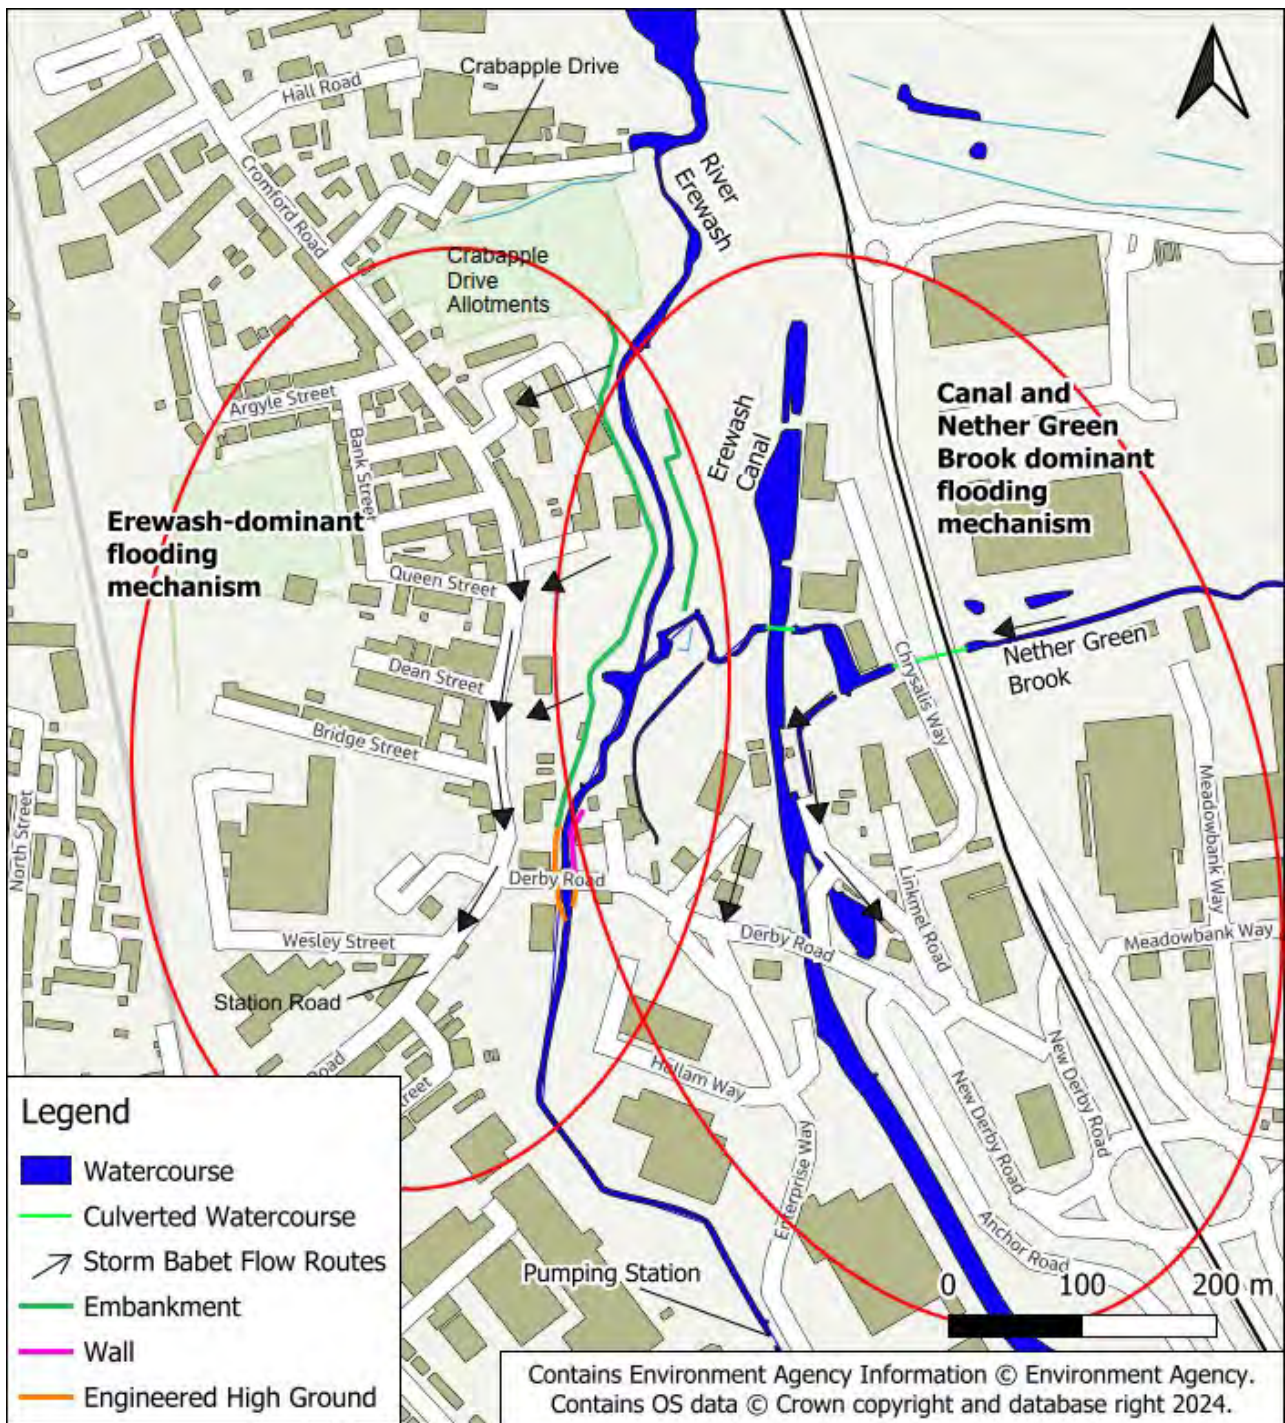
Figure 7-21: Flood mechanisms and flow directions at Langley Mill.

Overflowing of the Erewash Canal was entirely due to the River Erewash and Nether Green Brook over flowing into the canal; if this interaction had not occurred the canal would not have overtopped.

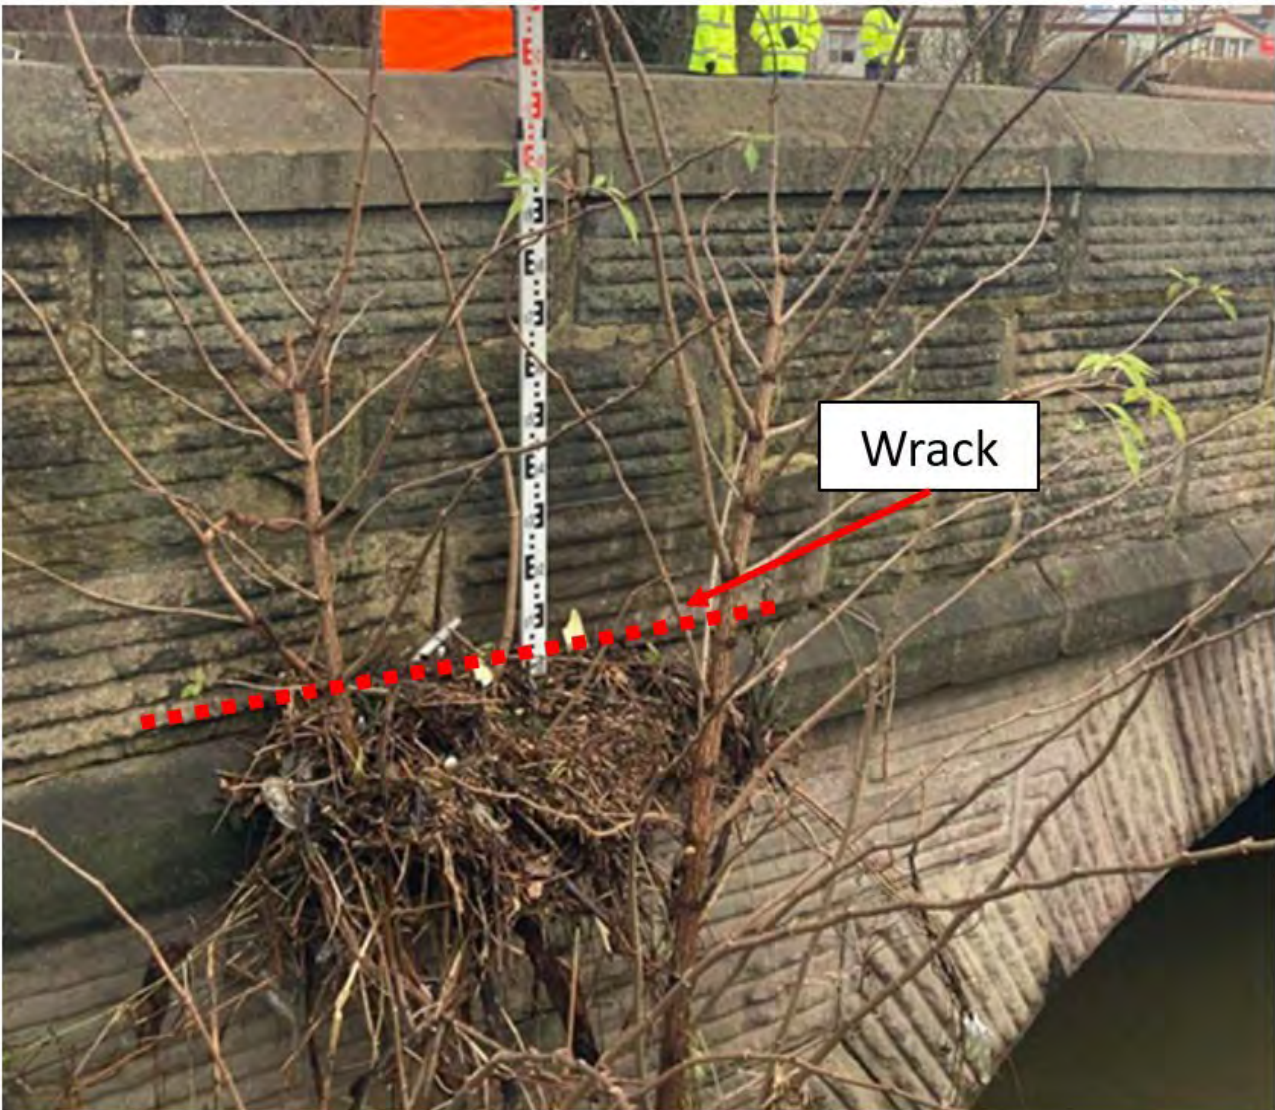
Figure 7-22: Wrack mark on the upstream face of Derby Road bridge. Source from the Environment Agency.

Another location where the River Erewash overtopped was at the Derby Road bridge. Water levels were high enough for the Erewash to overtop the bridge and cause flooding to Derby Road.

Figure 7-22 is presented below showing a wrack level on the upstream face of the Derby Road bridge crossing the River Erewash.

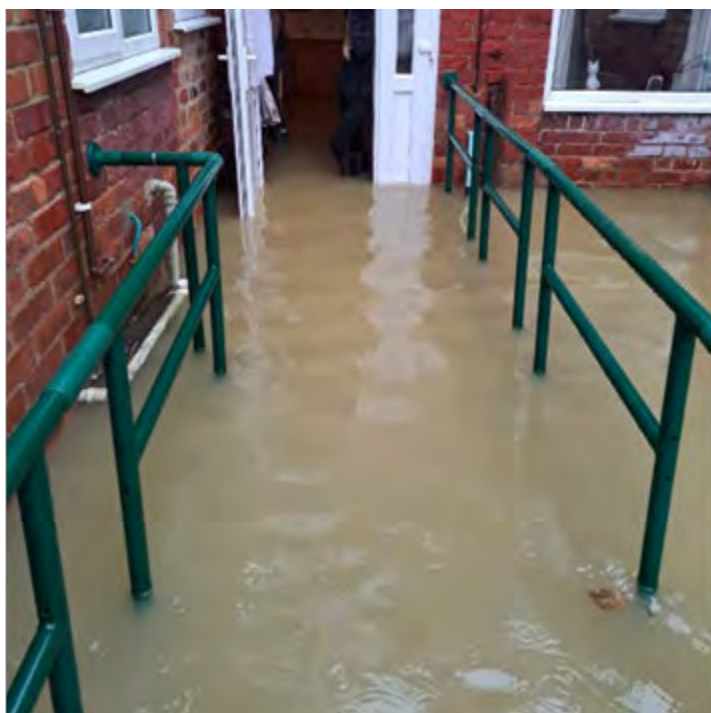
Figure 7-29: Flooding to a property in York Terrace.

A resident of York Terrace provided Derbyshire County Council with photographic evidence of the impact of flooding which can be seen in Figure 7-29 below. The resident also noted that flooding started to reach the outside of the property at 6:30am to 6:45 am and by 11:00am the property suffered internal flooding.

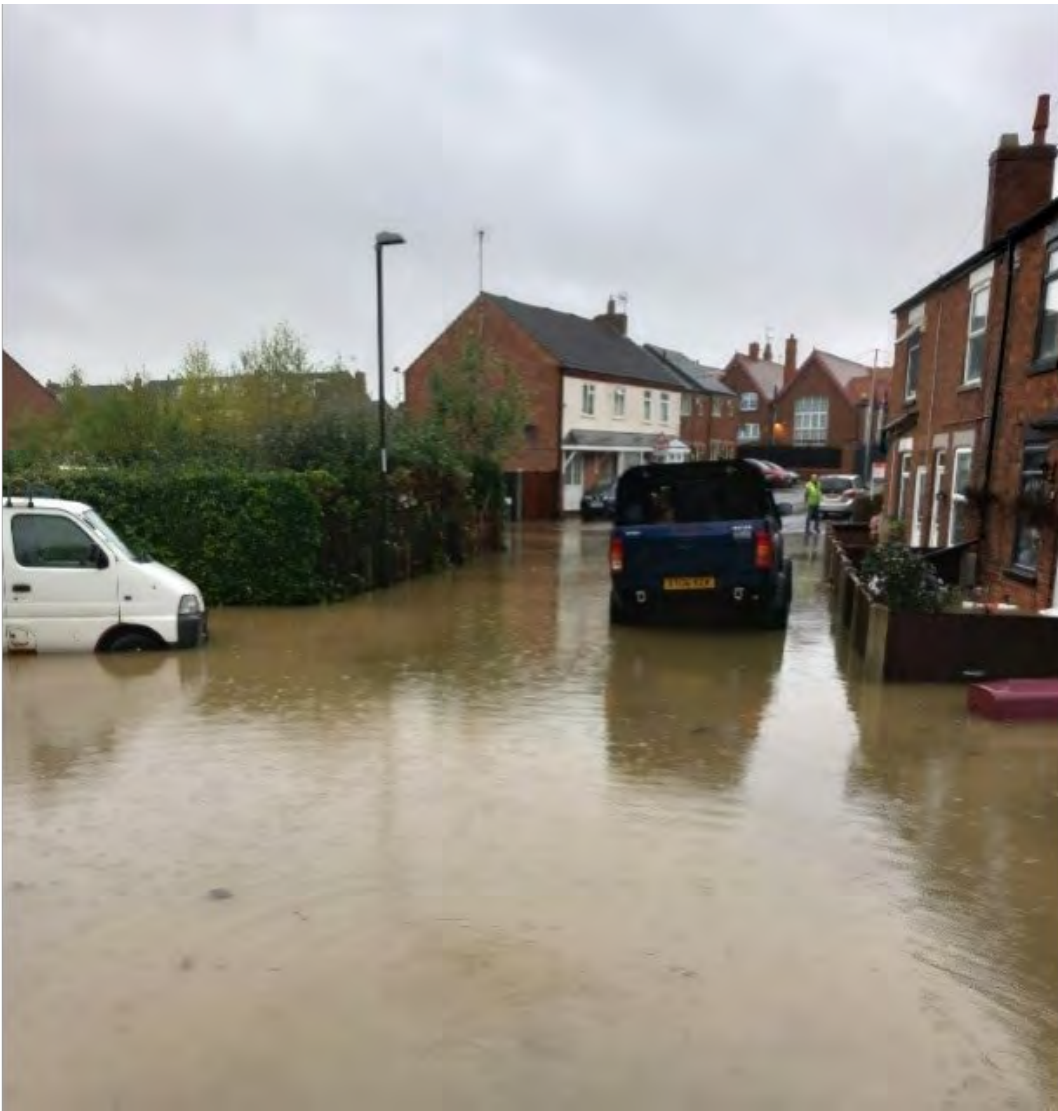
Figure 7-30: Low area in local topography where water will naturally gather.

Surface water was reported as contributing to the flooding of the community. York Terrace and Alexandra Terrace, north of the railway line. The community sits at a low point, lower than the land to the north of the community. This means any surface water runoff flowing southward down Alexandra Terrace will pool in this location. Figure 7-30 below shows the low point on Alexandra Terrace.

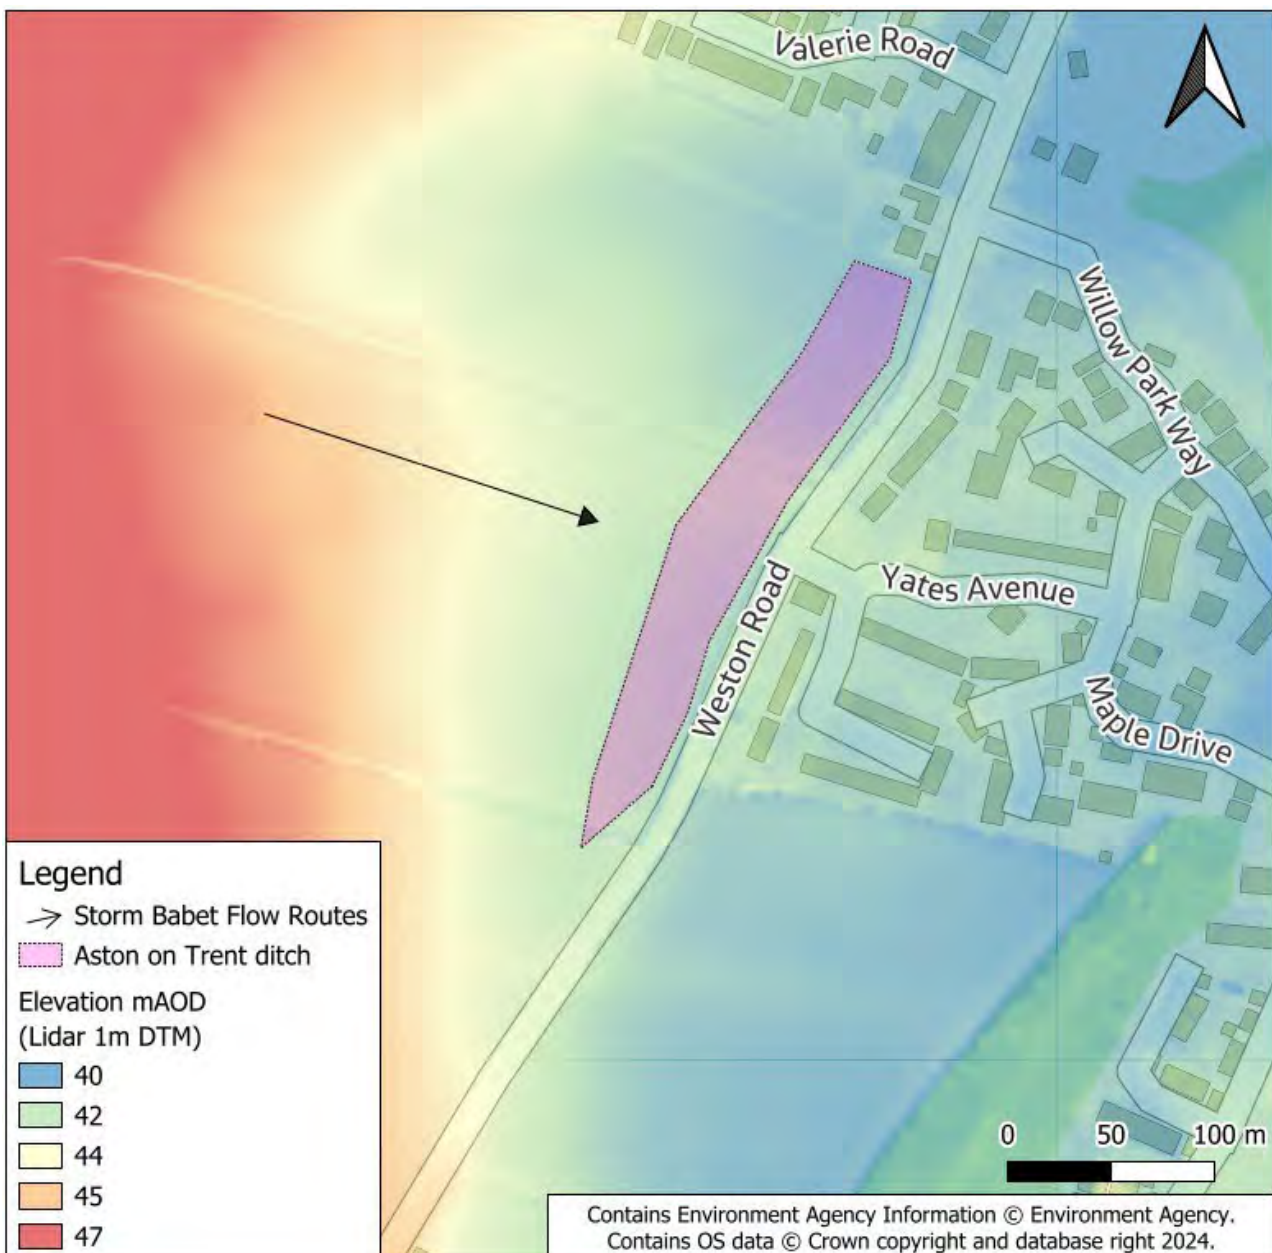
Figure 7-33: Topography of Aston-on-Trent, with arrows indicating the flow routes of surface flood water.

Local accounts suggested that there was a significant volume of run-off from farmland to the west of Weston Road during Storm Babet. Water initially collected in a large ditch to the east of the field at the boundary of Weston Road. The ditch was eventually overwhelmed spilling on to Weston Road, reaching the residential properties on Yates Avenue. The flow direction and ditch are illustrated in Figure 7-33.

Following the flooding in this area, recommendations have been made for a deeper excavation of the ditch,
