3. Derwent Catchment

3.1 Derwent Catchment Event Hydrology

3.2 Community Impacts - Lilac Way

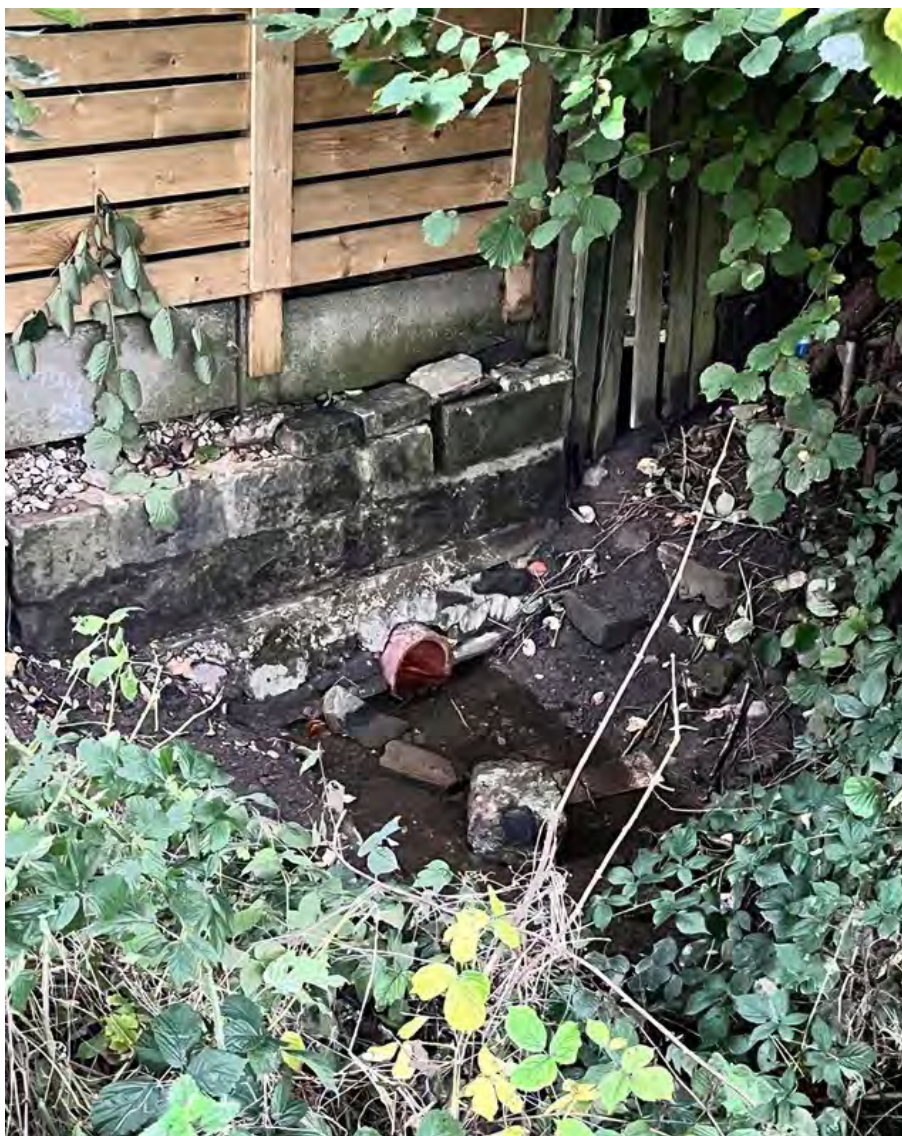
Lilac Way lies along a small, natural surface water drainage pathway. Unfortunately, this drainage pathway has been built on, and the watercourse buried within a culvert has limited capacity. This increases the likelihood of the culvert becoming blocked. Together with the intensity of rainfall occurring during Storm Babet, these are the causes of the flooding.

The inlet to this culverted watercourse is small, poorly designed and in poor condition. It can be seen in Figure 3-4 below.

Figure 3-4: The culvert inlet of the watercourse which flows southwards parallel to Lilac Way.

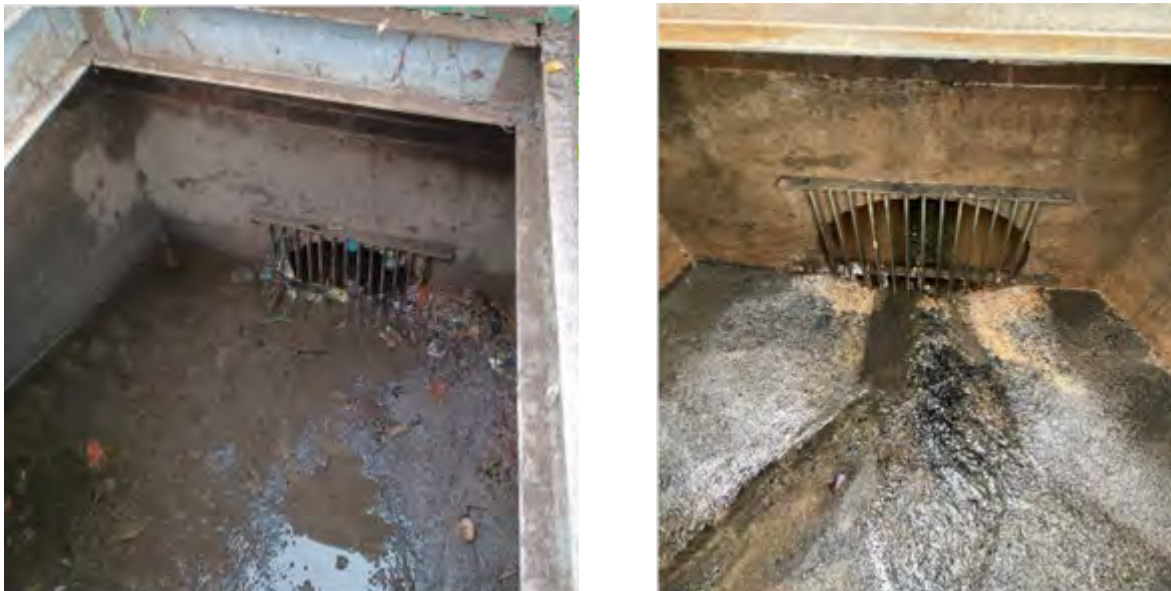
Restrictions within the culvert impeded flow which exacerbated the impacts of flooding. Siltation of a chamber near the downstream end of the culvert was reported, which has subsequently been removed by North East Derbyshire District Council. During the flooding, residents attempted to remove debris from the culvert. The chamber, before and after silt removal, is shown in Figure 3-5 below. It is noted that the siltation is only partial and that the size of the culvert here appears to be much greater than that at the inlet.

Figure 3-5: The picture on the left shows the chamber before cleaning and after de-silting on the right.

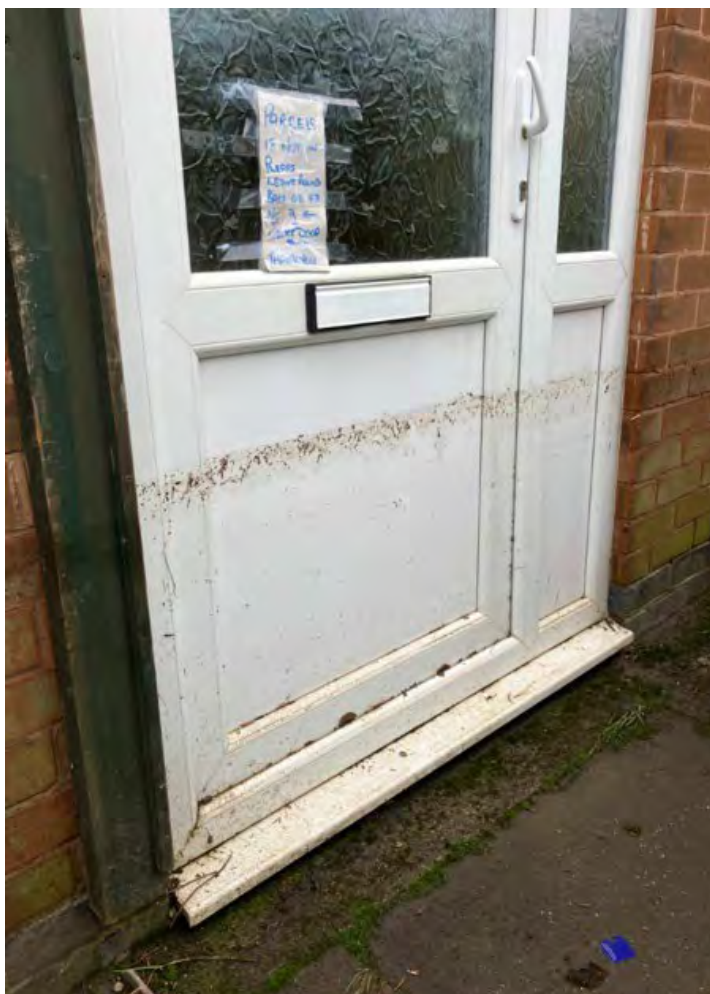
The reported depths of internal flooding reached 0.9m and entered homes via doorways. Figure 3-9 shows the water line on the door of one of the properties, indicating the depth of flooding.

Figure 3-9: Flood water line on property door.

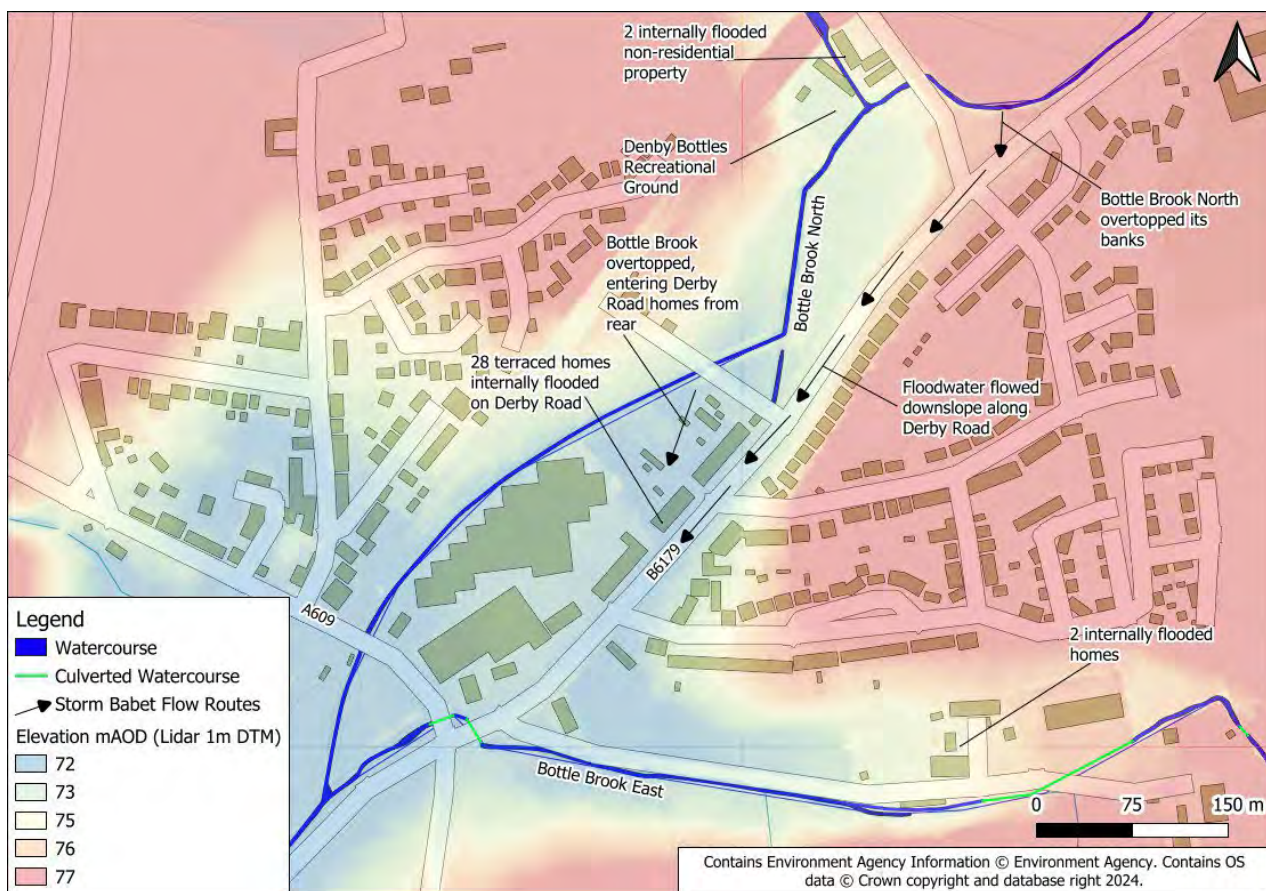
The source of flooding was from Bottle Brook North and Bottle Brook East. Figure 3-24 shows the Storm Babet flood flow routes and ground level at Denby Bottles.

Figure 3-24: Ground level and flow routes at Denby Bottles

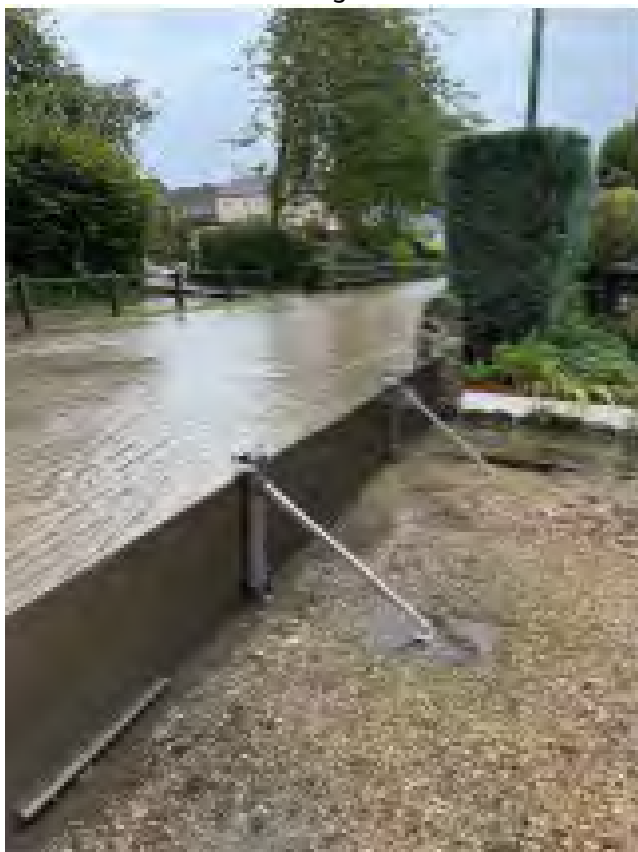
As can be seen in Figure 3-28 the property on Brookside Road that had a demountable flood barrier initially successfully prevented floodwater from Dam Brook from entering the property. On the 20th of October 2023 Dam Brook overtopped and flooded Brookside Road which subsequently resulted in the sewer network being overwhelmed and surcharging. This led to the internal flooding of the property. Figure 3-29 below shows the internal flood water damage.

Figure 3-28: Demountable flood barrier across a driveway prevents flood water reaching a property in Breadsall.

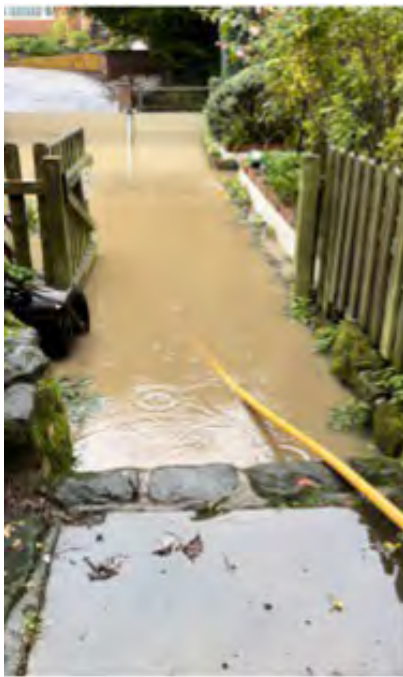
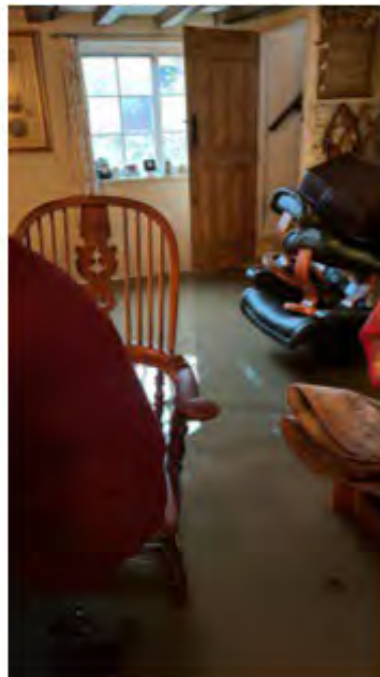
Figure 3-29: Flood water from drainage surcharge (left) and flood water within a property (right).

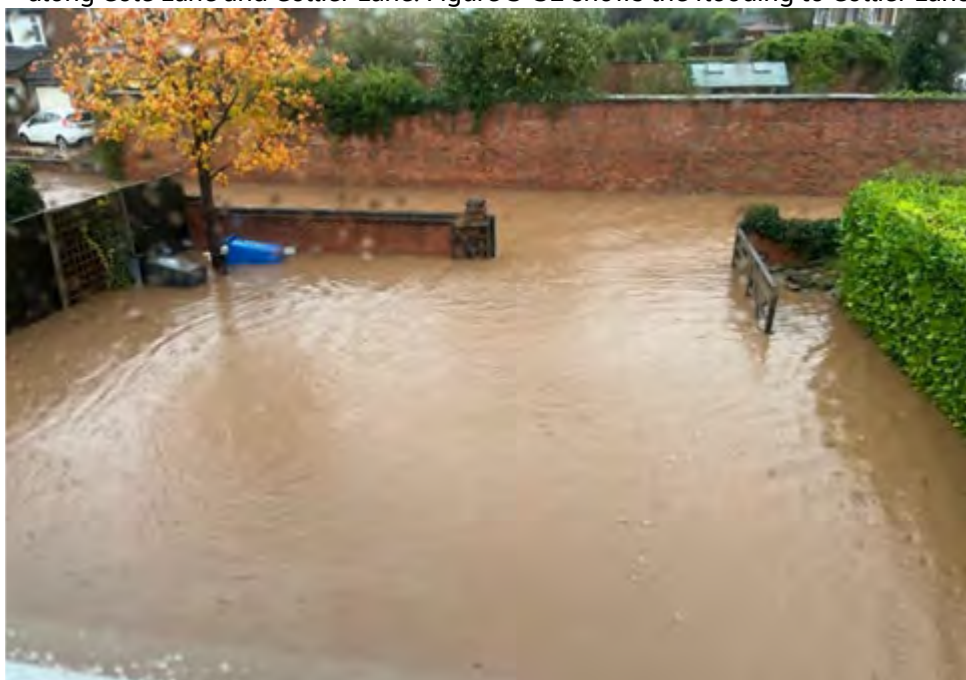
indicates that the culvert under Cole Lane was partially blocked, leading to the water level in Ock Brook to rise upstream (north) of Cole Lane. The Ock Brook then overflowed its banks, with flood water flowing westward along Cole Lane and Collier Lane. Figure 3-32 shows the flooding to Collier Lane.

Figure 3-32: Flooding to Collier Lane

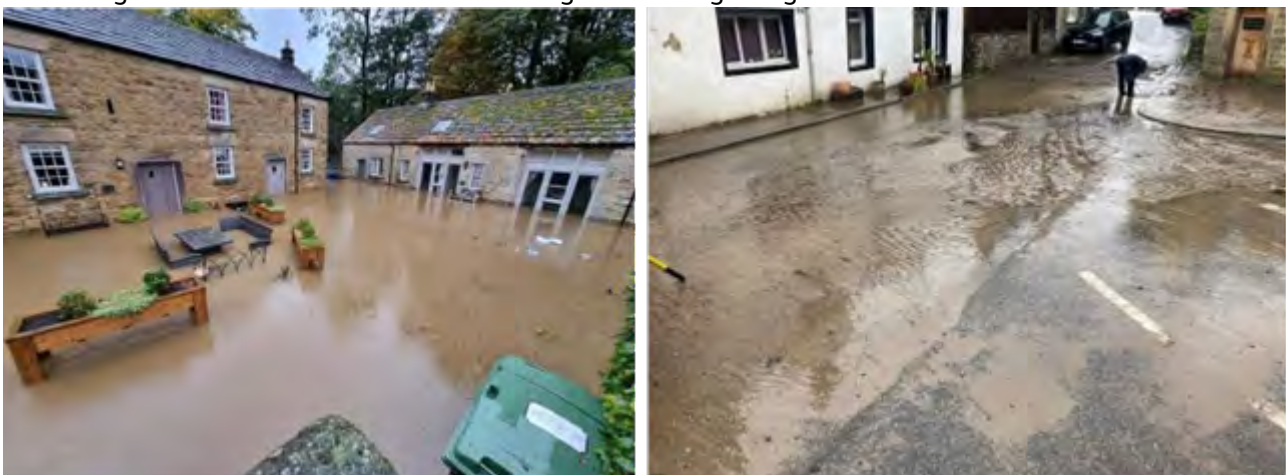
Derbyshire County Council observed flood damage to properties surrounding The Nook and determined that flooding was also related to old mine drainage (soughs) surcharging and flooding properties and the Nook road. Figure 3-36 shows the extent and damage of flooding along The Nook.

Figure 3-36: Flooding to properties on The Nook (left) and damage caused by flooding to The Nook (right)

Due to the nature of the steep hillside to the north of the community, surface water runoff is another likely cause of flooding, especially as The Nook is in a low-lying area adjacent to the watercourse. Surface water runoff from the field behind Denman Crescent is reported to be the source of internal flooding to the home which flooded in this location.

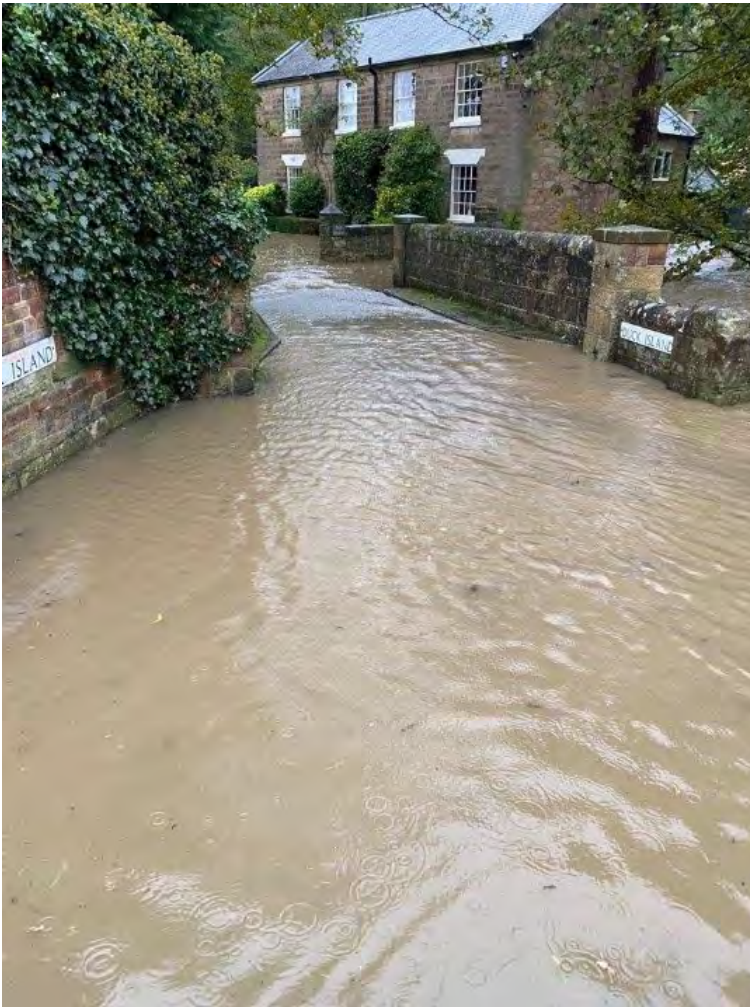
Figure 3-40: Flood water flowing over Duck Island Bridge

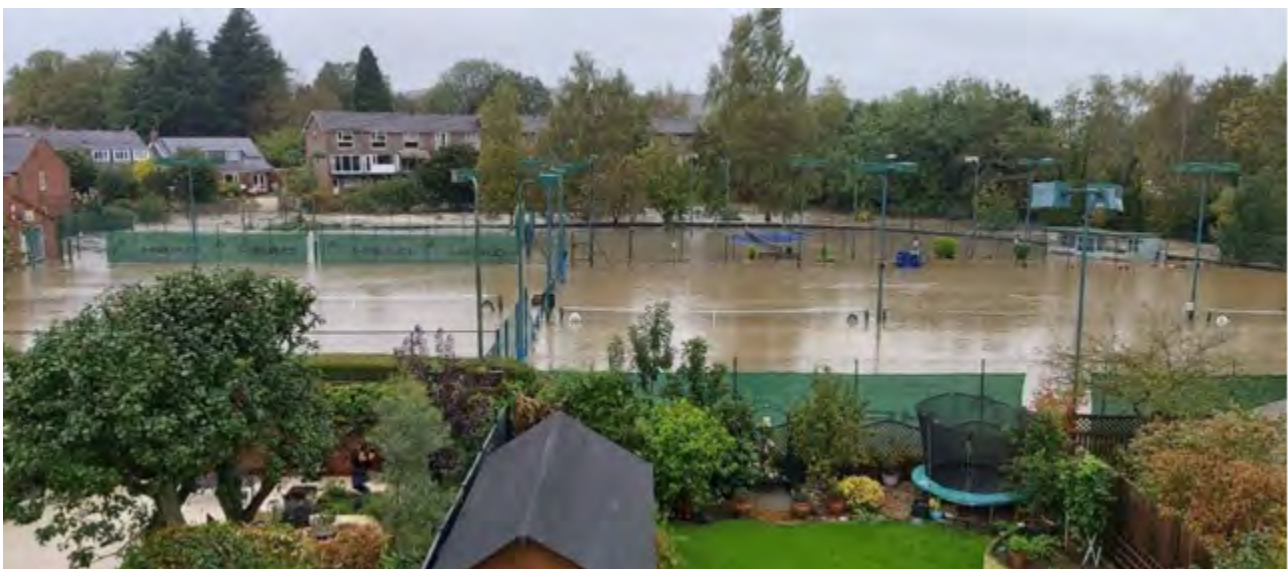
Figure 3-41: Flooding of Duffield Tennis Courts backing onto properties on Ecclesbourne Avenue

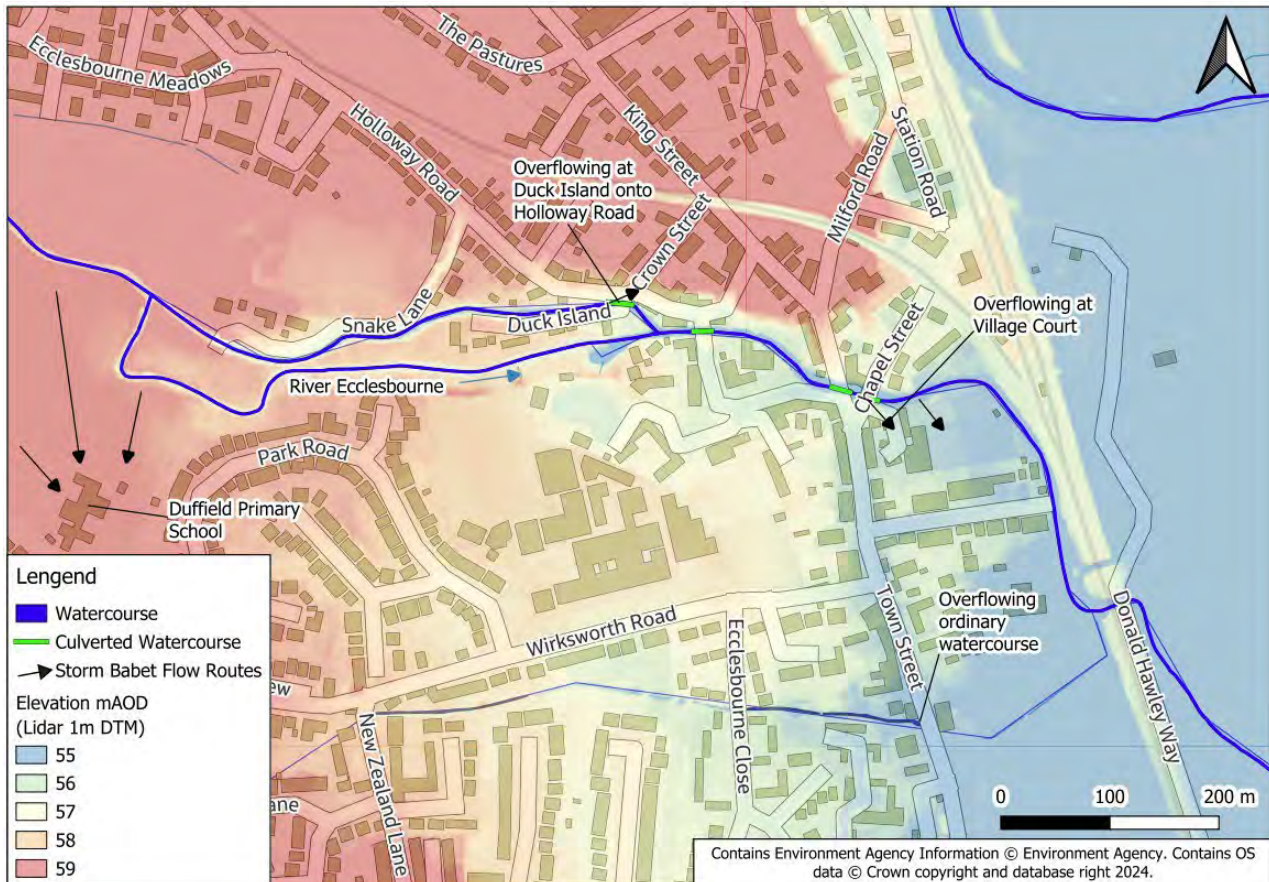
Figure 3-42: Map of Duffield with flooding flow routes indicated with blue arrows.

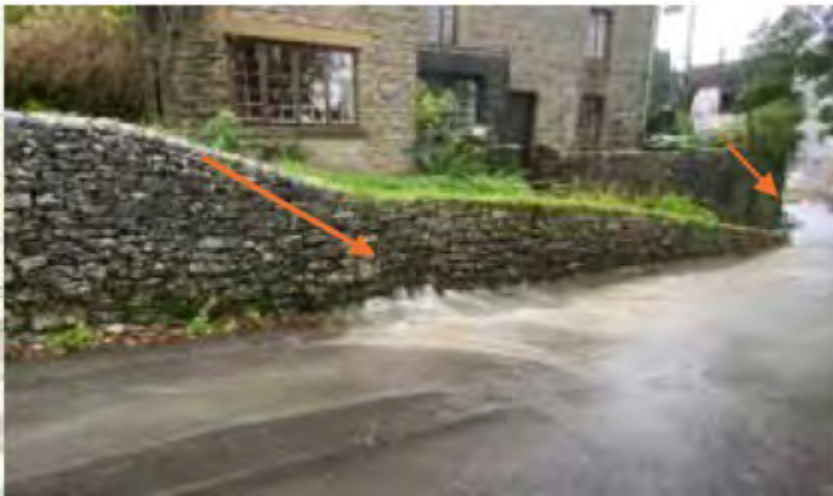
Figure 3-46: Surface water runoff flowing through a drystone wall and onto Brookside.

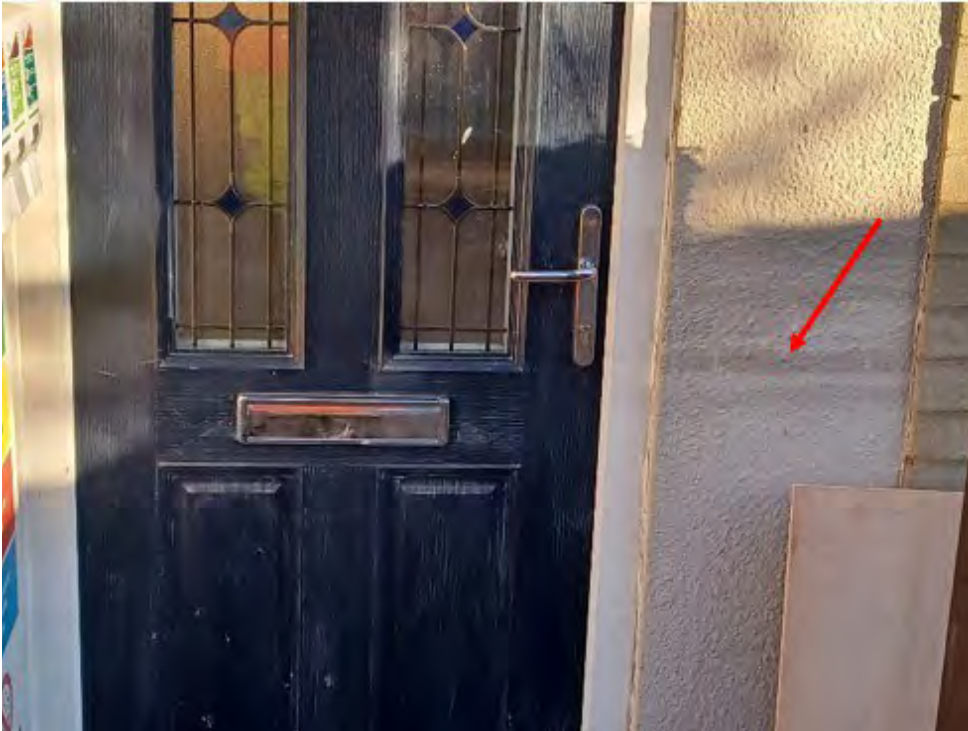
Figure 3-54: Flood water marks about halfway up the door and wall of a property in the community marked by a red arrow.
