## 4. Don and Rother Catchment

### 4.1 Don and Rother Catchment Event Hydrology

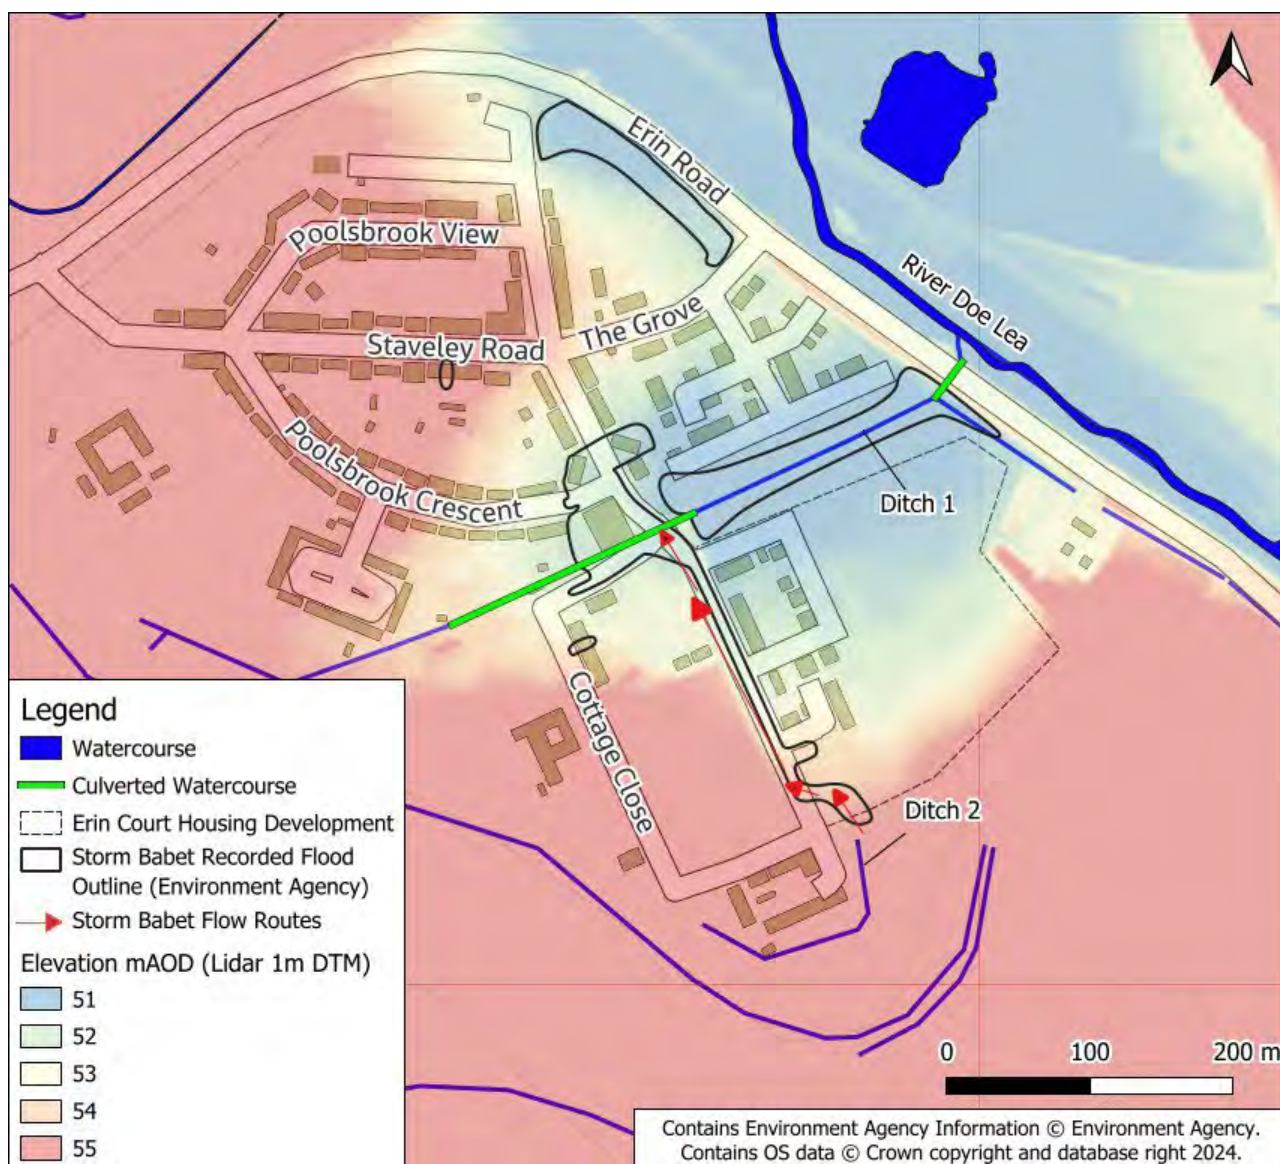
Floodwater flowed from the woodland to the south of Erin Court into the housing development where two homes were flooded internally. This floodwater then flowed downslope along Staveley Road to the low spot, internally flooding the six other properties. It is understood that the floodwater that flowed out of the woodland originated from Ditch 2. Chesterfield Borough Council, as the riparian owner of Ditch 2, have since been investigating the cause of flooding. Investigations are ongoing to understand to what extent a potential blockage could have exacerbated the impact of exceptional weather.

The sewer network discharged at the rear of No. 58 Staveley Road, at the junction of Staveley Road and Poolsbrook Crescent and from the trunk sewer adjacent to the eastern end of Ditch 1 by the A6192. The Yorkshire Water pumping station is shown on Figure 4-2. Yorkshire Water is undertaking an investigation into the potential pumping station failure.

Figure 4-5: Ground level, flooding extent and flow routes at Poolsbrook.

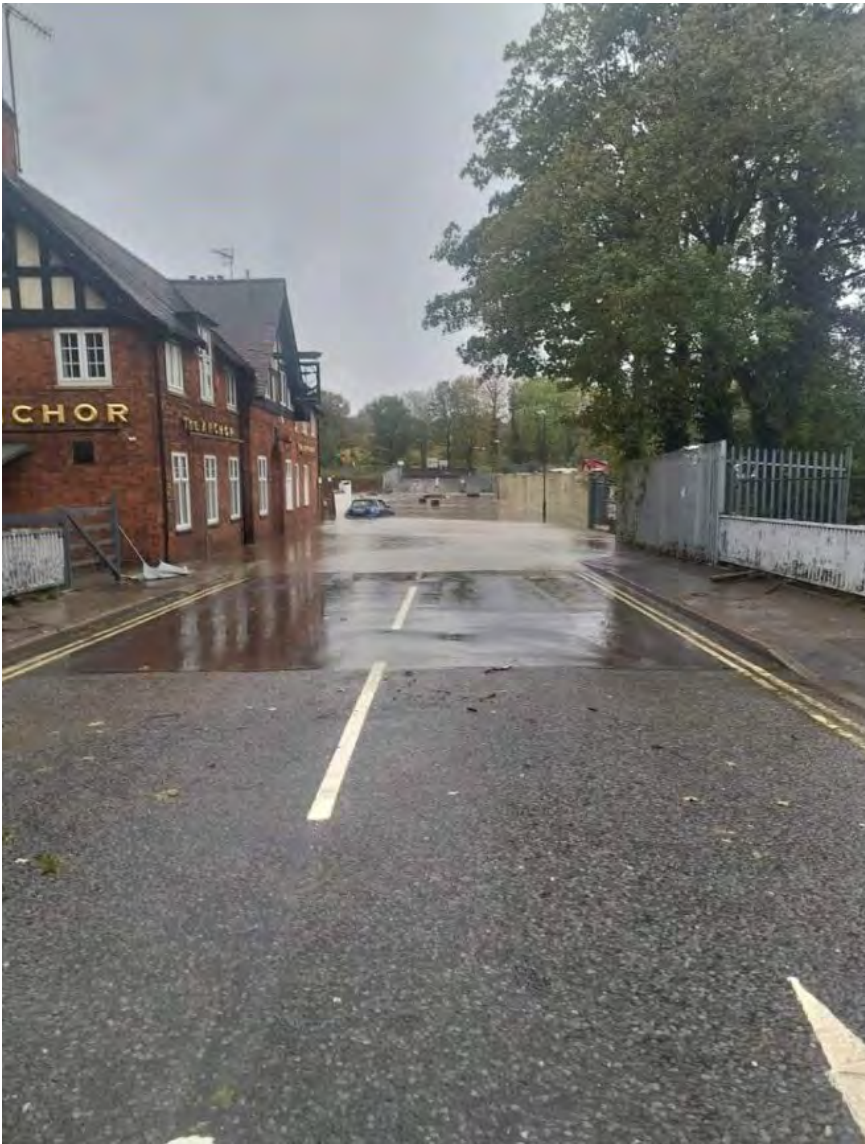
The River Hipper overtopped near the derelict brownfield site upstream of Factory Street, inundating this site before flooding Factory Street and the Lidl car park. Properties on Chatsworth Road, upstream of the Factory Street bridge, are not reported to have internally flooded. Factory Street bridge was surcharged, as is evidenced by Figure 4-23, taken after water levels had receded somewhat. The figure shows debris caught in the bridge rails on either side of the road. A public house was internally flooded on Factory Street, shown in Figure 4-23 to be submerged south of the River Hipper. Media evidence indicates that the flood depth at the entrance to Lidl, which is a low spot-on Factory Street, likely exceeded 0.5m.

**Figure 4-23: Flooding of low spot on Factory Street. Photograph taken from immediately north of Factory Street bridge.**

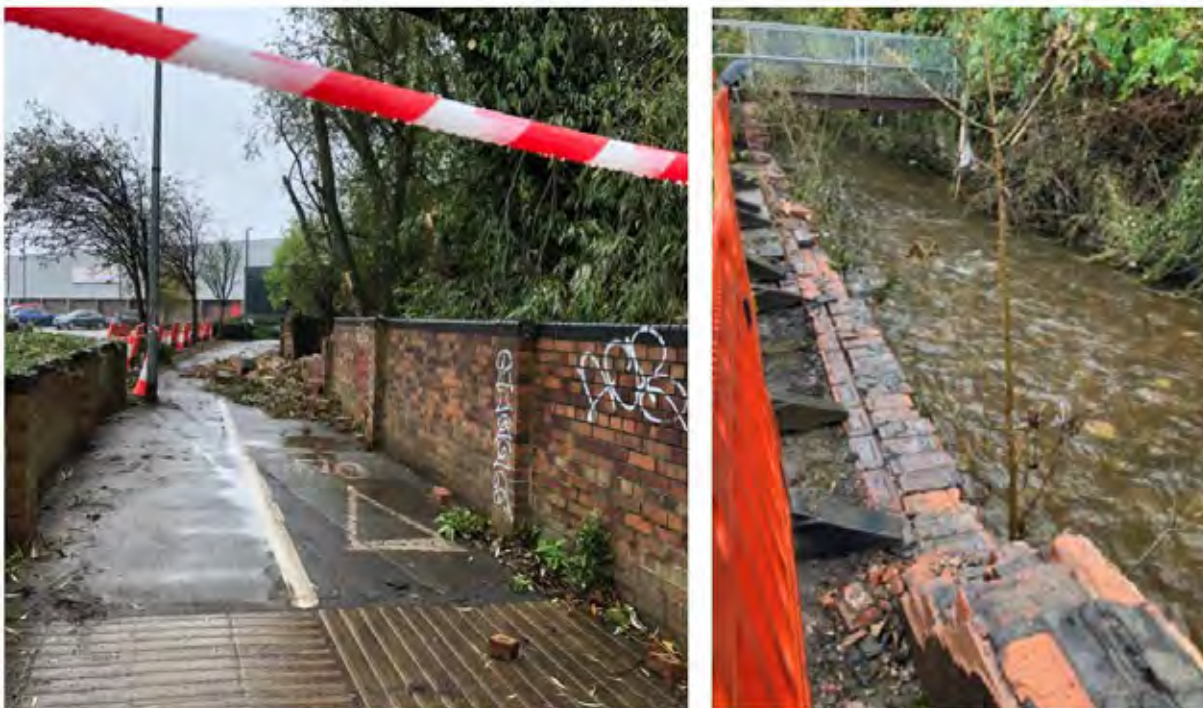
River channel exceedance within this community caused numerous instances of infrastructure damage. For example, the overtopping of Holme Brook and River Hipper caused a riparian owned brick wall to collapse adjacent to West Bars roundabout and just upstream of the culvert immediately west of Boythorpe Road, respectively. The damage sustained to a red brick wall during Storm Babet is shown in Figure 4-24 below. The area is taped off and cones have been placed around the section that has collapsed.

**Figure 4-24: Collapsed walls as a result of the overtopping of Holme Brook (left) and the Hipper (right).**

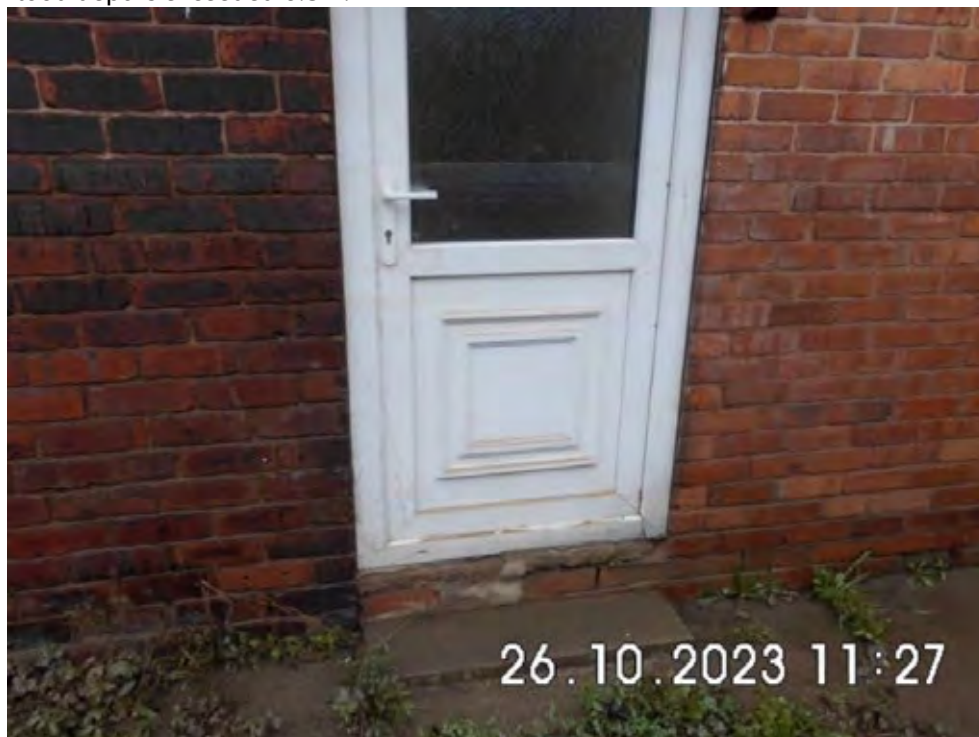
**Figure 4-28: Water mark on the rear door of a property on Hawthorne Street.**

Residents on Hawthorne Street reported that floodwater also overtopped the embankment at the south-east end of the street. Sherwood Street residents reported floodwater to have initially originated from a manhole, and that floodwater then entered the rear gardens of Sherwood Street homes from the Rother by infiltrating through the wall rather than by overtopping it (i.e., penetrated through the flood wall to the north-east of Sherwood Street). Note, however, that post-event asset surveys conducted by the Environment Agency did not detect any infiltration. The initial route of floodwater entering homes on Sherwood Street was reported to be through property air bricks and subsequently through the floor.

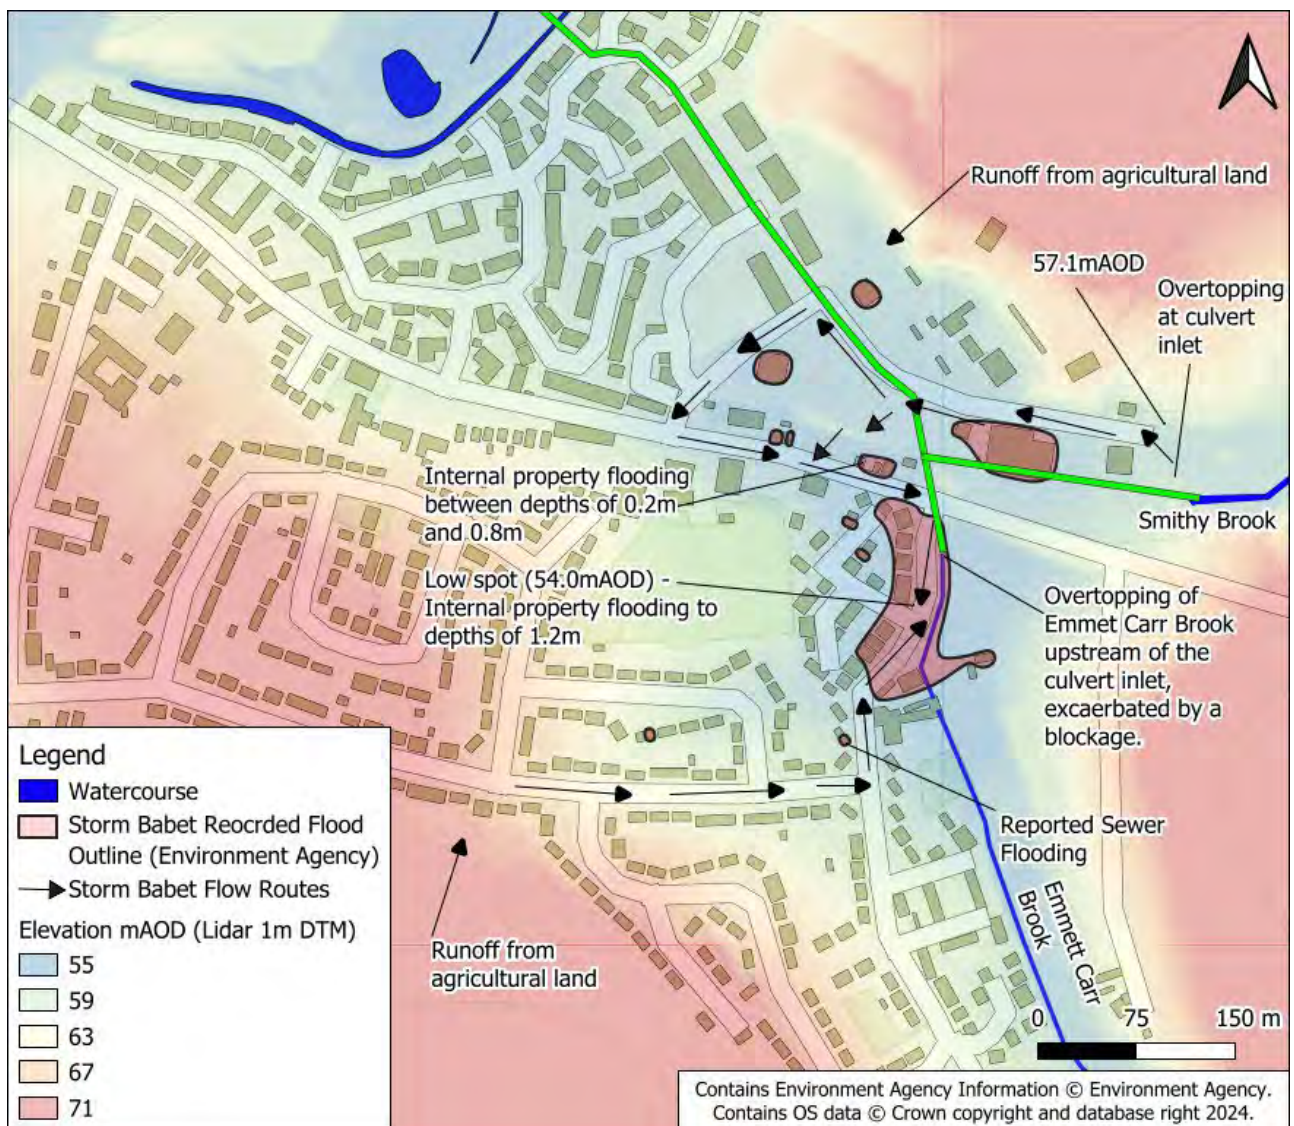
Figure 4-32 shows the flood extent, mechanisms and flow routes that occurred at Renishaw. It is clear that in addition to the exceptional rainfall, the flooding was also caused by culvert blockages at the inlet of both Smithy Brook and Emmettt Carr Brook culvert inlets. Flood depths of up to 1.5m outside and 1m inside properties were reported.

Flow routes traversed westwards along Smithy Brook Road after having overtopped at the Smithy Brook culvert inlet. Overflowing is also considered to have occurred upstream of the Emmet Carr Brook culvert inlet. Both instances are noted as being exacerbated by culvert blockages. Smithy Brook flood water is shown to join Sheffield Road and the Emmet Carr Brook floodwater. Internal flood depths are thought to have reached depths of 0.2m to 0.8m on Sheffield Road, and upto 1.2m in a property on Emmet Carr Lane.

Figure 4-32: Ground level and Storm Babet flow routes at Renishaw.

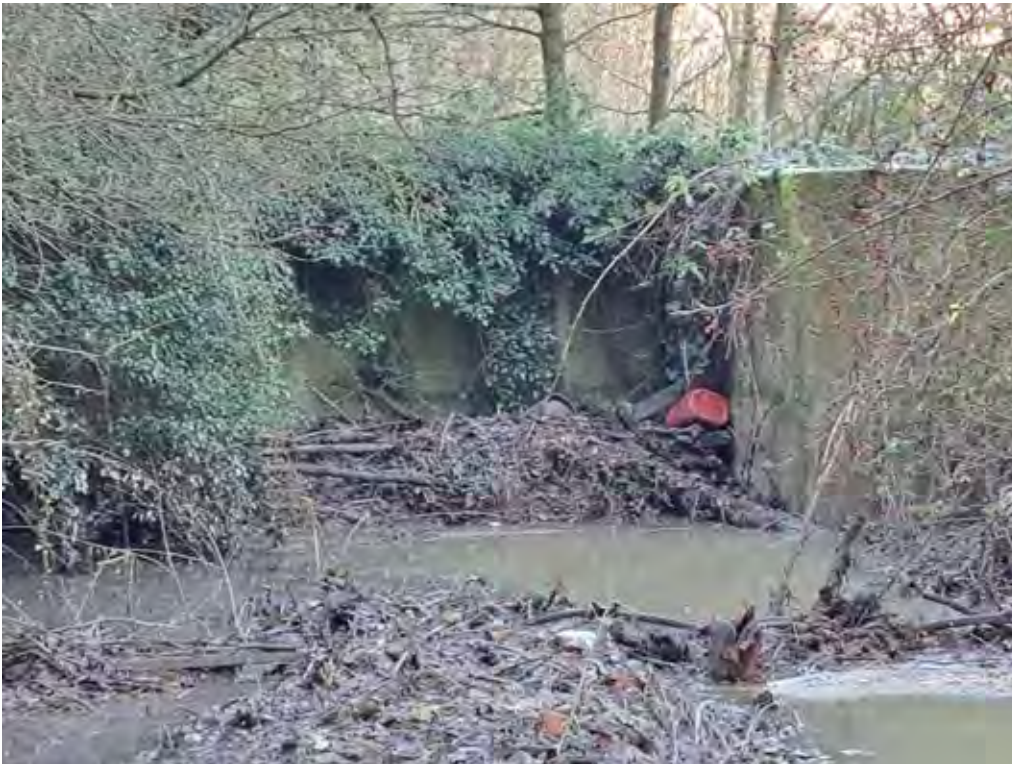
**Figure 4-33: Debris blockage at Smithy Brook culvert inlet (upstream of Smithy Brook Road).**

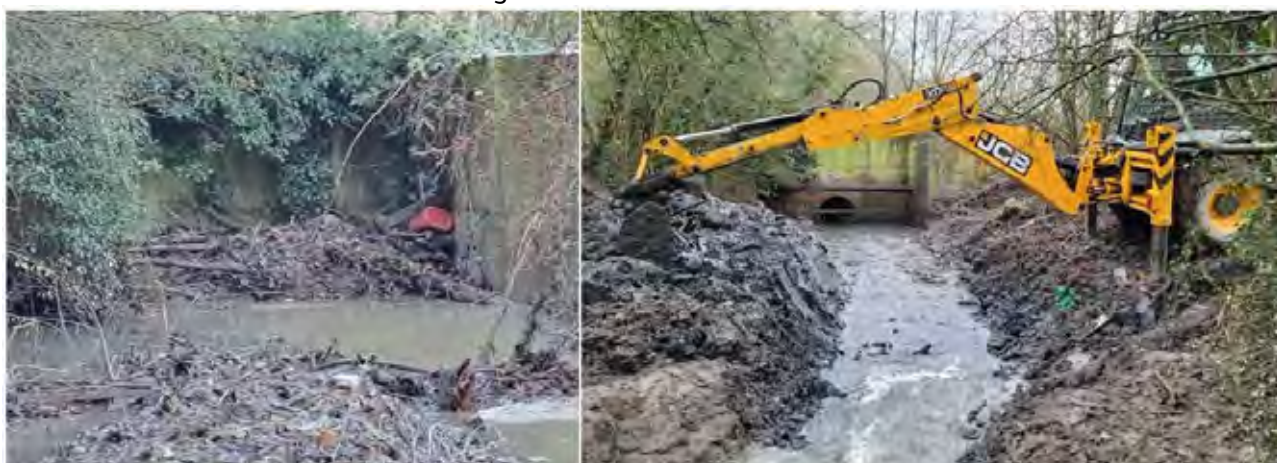
**Figure 4-34: Smithy Brook culvert prior (left) and post (right) trash screen clearance.**

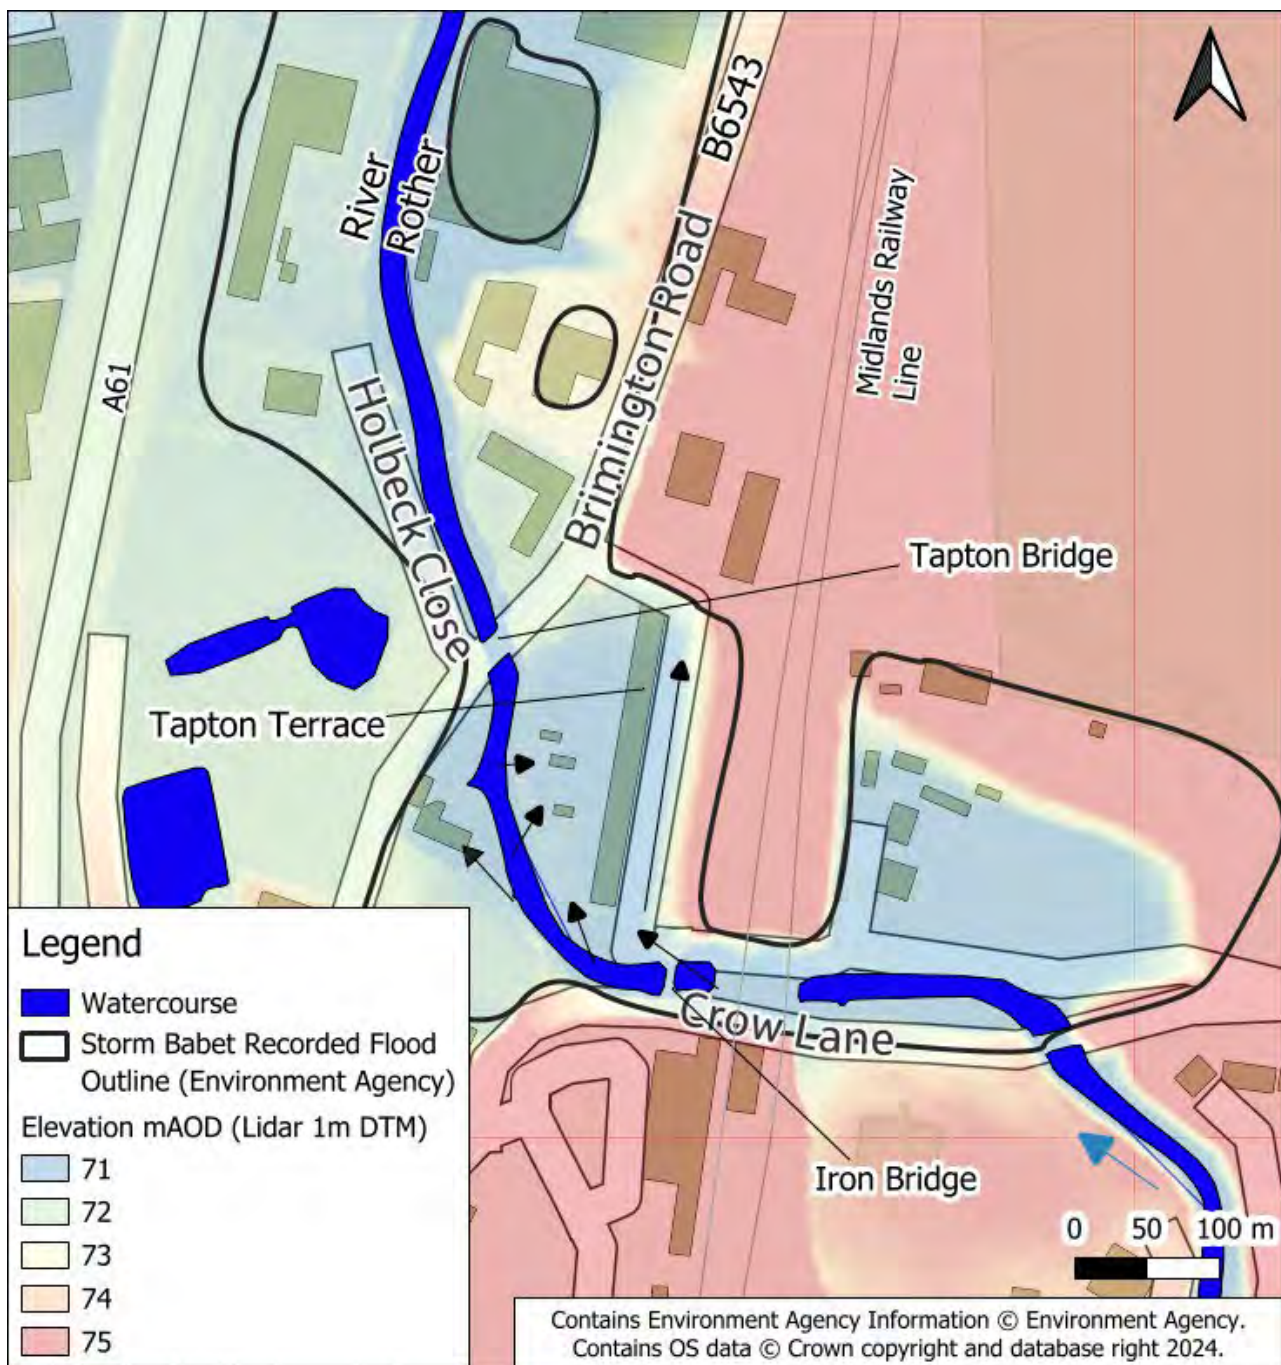
Figure 4-38: Ground level and Storm Babet flow routes at Tapton Terrace.

Investigations are ongoing to determine the impact of Tapton Bridge on restricting flow in the River Rother. Initial flooding near Tapton Terrace occurred at the low spot of the west bank of the river, impacting a non-residential property. River levels then exceeded the low spot on the east bank of the river, impacting the rear of all twenty-six homes, before flooding from the front, down to Tapton Bridge. Flooding reached depths of 1.5m in some properties, which would exceed the design standards of external PFR measures. Flooding of such depths represents a hazard to members of the public.

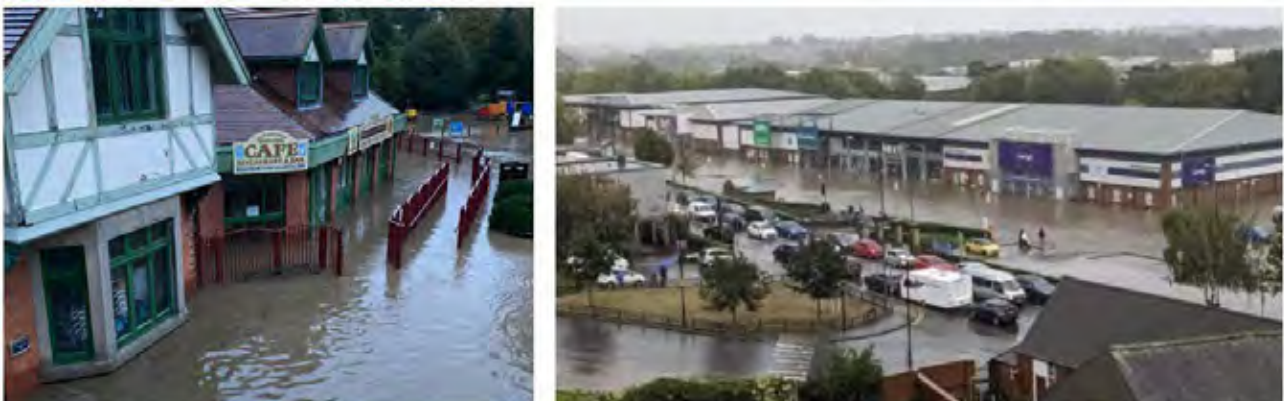
Figure 4-43: Left - Flooding at a business within Queens Park. Right - Flooding on the northern side of Ravenside Retail Park.

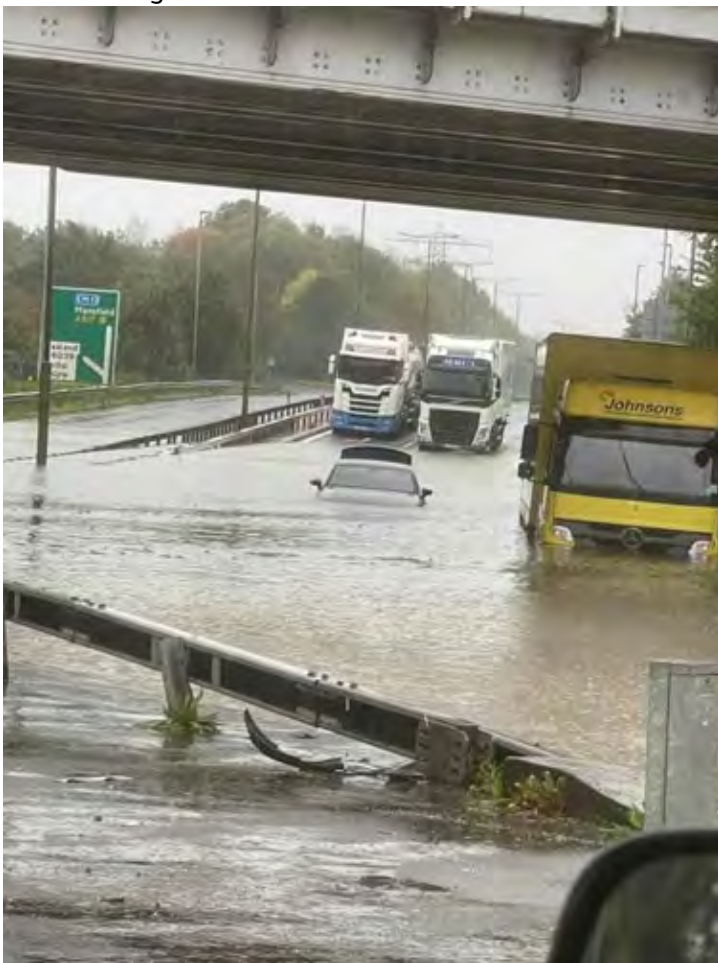
Flooding at this community had a substantial impact on infrastructure in the vicinity of Horns Bridge. Numerous roads were impassable due to excessive flood depths, including all arms of Horns Bridge roundabout. Watermarks on railings and signposts at the roundabout indicate water depths reached about 0.5m. The A617, to the south-east of Horns Bridge roundabout, was flooded to depths exceeding 0.5m at its low spot. The cause of flooding here is understood to have been a combination of river, sewer, and surface water sources. Floodwater overflowing the River Rother near to the A617 is understood to have flowed from both north and south directions towards the low spot on the A617. Additionally, a sewer passes beneath the rail embankment at this location, which has a history of being overwhelmed. During Storm Babet, floodwater surcharged from the manhole on the A617, contributing to the flooding there. In addition, surface water is likely to have contributed to flooding at this location due to the local topography. Flooding at the low spot is shown in Figure 4-44.

**Figure 4-44: Flooding on the A617 at the low spot beneath the railway underpass at Horns Bridge. Photograph taken from Horns Bridge Roundabout.**

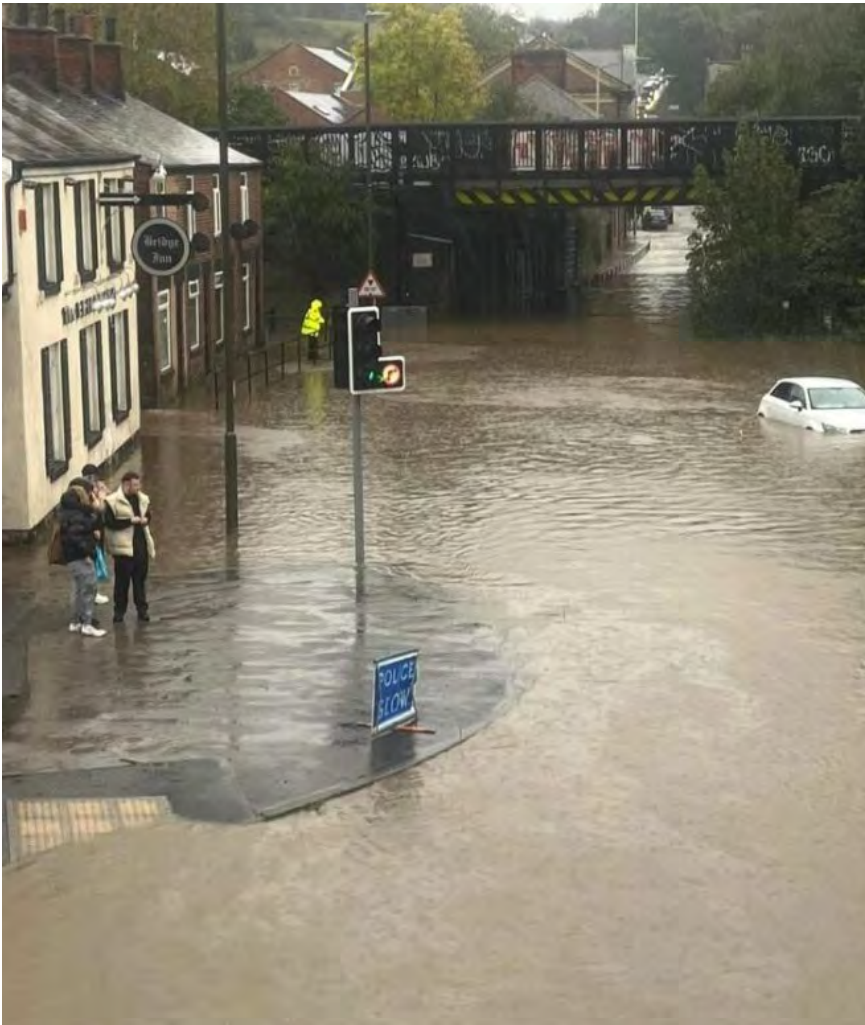
Figure 4-46: Flooding on Hollis Lane, facing eastwards towards Hady Hill.

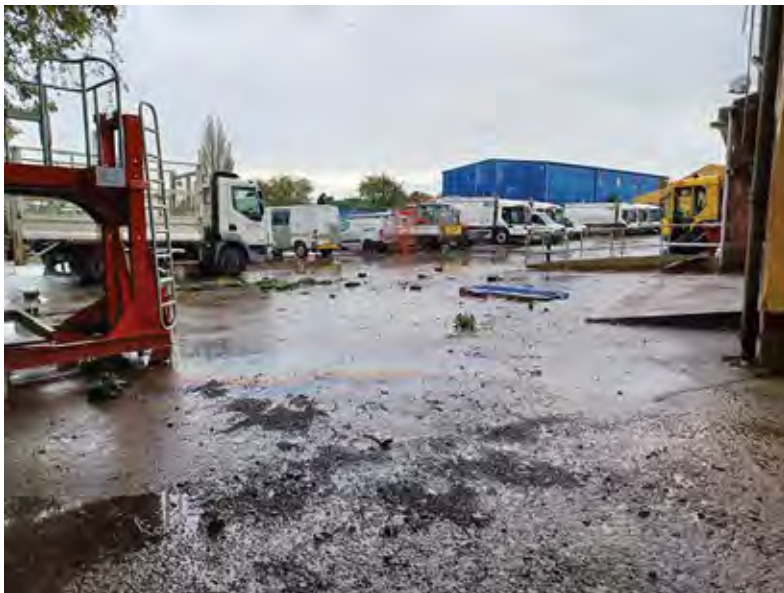
Figure 4-55: Eckington Depot affected by flooding because of Storm Babet.

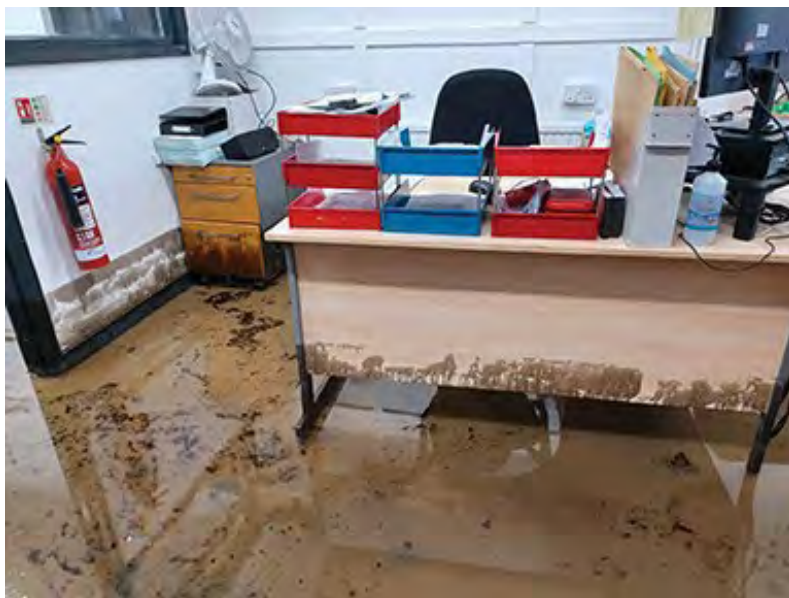
Figure 4-56: Interior of Eckington Depot affected by flooding because of Storm Babet.
