## 5. Dove Catchment

### 5.1 Dove Catchment Event Hydrology

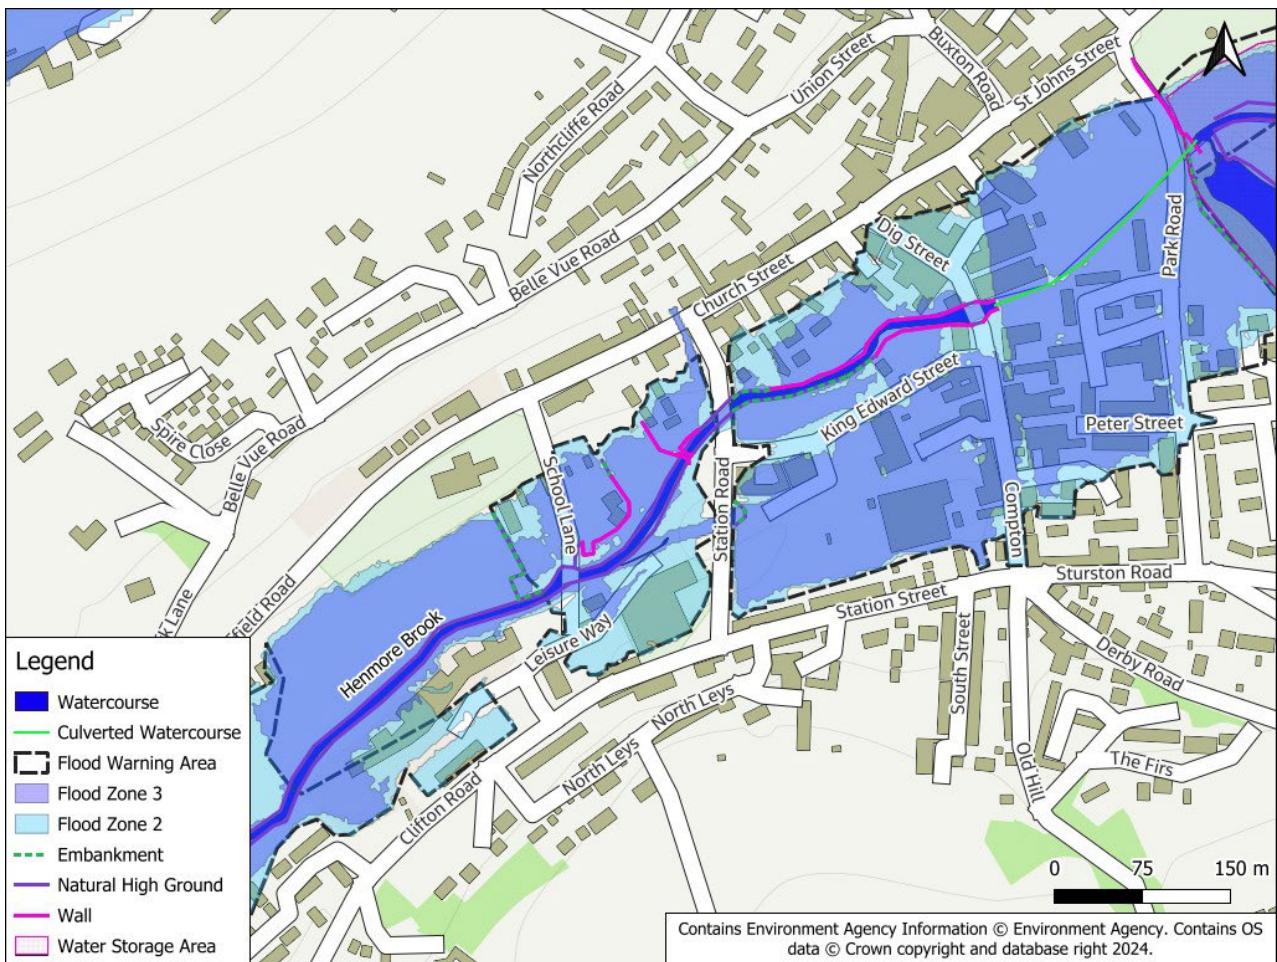
**Figure 5-3: Flood Risk Management Arrangements and flood zones within Ashbourne.**

The Flood Map for Planning (<https://flood-map-for-planning.service.gov.uk/>) shows that all of the flooded homes within this community are in Flood Zone 2 and 3, see Figure 5-3. Areas in Flood Zone 2 have between a 1% and 0.1% AEP of river flooding. Areas within Flood Zone 3 have a greater than 1% AEP of flooding from rivers.

The Environment Agency's Asset Information and Maintenance Programme (<https://environment.data.gov.uk/asset-management/>) shows there are several flood defence assets within the community, as well as the wider Ashbourne area. There are 3 purpose built flood defences in the vicinity of the properties that overtopped as their design level was exceeded by the flood. The defences are designed to provide a 1% AEP Standard of Protection (SoP). The Mansion House Garden flood wall is located to the south and east of the properties on Coachmans Close and is at target condition. The Mansion House garden embankment is an extension to the Mansion House Gardens floodwall and is currently below required condition, however there is a programme of works to rectify this. The Church Hall Car Park Embankment is to the west of School Lane and is at target condition. All of these flood defence assets were built in 2012 and are maintained by the Environment Agency. All the aforementioned condition assessments were undertaken post Storm Babet.

The Ashbourne Flood Storage Reservoir (FSR) built in 2014 in Ashbourne Park is approximately 550m upstream of the flooded properties. It was designed to store water during flood events and provide 1% AEP SoP to the properties downstream in Ashbourne. The reservoir is maintained by the Environment Agency and is considered to be in good condition. Figure 5-3 shows all the flood risk management arrangements described above.

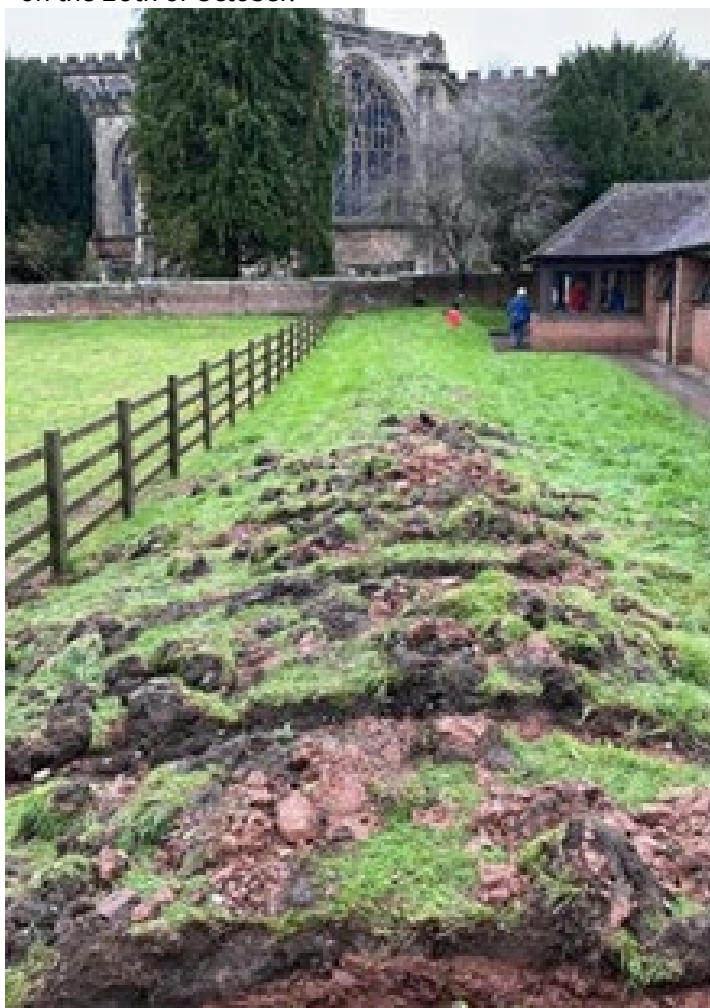
reported depth of 23 cm. Figure 5-6 shows that channels were excavated through the top of the flood embankment to allow flood water to drain away from the church hall. These were excavated around 3:00pm on the 20th of October.

**Figure 5-6: Channels were excavated into the flood embankment to the west of St Oswald's Church Hall to allow water to escape.**

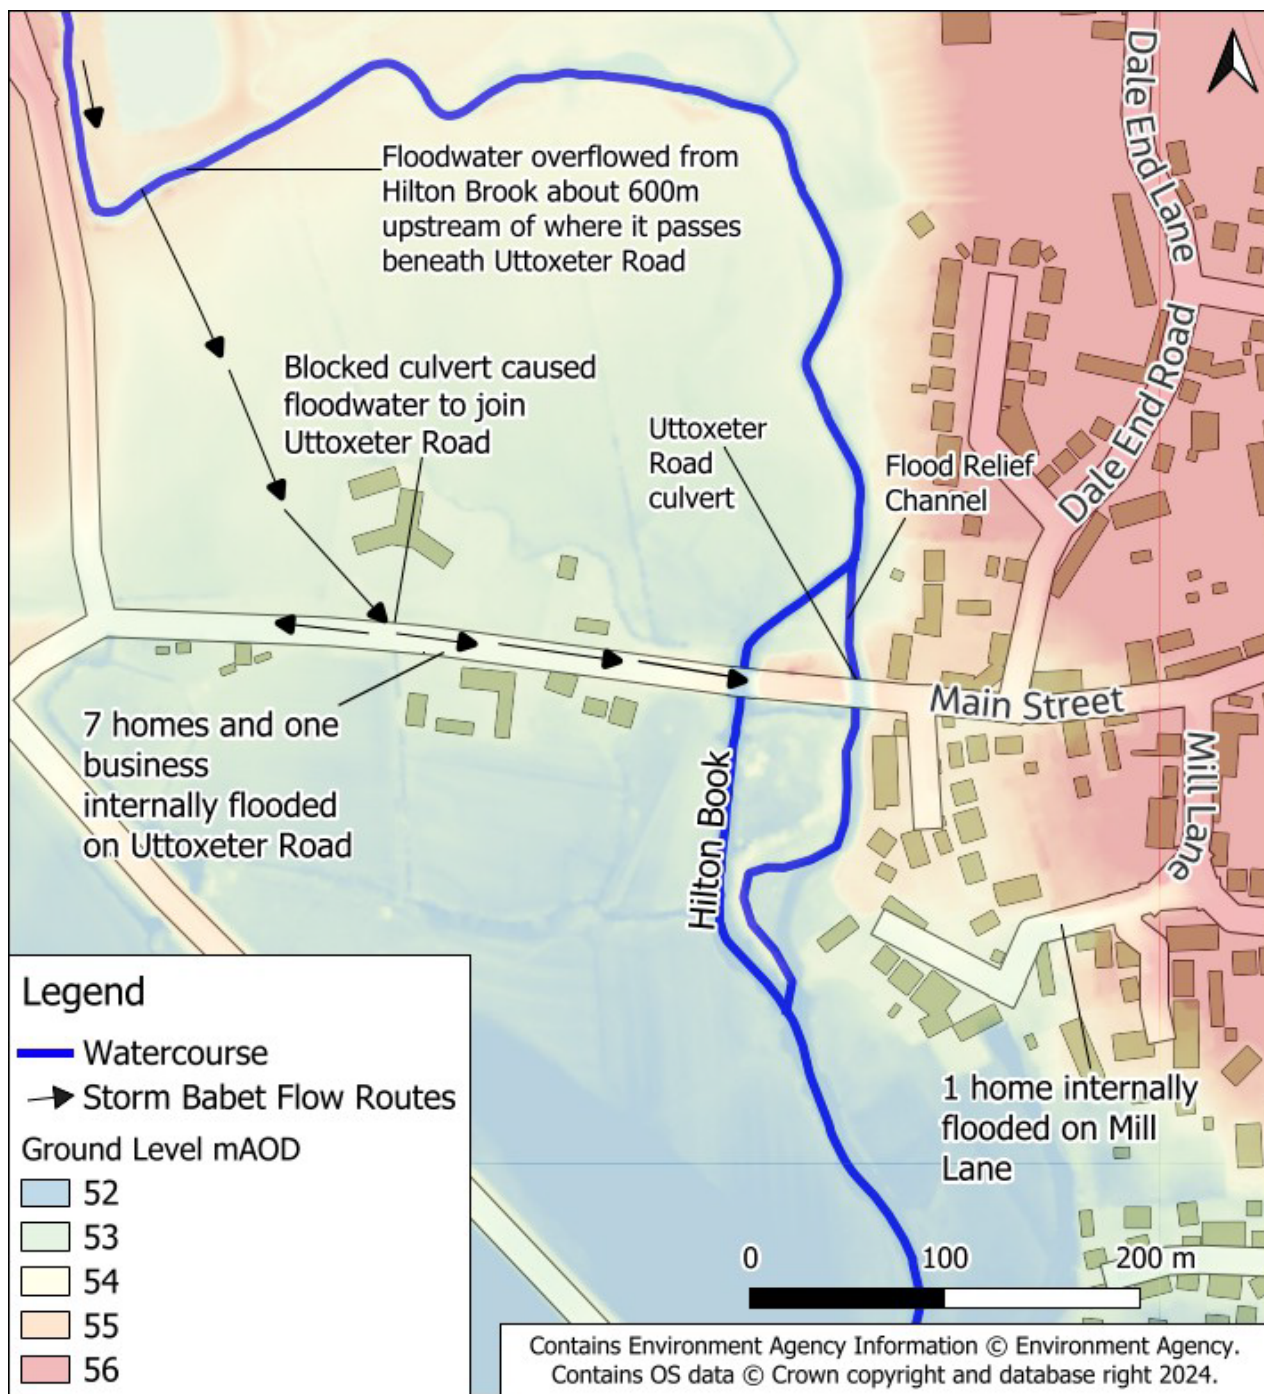
Figure 5-10: Ground level and Storm Babet flow routes at Hilton.

The primary source of flooding affecting all properties within this community is assumed to be from Hilton Brook due to overflowing upstream of Hilton village and flooding Uttoxeter Road.

Hydrology data has been taken from the Sutton Mill river level gauge on Hilton Brook. The gauge is located upstream of the community affected at Sutton Mill. The Sutton Mill gauge shows that on the 20th of October 2023, the peak level recorded was 1.84m; the highest level ever recorded at this gauge. The gauge indicated that the water began to rise at 1:30am, reaching its peak at 5:30pm.

The depth of internal flooding was almost 1m at some properties. The semi-detached properties within the area are known to frequently flood. One property has a sump and pump chamber already installed. A few of these properties only flooded externally. South Derbyshire District Council have stated that, water had overtopped Hilton Brook upstream of the village and flooded Uttoxeter Road before it got to the relief channel. Anecdotal evidence suggests that in addition to a sharp bend in the brook, there was also a weir at this location that may have an impact on flow causing water to escape the channel. Details of action taken during the event by flood risk management authorities are included in section 5.3.5.

It was reported by a councillor from South Derbyshire that the Hilton Brook culvert beneath Uttoxeter Road was blocked. This resulted in the channel overtopping upstream of the culvert inlet. Floodwater then flowed onto Uttoxeter Road and downslope westwards, internally flooding seven properties on Uttoxeter Road. Figure 5-10 shows the ground level and Storm Babet flow routes at Hilton.

The Environment Agency have subsequently discussed the flooding with a local District Councillor and as requested inspected the Hilton Brook around the flooded properties. The Flood Relief channel was found to be operating as designed. The Environment Agency determined there may be an opportunity to redirect floodwater, that escapes further upstream away from property, back towards the Hilton Brook channel which would reduce the chances of property flooding in the future. Investigations are underway to determine the feasibility of these adaptations..
