6. Idle and Torne Management Catchment

6.2 Community Impacts – Clowne

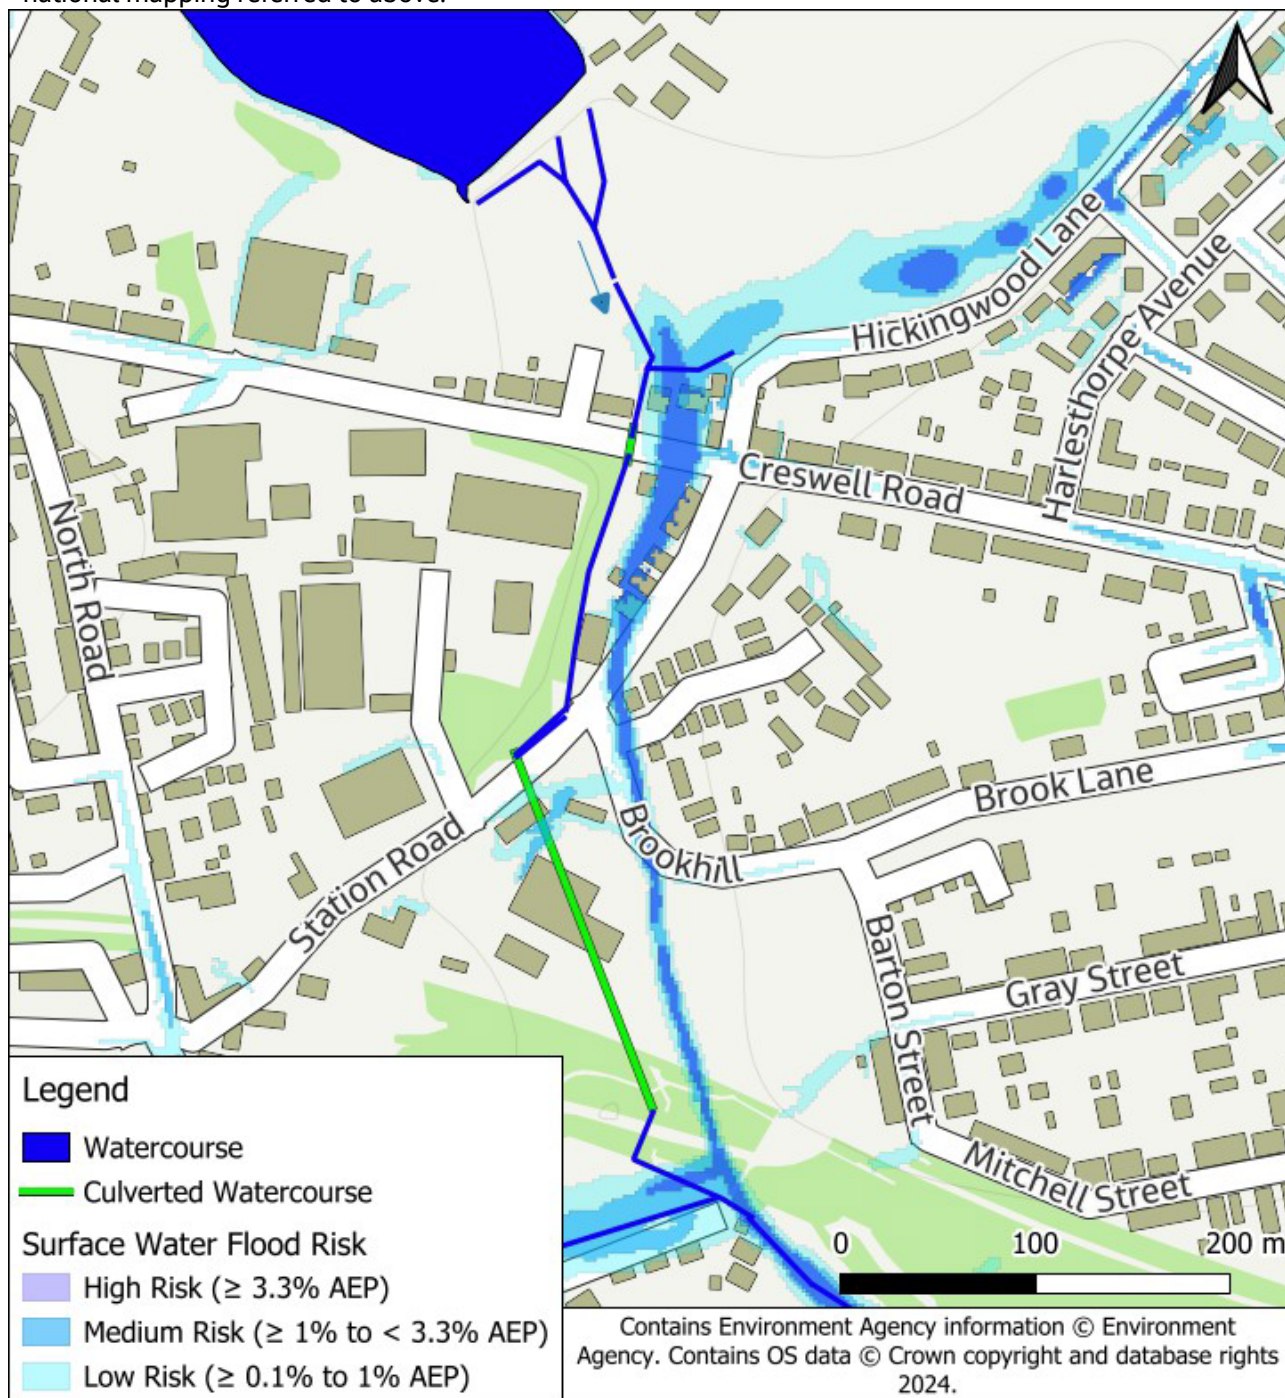
Figure 6-3: Map showing the chance in any given year of flooding from surface water at Clowne (Source: Long Term Flood Risk Map).

However, some homes on North Road have a high risk of surface water flooding, based on the Long Term Flood Risk Map (<https://check-long-term-flood-risk.service.gov.uk/postcode>). High risk is defined as greater

than 3.3% AEP of flooding. Figure 6-3 shows the surface water flood risk for the community based on the national mapping referred to above.

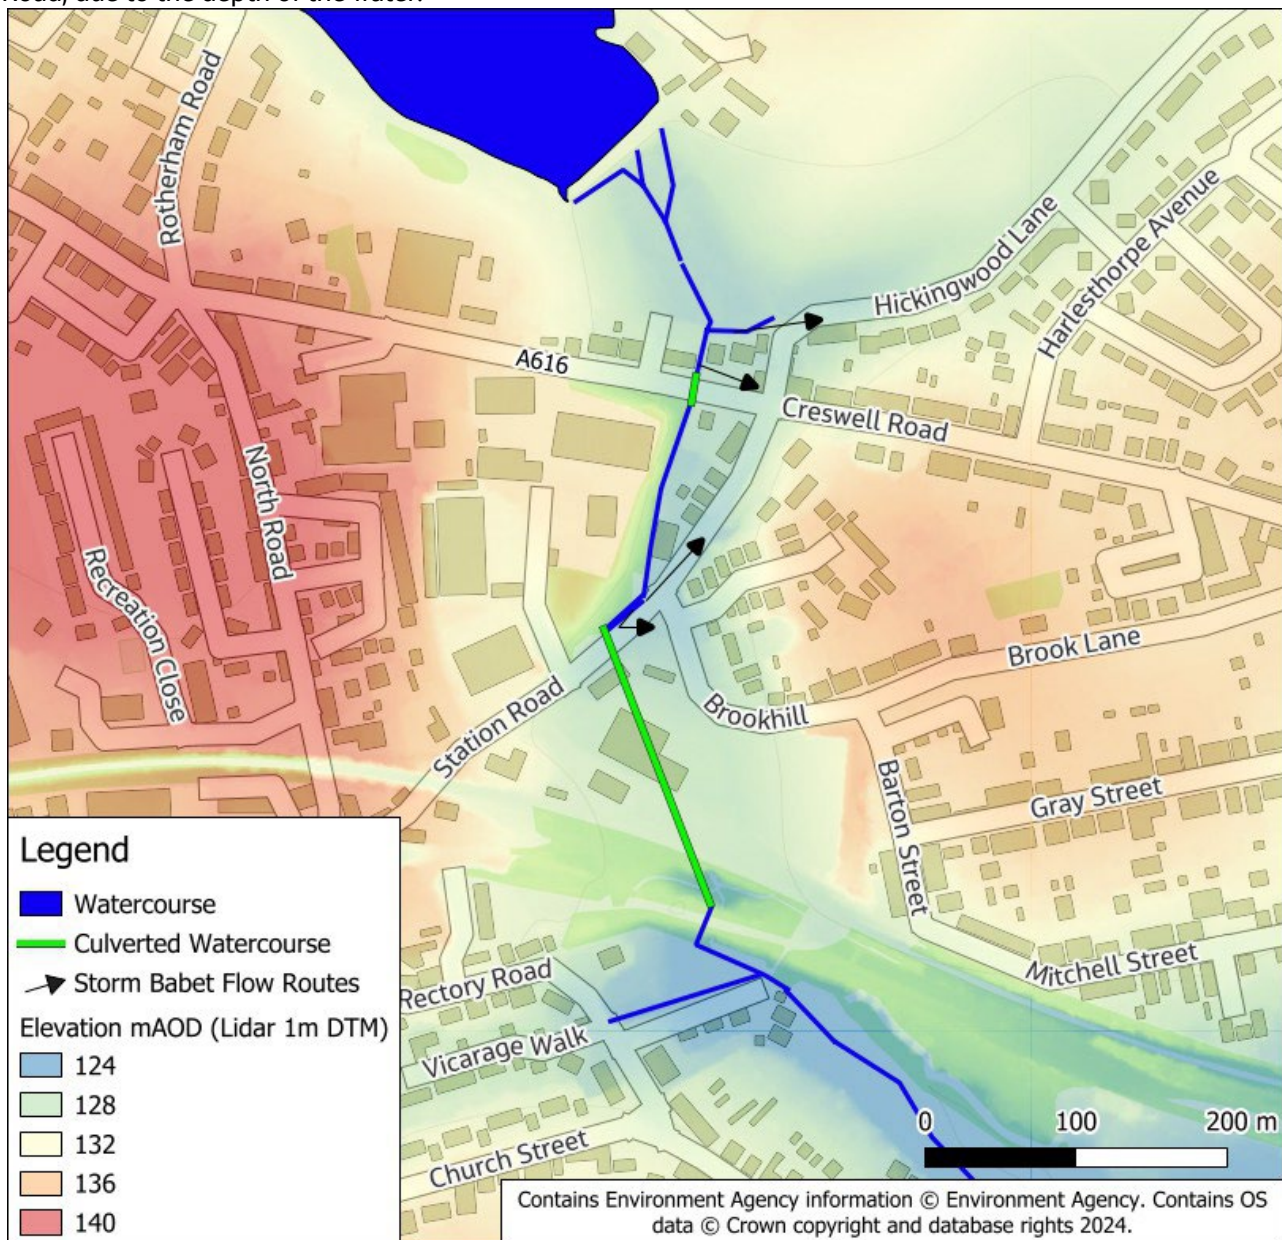
Figure 6-4: Ground level and Storm Babet flow routes at Clowne.

Figure 6-4 indicates the local topography and flow routes during Storm Babet. The primary source of flooding affecting all of the properties within this communities was from the ordinary watercourse. Flooding may have been exacerbated by the culvert under Station Road and the A616 (Creswell Road) being overwhelmed.

The flooding was exacerbated by surface water run off due to saturated ground north of Hickingwood Lane. The surface water then flowed towards the watercourse and increased levels. There are also a number of road gullies along the A616 (Creswell Road) and Station Road that discharge into the watercourse. Details received from the residents suggest that the flooding issues arose from the gullies being unable to discharge to the watercourse.

It has been reported that the flooding caused several garden walls to collapse at properties along Station Road, due to the depth of the water.
