## 7. Trent Lower and Erewash Catchment

### 7.1 Trent Lower and Erewash Event Hydrology

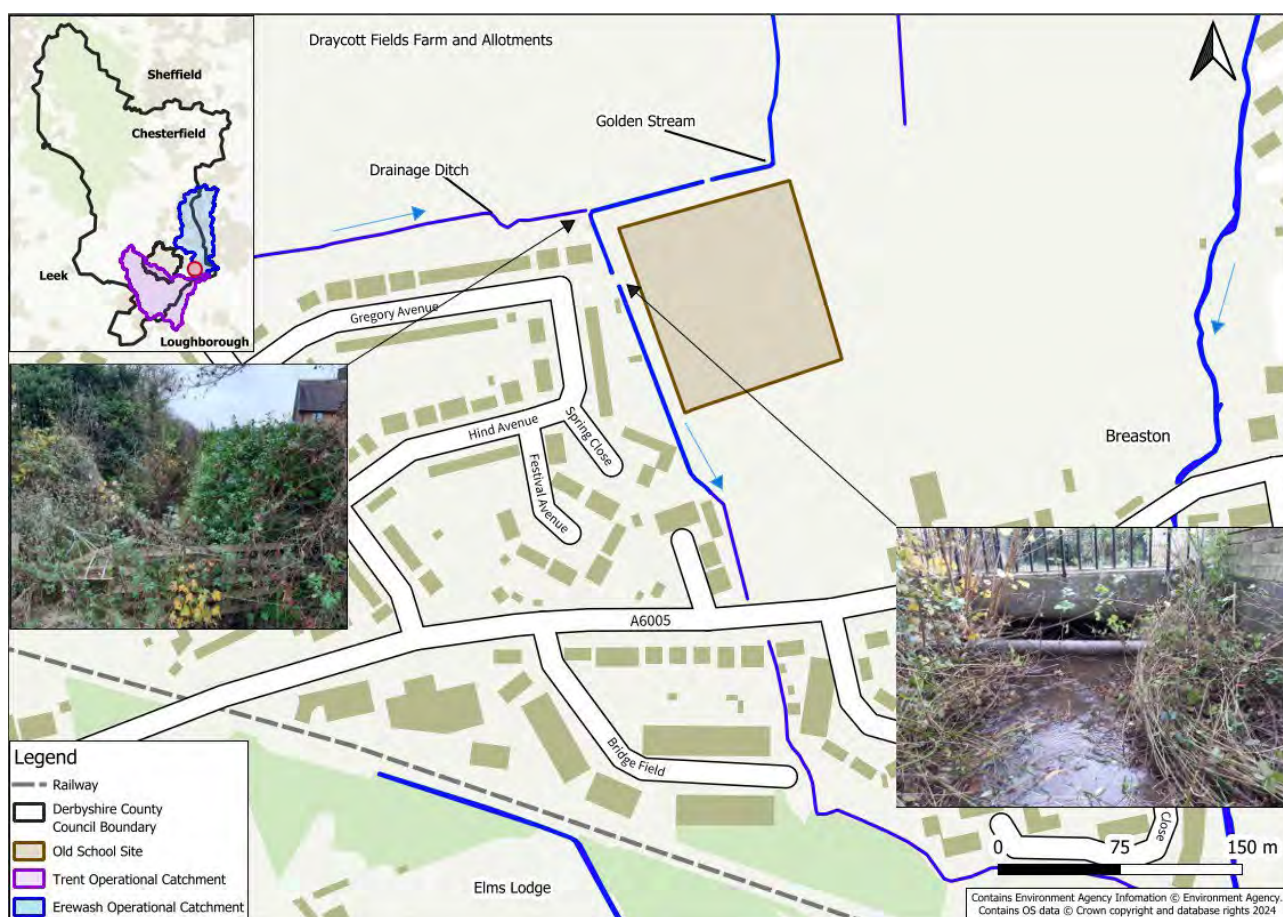
Residents have reported a lack of maintenance along the drainage ditch between Gregory Avenue and Johnson's Meadow, and along Golden Stream. It was reported that maintenance has not occurred for numerous years prior to Storm Babet. The riparian zone, stream banks and in-channel area in these stretches of watercourse became extensively overgrown with vegetation, see Figure 7-5. The stream collects runoff from fields to the north. During Storm Babet, the ability of the ditch to convey water is likely to have been restricted by this vegetation. Together with the high flows, this resulted in the overtopping of banks of the Golden Stream and the flooding of back gardens of neighbouring houses.

**Figure 7-5: Location of features which exacerbated flooding within the Breaston community.**

A box culvert on the Golden Stream located east of the east end of Gregory Avenue has been identified as receiving irregular maintenance. Maintenance along Golden Stream would include the removal of vegetation and debris to ensure the channel is clear for water flow. In addition to this, a pipe across the channel obstructs flow, see Figure 7-5. When combined with overgrown vegetation, the culvert became obstructed, causing the back-up of flow, resulting in the overtopping of banks. This water ended up in the road and flowed southwards. Videos provided from residents show this water flowing from Gregory Avenue, into Hind Avenue, and then into both Spring Close and Festival Avenue.

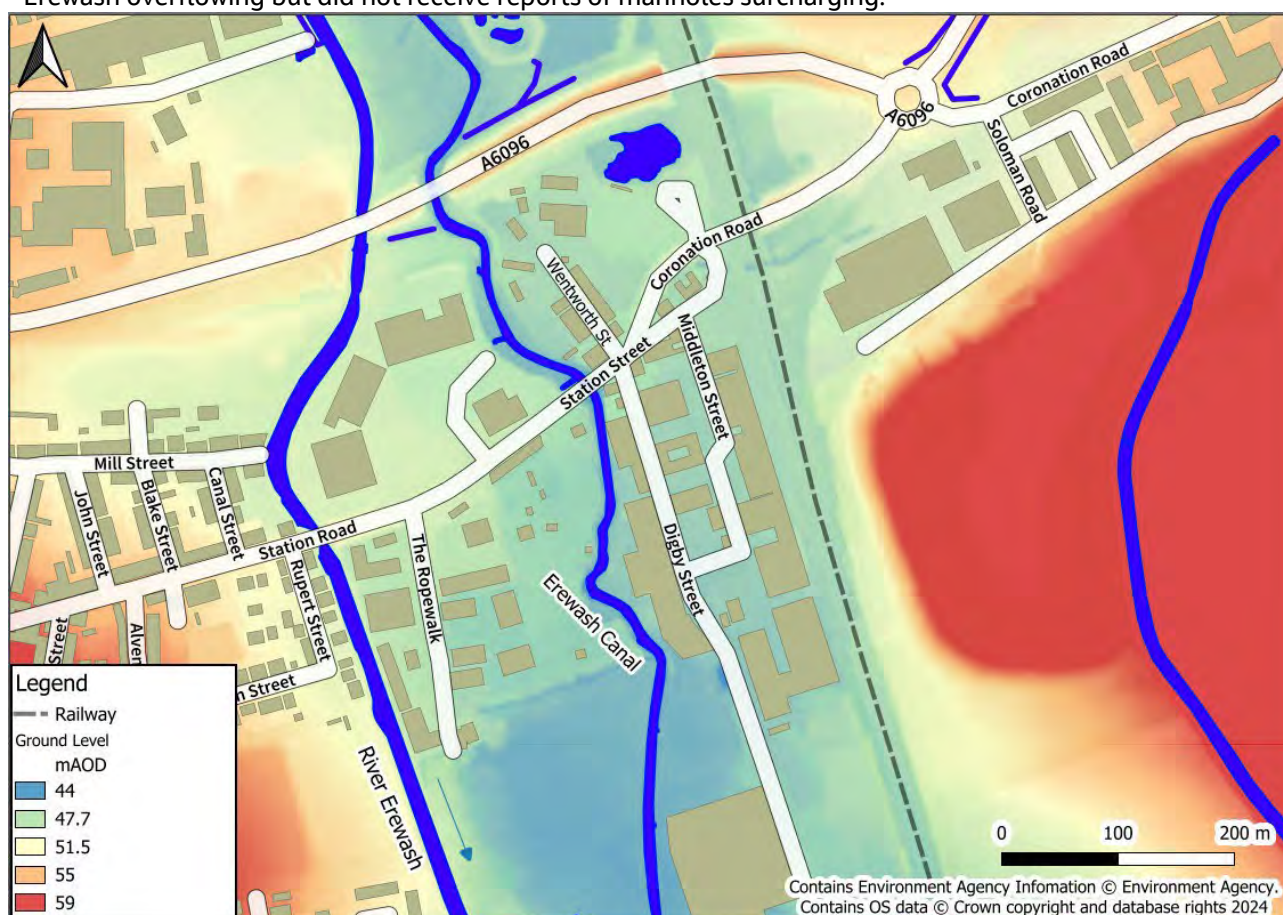
Station Street, Wentworth Street and Digby Street all experienced surface water flooding. Figure 7-9 shows that these streets are situated at a lower elevation than the rest of the community, with neighbouring fields sloping towards Digby Street. This flooding caused impacts to the road network and the internal flooding of businesses and homes. There were complaints issued that street gullies were not clear for flow. Residents believe that blocked drains were the cause for flooding along Digby Street, although this has not been substantiated as the cause of the flooding. The properties on Station Road, experienced flooding to their basements, and there were anecdotal reports of floodwater coming up through the floor of properties and rising up through drains. Severn Trent received reports of flooding along Station Road due to the River Erewash overflowing but did not receive reports of manholes surcharging.

Figure 7-9: Topography at Ilkeston.

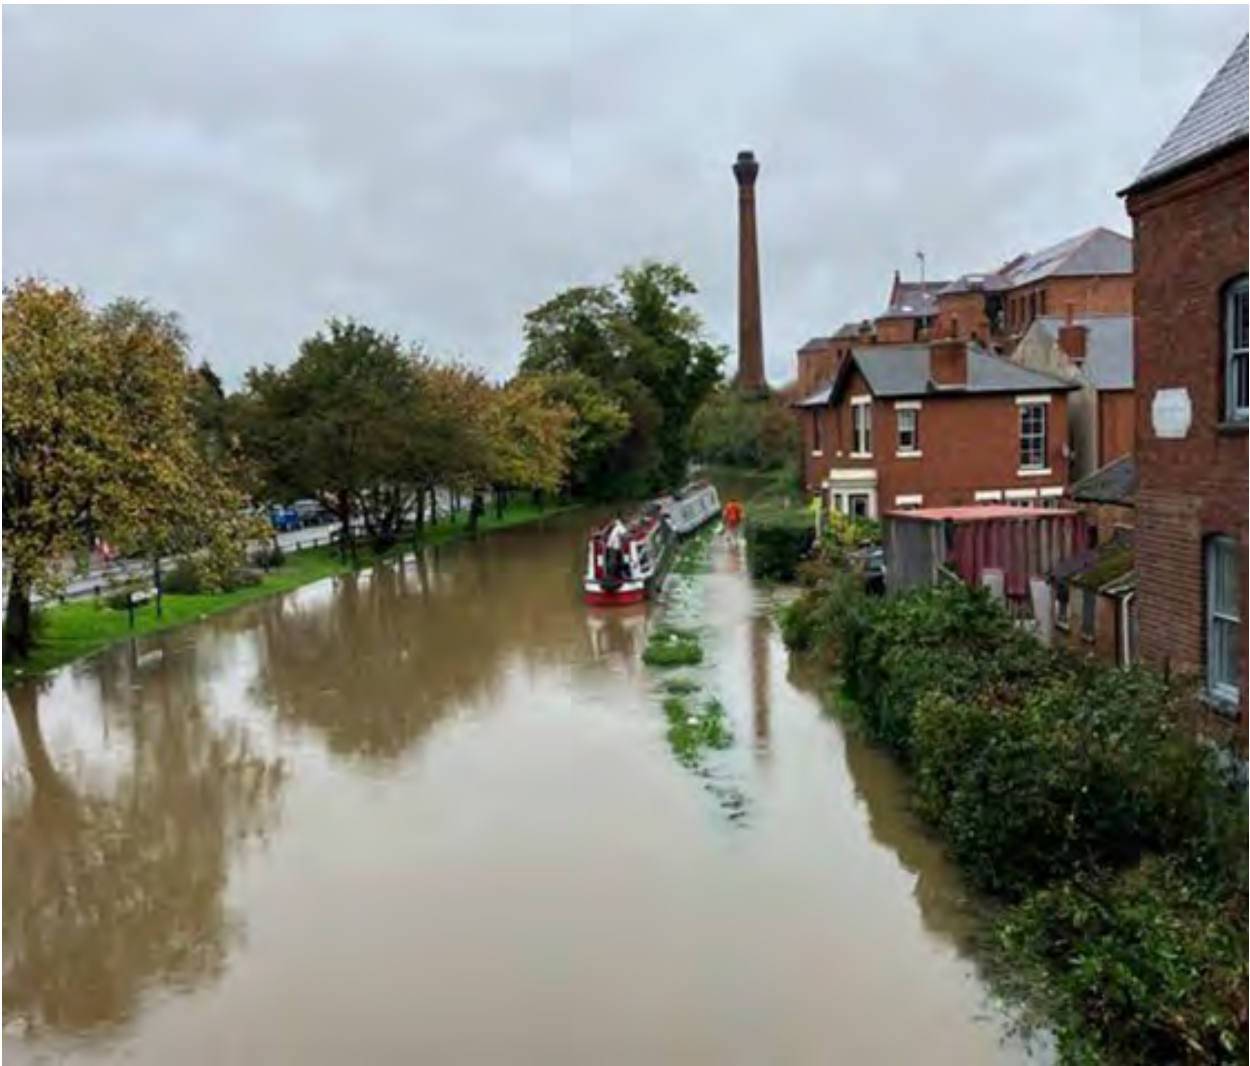
The River Erewash overtopped its banks and flowed into the Erewash Canal north of Gas Street, opposite Brookfield Mews. The defences north of Gas Street tie into the railway embankment. The Environment Agency acknowledge they do not know the porosity of this embankment and that this needs further investigation. It is also likely that a connection between the Erewash Canal and the River Erewash opened a flow path via the canal which led to flooding of properties. There were also other river-canal interactions upstream during this event at Langley Mill and other rural areas, making it possible that the canal was already elevated before the River Erewash overtopped at this location. These factors caused water levels in the canal to rise, creating a secondary flow path for the flood water, which flowed south across the community. The onset of flooding was reported to be very quick. The volume of water caused significant property damage, with several properties' floors being lifted by the force of water. Figure 7-13 below shows flooding from the canal, which was caused by the River Erewash overflowing into the canal. The photograph was taken from Station Road looking north along the canal.

**Figure 7-13: Flooding of the Erewash Canal: The River Erewash overtopped, and fluvial flood water entered the Erewash Canal which acted as a conduit for the flood flow.**

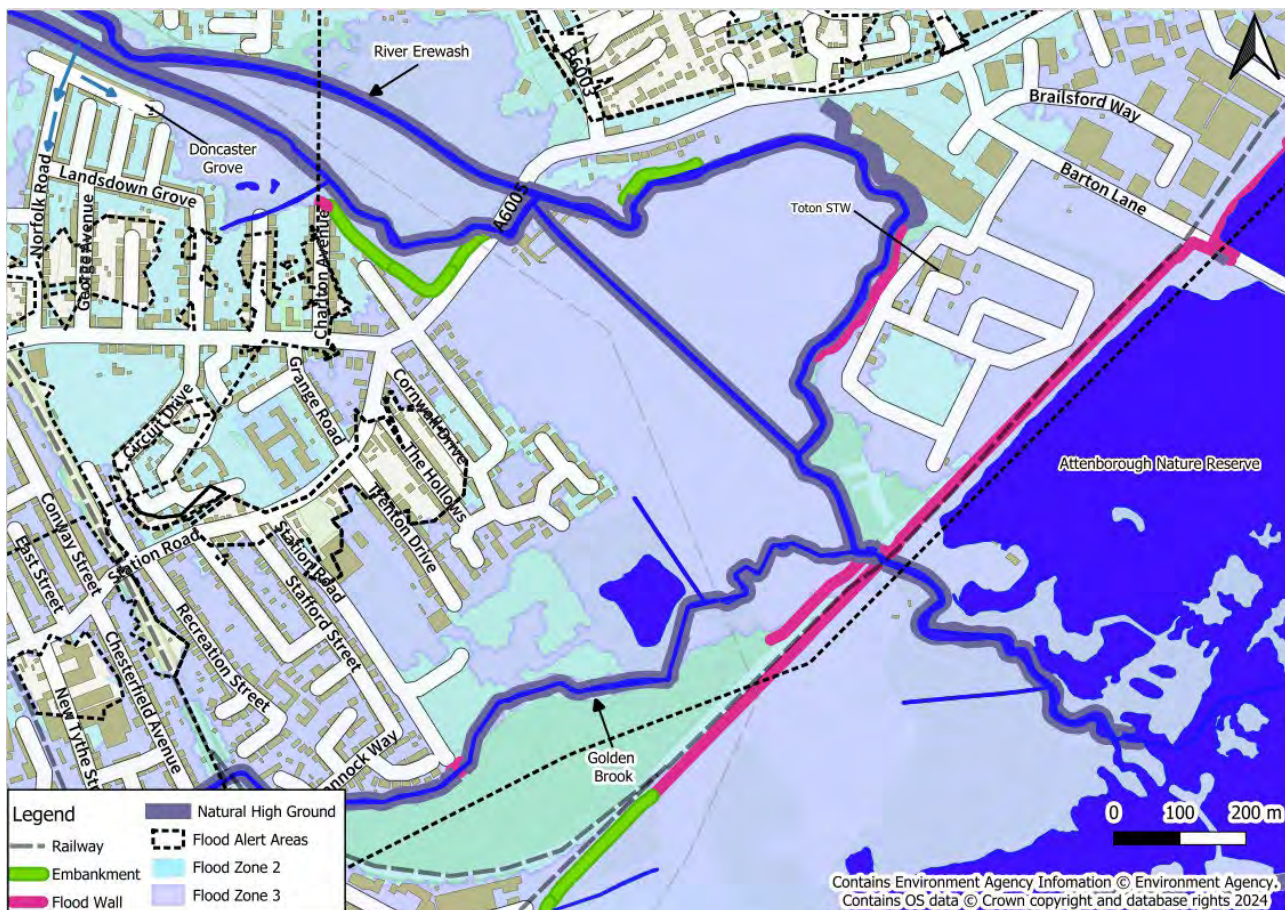
Figure 7-17 shows the flow routes from the River Erewash overflowing and initially joining Doncaster Road.

Figure 7-17: Flood Zones, assets and flow routes from the River Erewash entering the community via Doncaster Grove

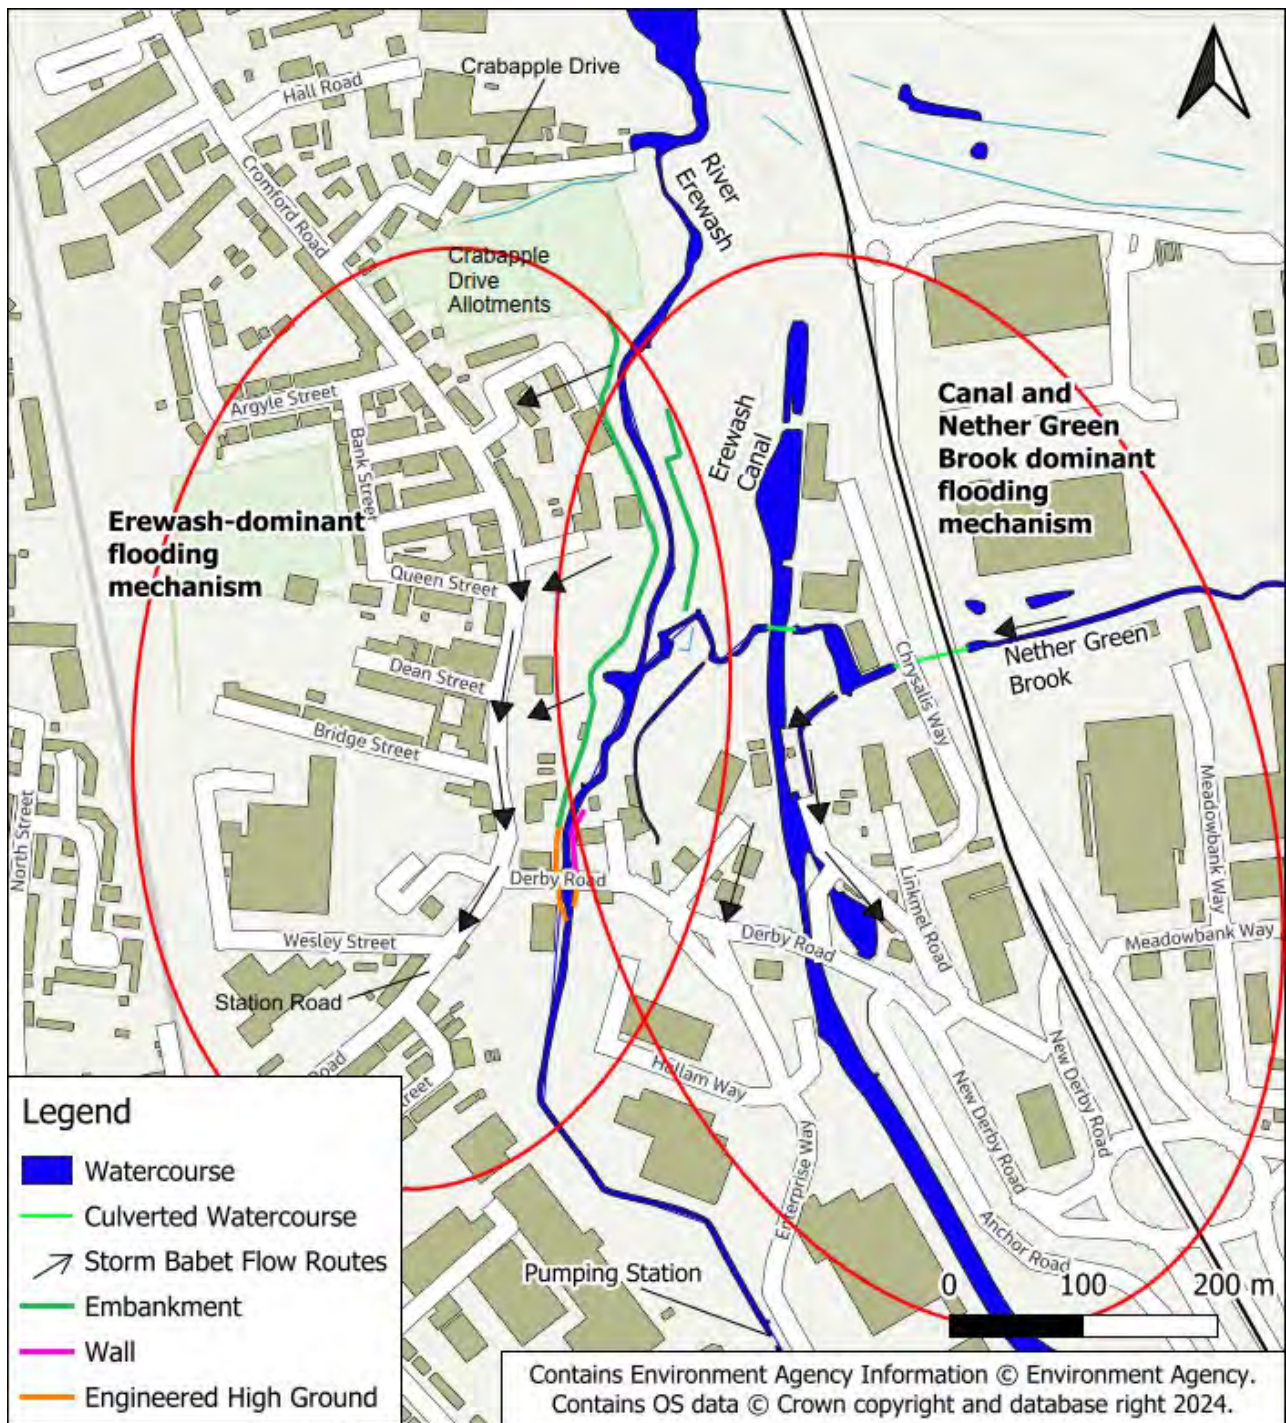
Overflowing of the Erewash Canal was entirely due to the River Erewash and Nether Green Brook over flowing into the canal; if this interaction had not occurred the canal would not have overtopped.

Figure 7-21: Flood mechanisms and flow directions at Langley Mill.

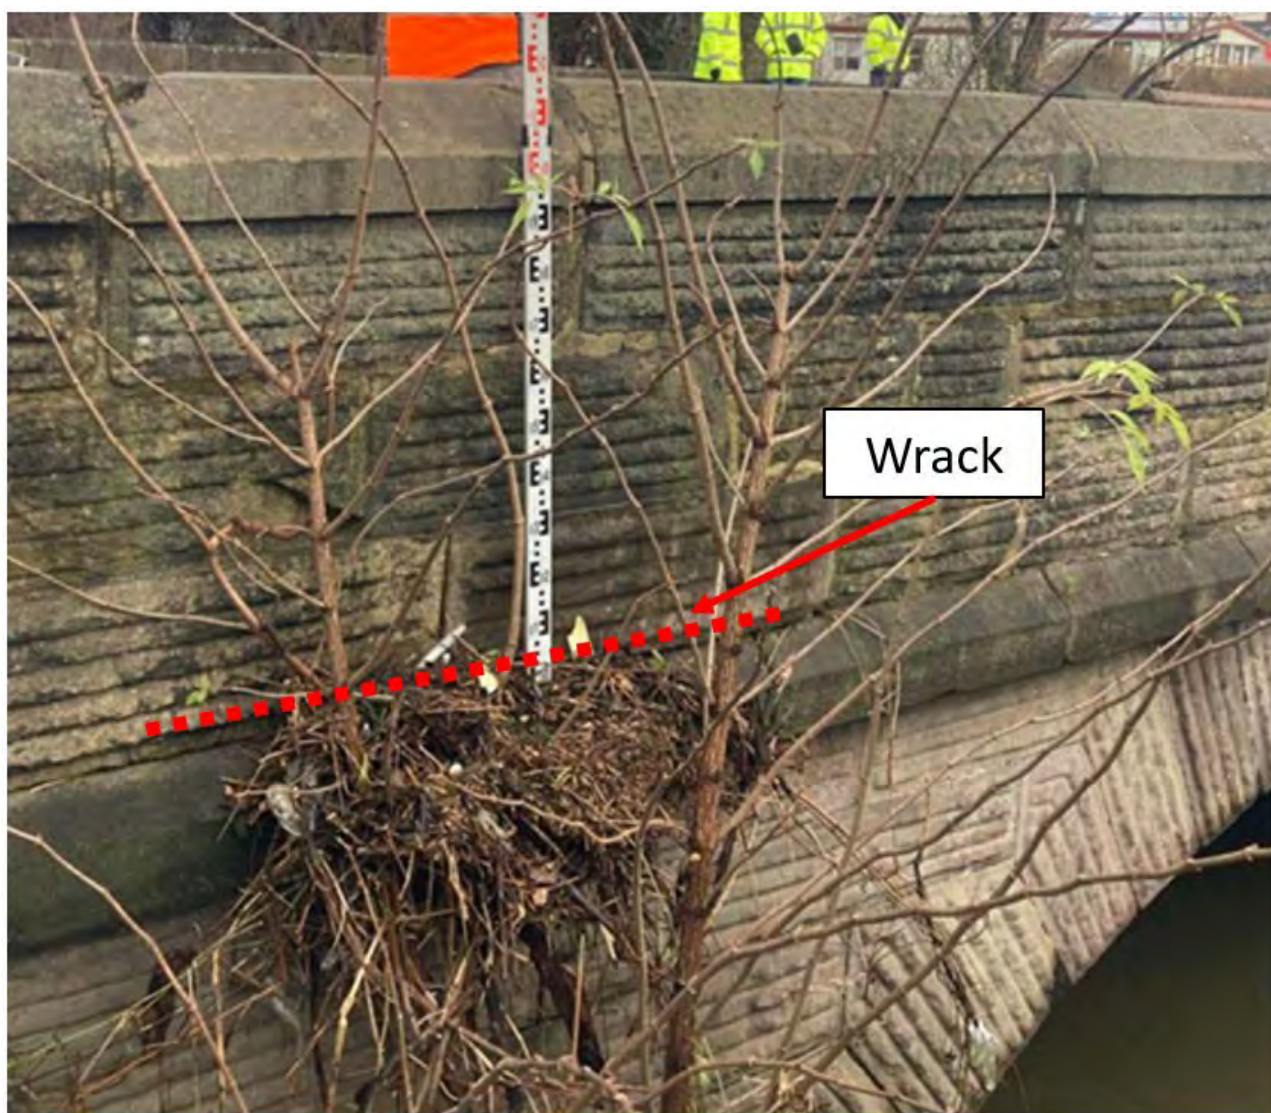
Another location where the River Erewash overtopped was at the Derby Road bridge. Water levels were high enough for the Erewash to overtop the bridge and cause flooding to Derby Road.

Figure 7-22 is presented below showing a wrack level on the upstream face of the Derby Road bridge crossing the River Erewash.

**Figure 7-22: Wrack mark on the upstream face of Derby Road bridge. Source from the Environment Agency.**

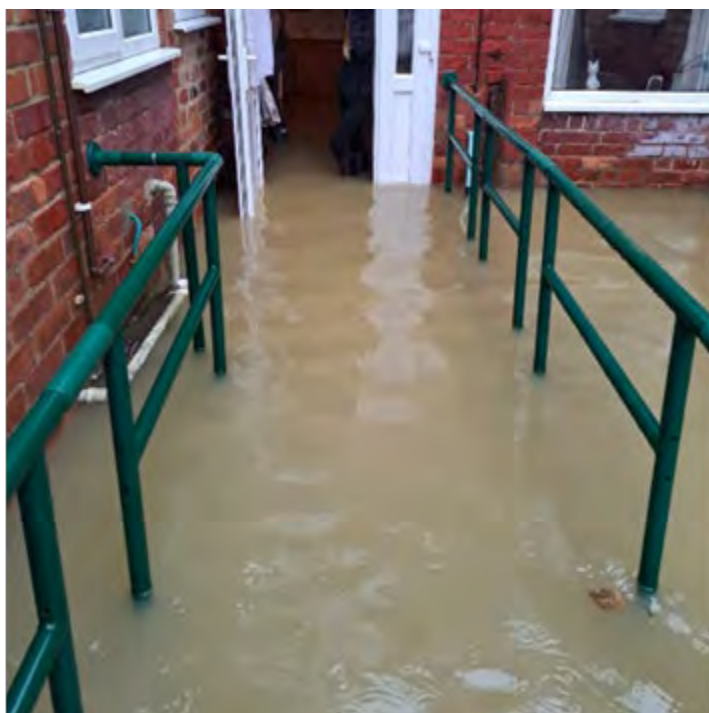
A resident of York Terrace provided Derbyshire County Council with photographic evidence of the impact of flooding which can be seen in Figure 7-29 below. The resident also noted that flooding started to reach the outside of the property at 6:30am to 6:45 am and by 11:00am the property suffered internal flooding.

**Figure 7-29: Flooding to a property in York Terrace.**

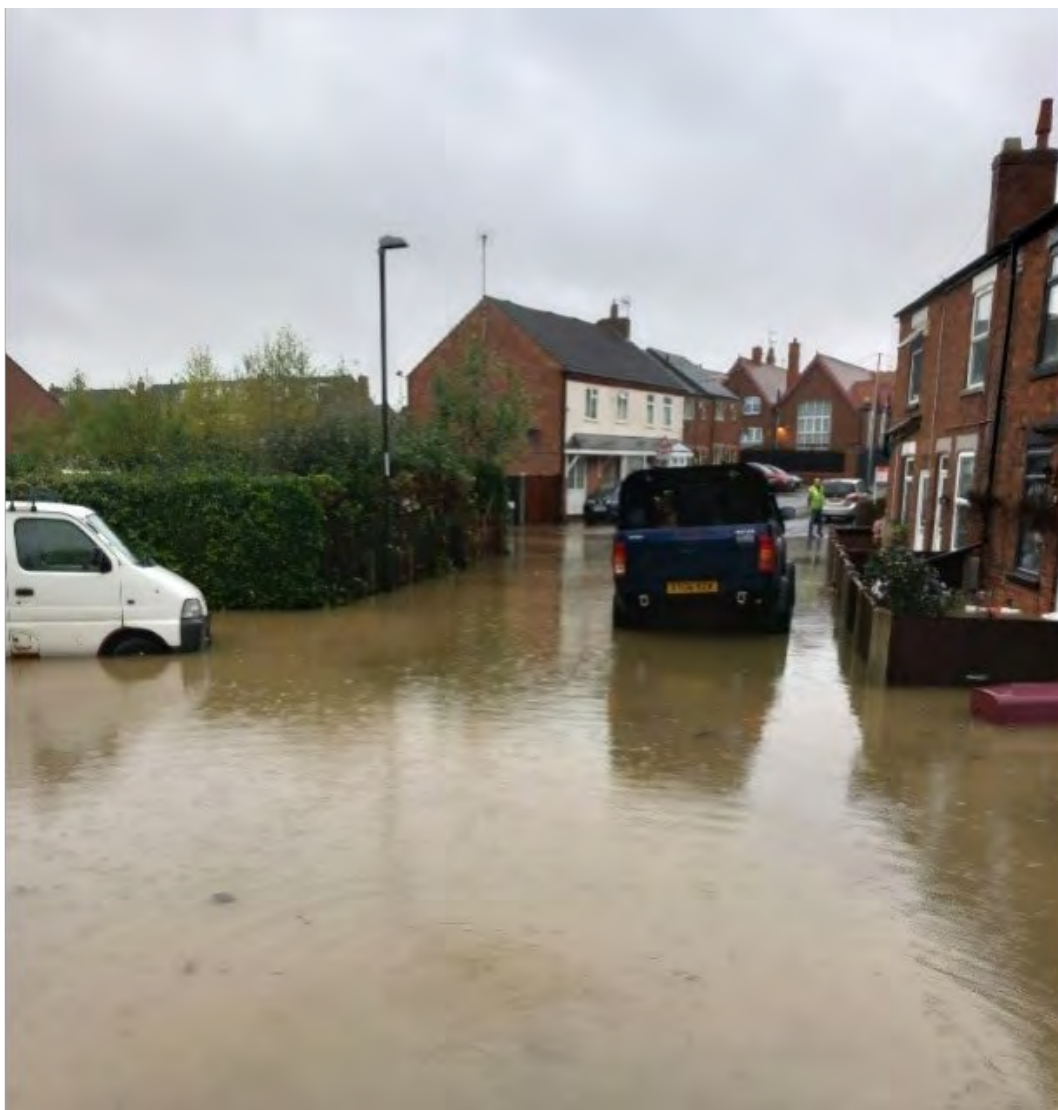
Surface water was reported as contributing to the flooding of the community. York Terrace and Alexandra Terrace, north of the railway line. The community sits at a low point, lower than the land to the north of the community. This means any surface water runoff flowing southward down Alexandra Terrace will pool in this location. Figure 7-30 below shows the low point on Alexandra Terrace.

Figure 7-30: Low area in local topography where water will naturally gather.

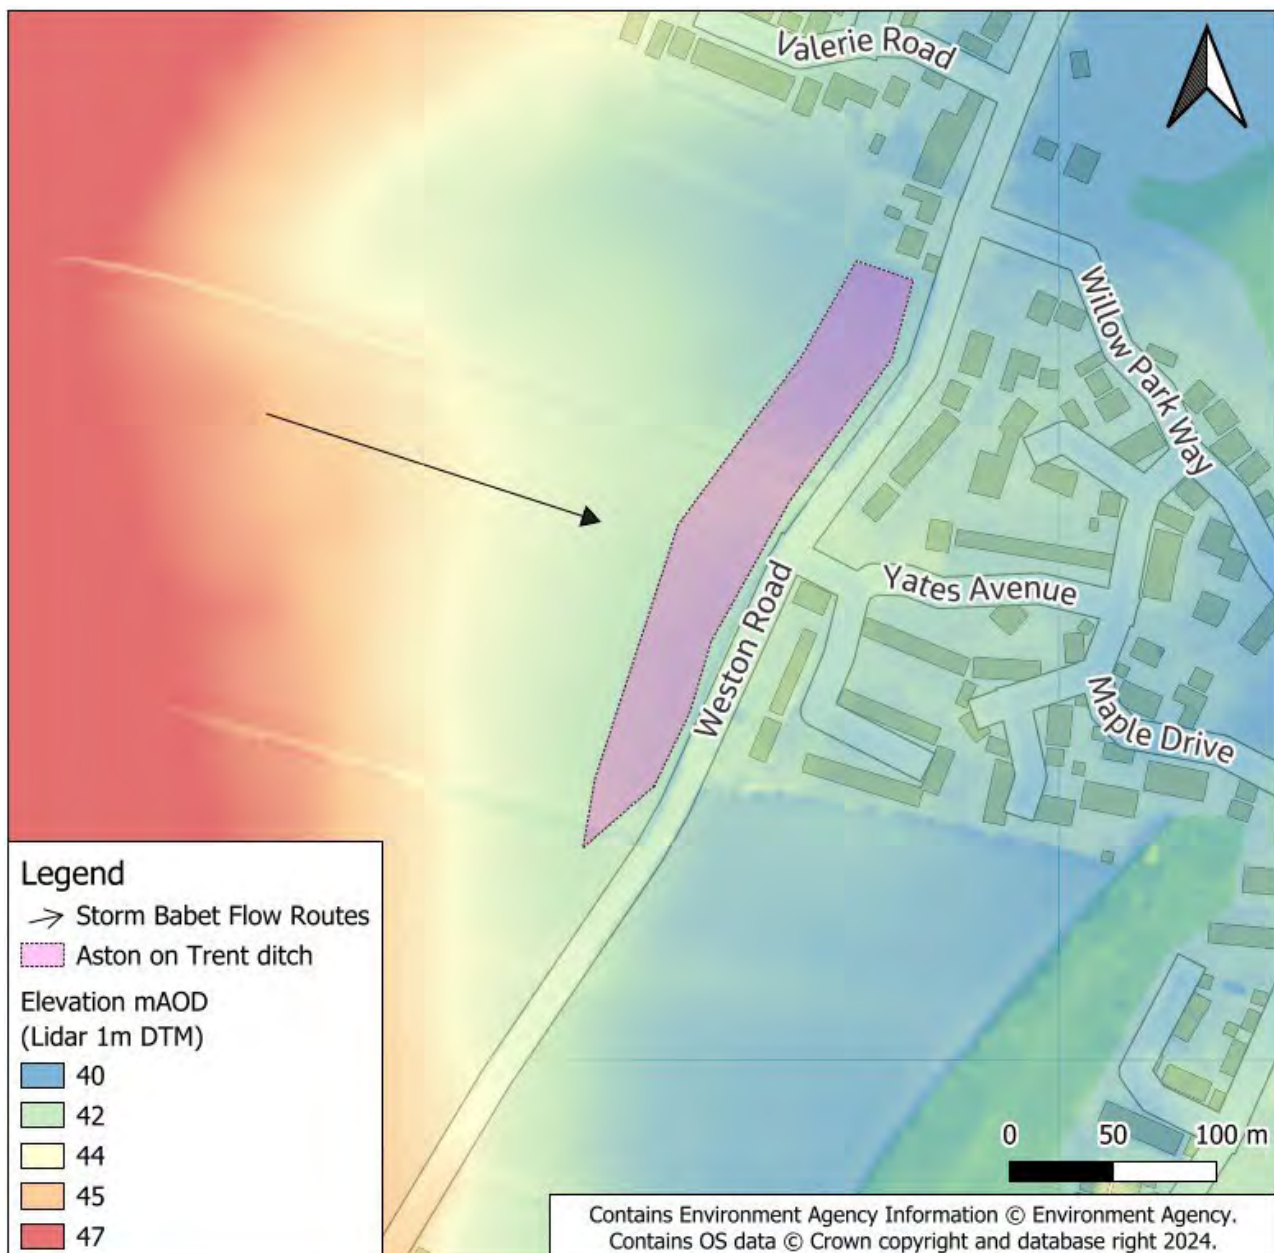
Local accounts suggested that there was a significant volume of run-off from farmland to the west of Weston Road during Storm Babet. Water initially collected in a large ditch to the east of the field at the boundary of Weston Road. The ditch was eventually overwhelmed spilling on to Weston Road, reaching the residential properties on Yates Avenue. The flow direction and ditch are illustrated in Figure 7-33.

Figure 7-33: Topography of Aston-on-Trent, with arrows indicating the flow routes of surface flood water.

Following the flooding in this area, recommendations have been made for a deeper excavation of the ditch,
