Property Flood Resilience

Stories from homes and businesses who have made adaptations to help them recover more quickly after a flood

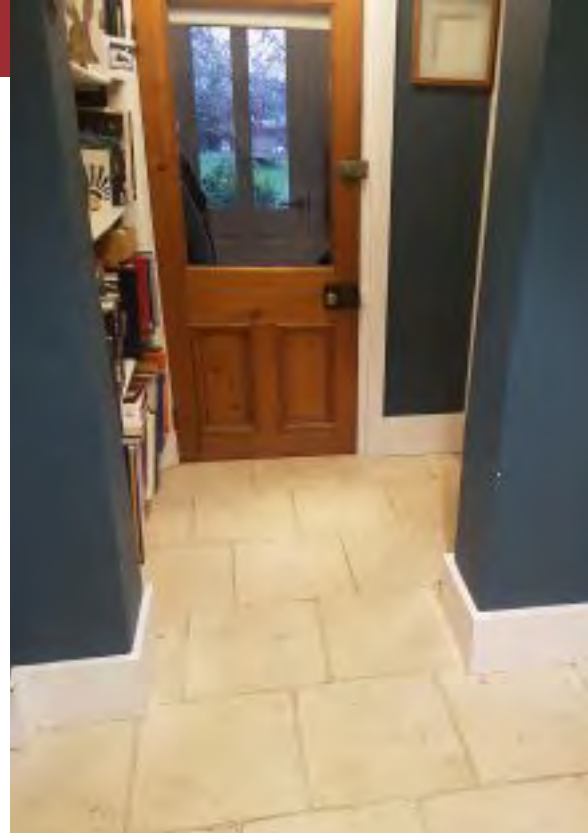
All the items shown here have survived one or more floods.

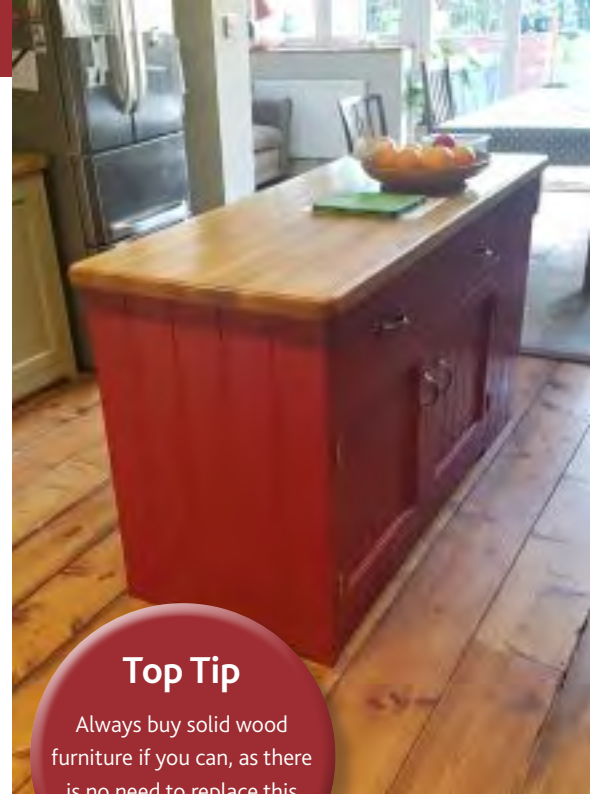
Solid wood kitchen, easily washed down, and all parts are free-standing so moveable.

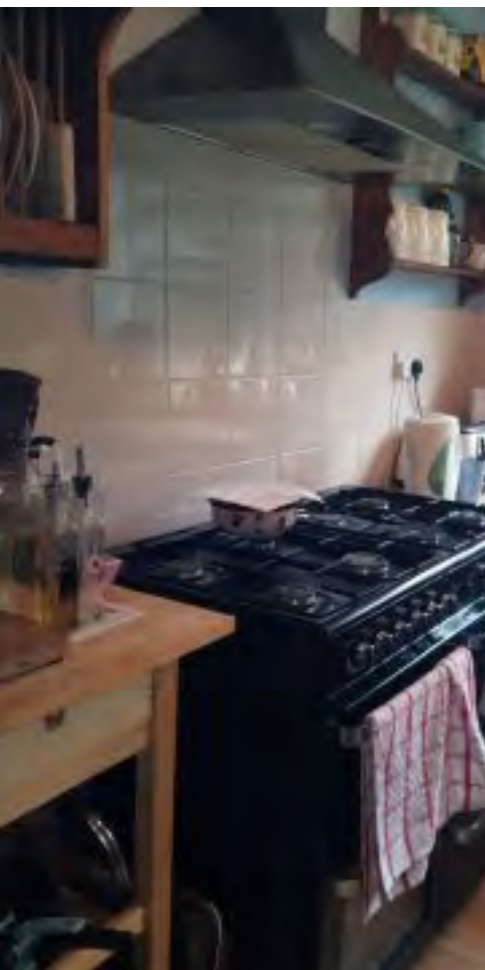
Solid wood kitchen units are freestanding so can easily be removed.

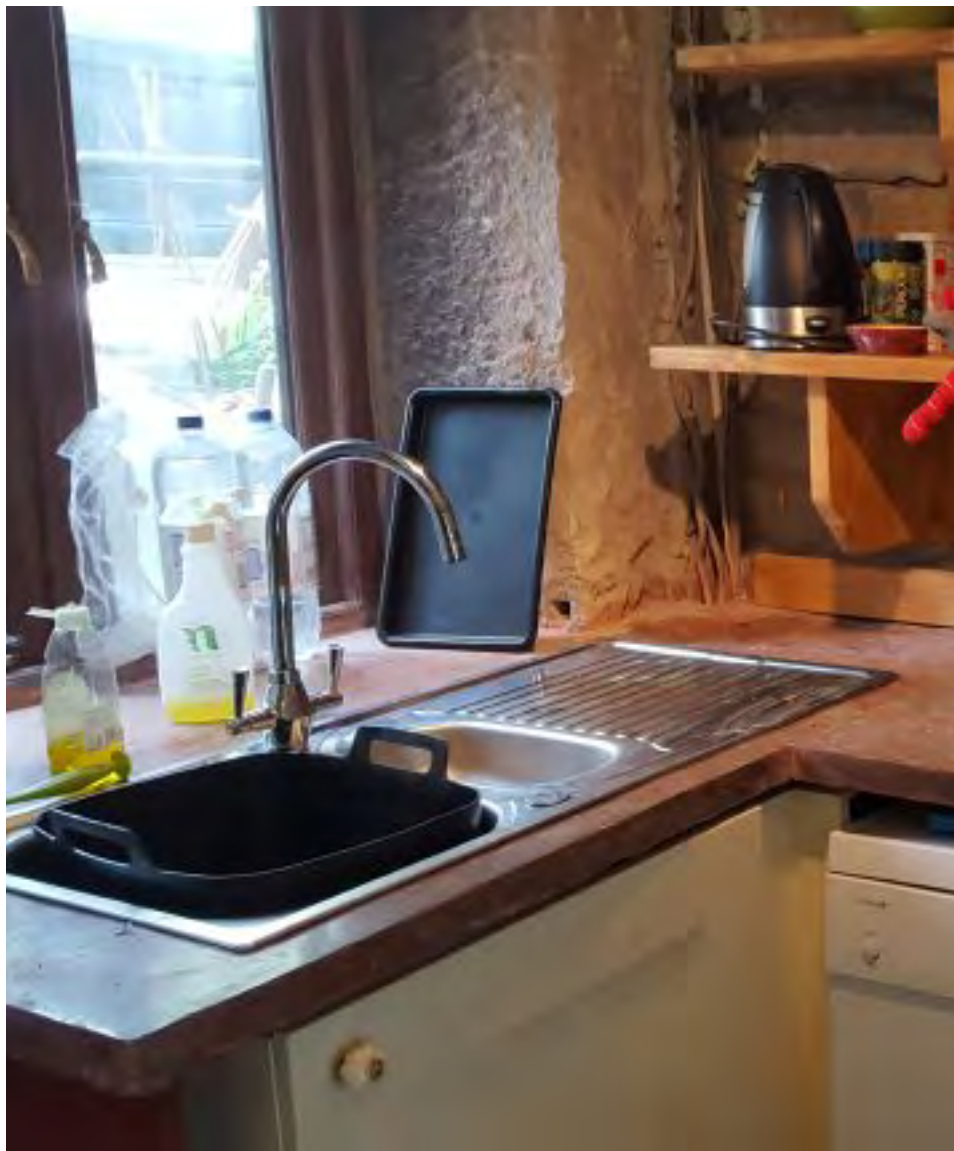
The kitchen worktop is polished concrete and was saved in the flood

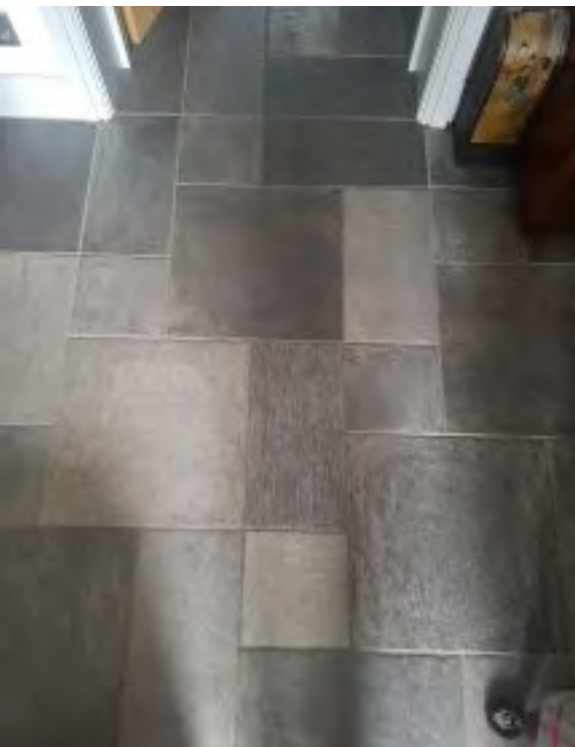
Tiling in the ground floor above insulation and underfloor heating.

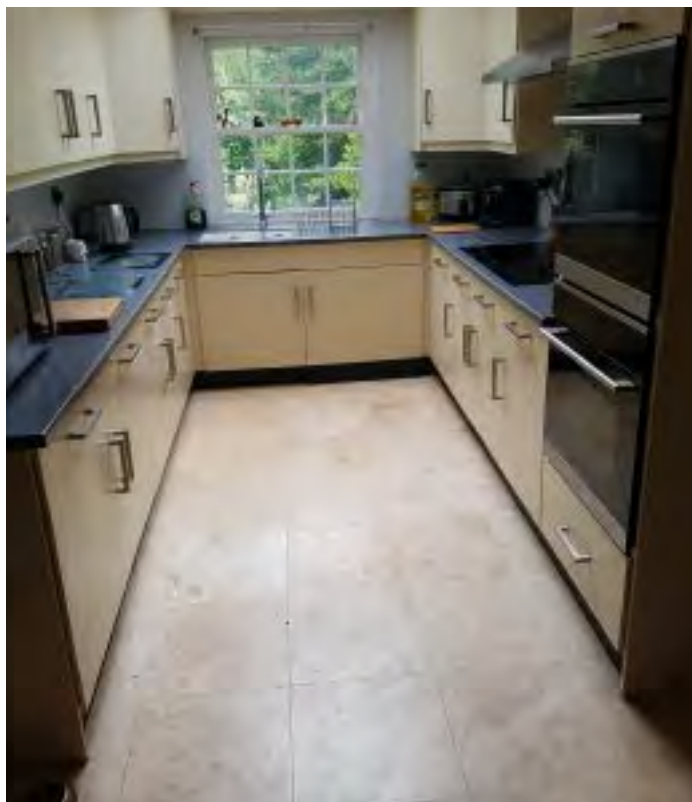
A Corian plastic kitchen was fitted.

He decided that because the kitchen was the most expensive item to replace, he would have a Corian plastic kitchen fitted. It appears that the company is no longer in existence, but a quick web search showed that Corian and laminated Aquoline kitchens are still available. He has stone tiled floors that survived the floods and now also has waterproof plaster on the walls.

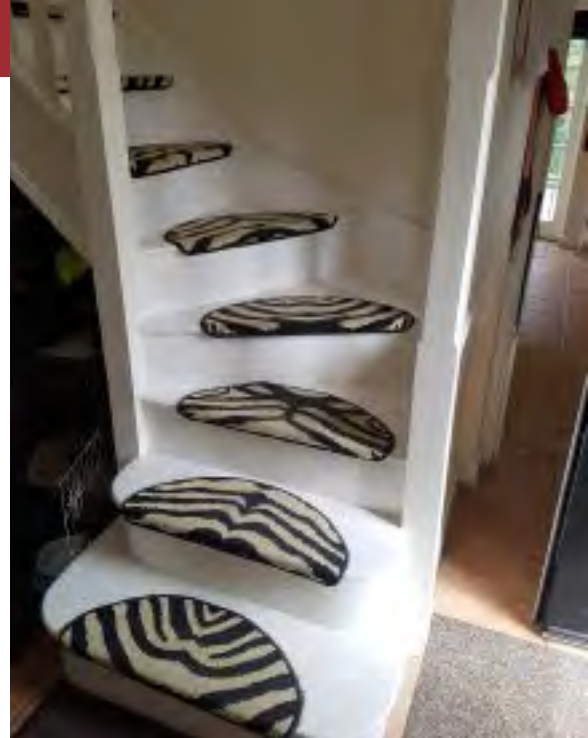
The staircase has only minimal carpet, which can easily be replaced.

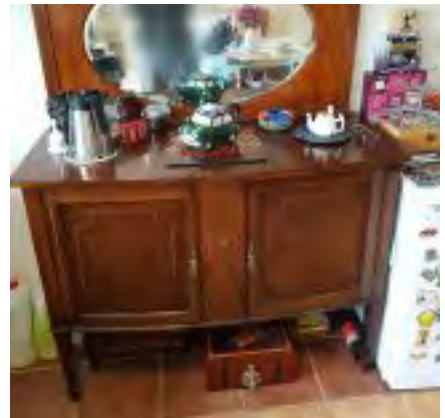
A hard wood dresser had survived the deep floods.

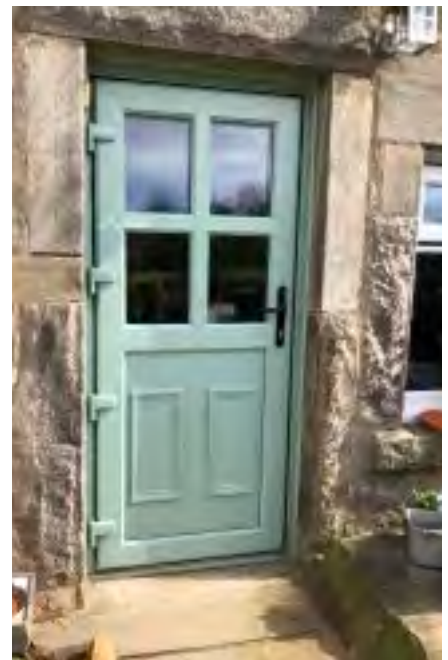
Flood door fitted.

- Kitchen moved upstairs.
- Replaced original window with a flood proof window.
- Fitted a flood door.
- Moved boiler up the wall.
- Isolate the electrics, so upstairs can continue to function during a flood.

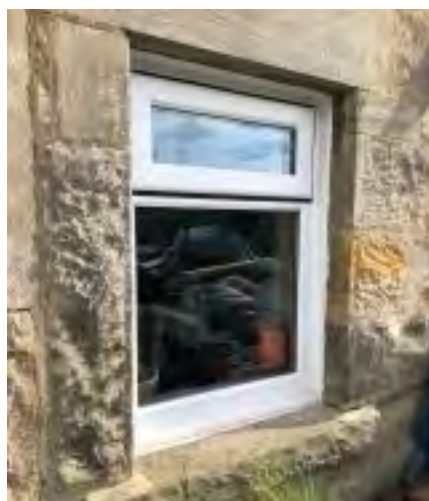
Original window replaced with a flood proof window.

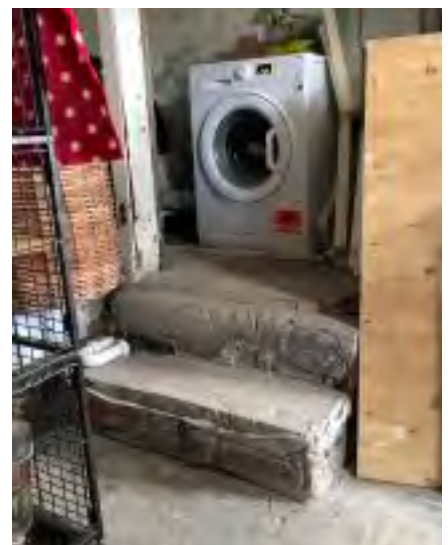
White goods in the basement room are now raised up.

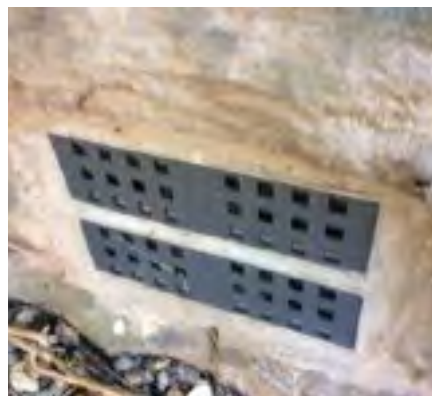
Self-closing airbricks.

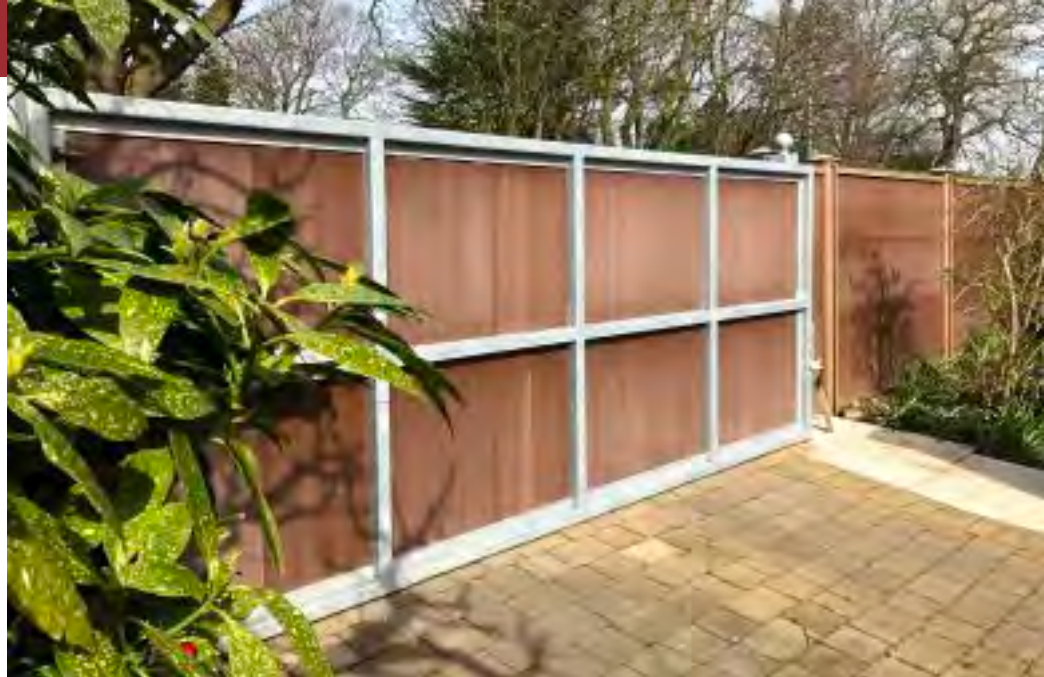
The front entrance gate is the same material as the fence panels and is fitted tightly to prevent ingress of water.

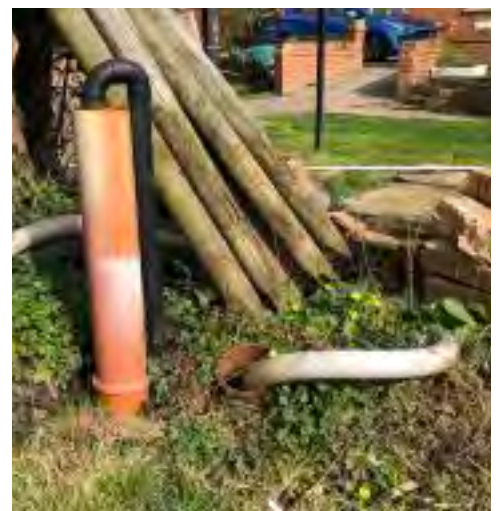
Rainwater runs through a series of French drains into a large sump into which a strong pump is fitted which pumps the water outside the garden boundaries.

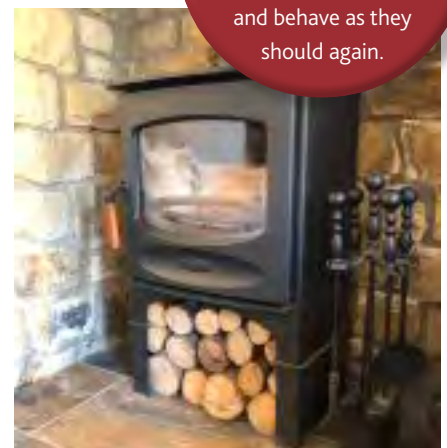
White goods in the utility room are now on a plinth and even the wood burning stove in the lounge is raised up.

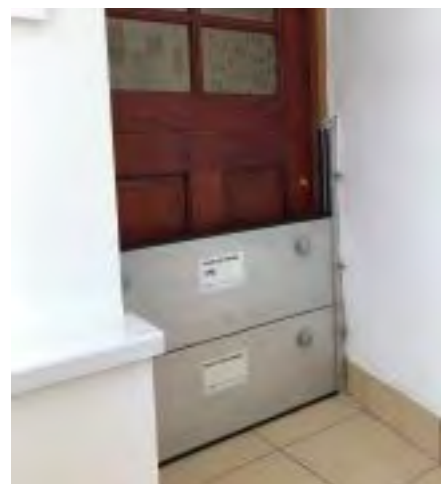
Flood barriers to all external doors and tiled floors.

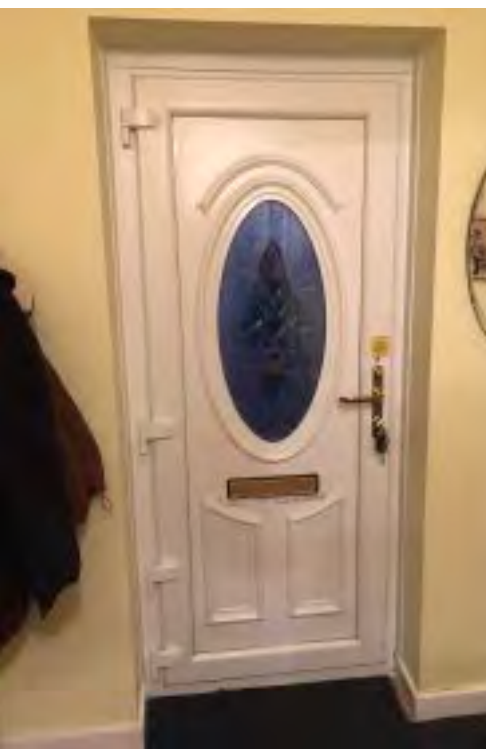
Flood resilient front door has been installed.

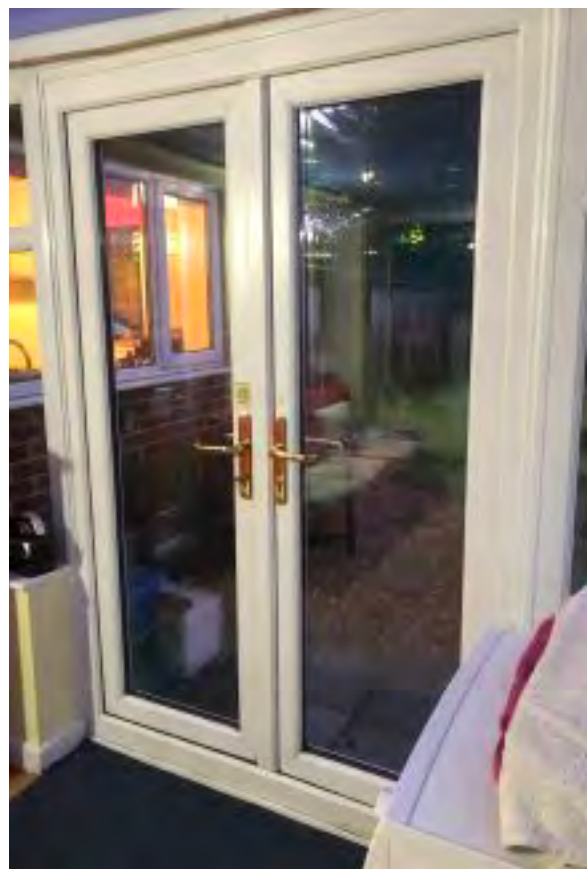
Flood resilient patio doors have been installed.

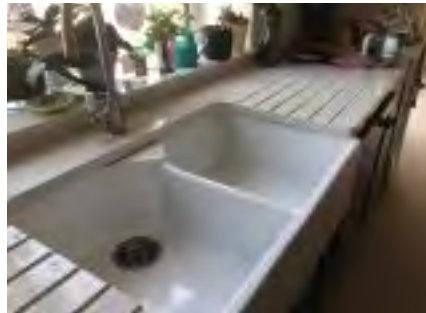
The Belfast sink is easily cleaned.

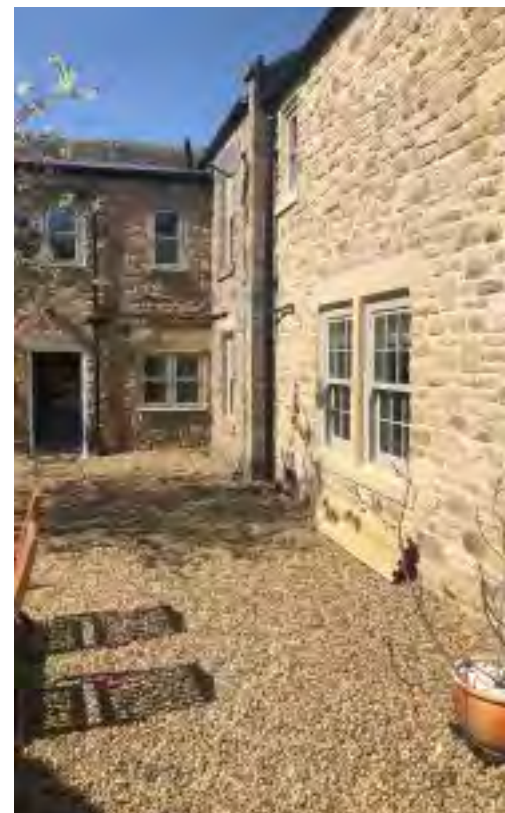
Permeable patio areas surround most of the house.

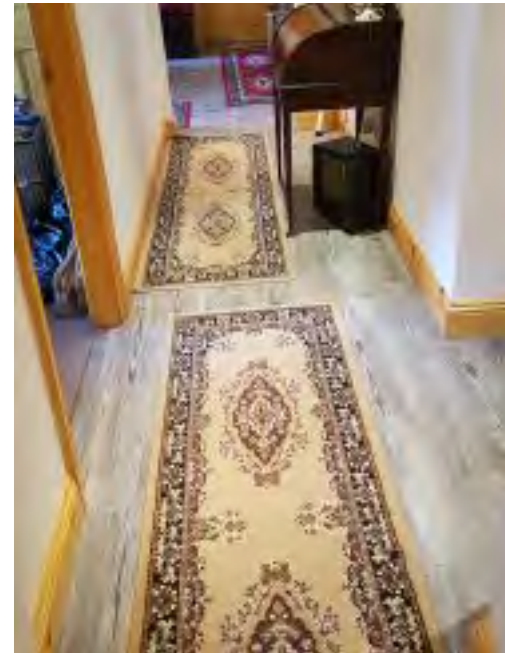
Ceramic tiled hall with rugs.

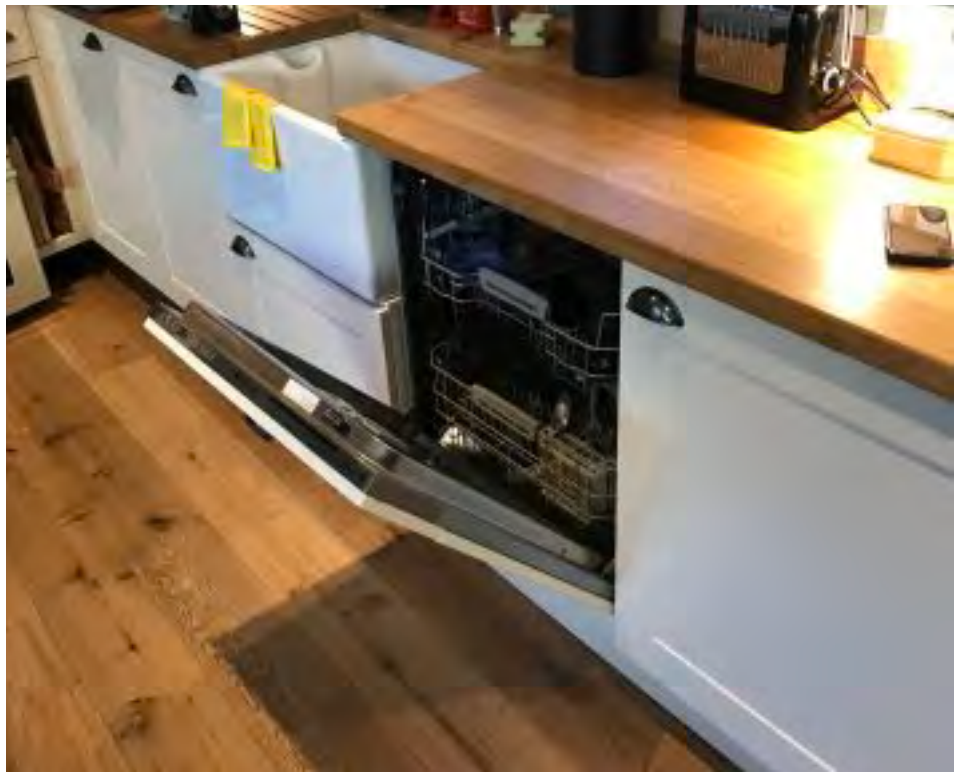
Existing kitchen and floor finishes were removed, and then re-installed following completion of the work.

It was obvious that this problem would reoccur (likely with increasing frequency due to climate change), so a specialist survey was undertaken with an ensuing recommendation that a cavity drain waterproofing system be installed, along with a small packaged pumping station. The work was carried out by a specialist membrane provider and is a typical structural waterproofing solution, where external ground levels are high and there is a likelihood of the presence of water.*

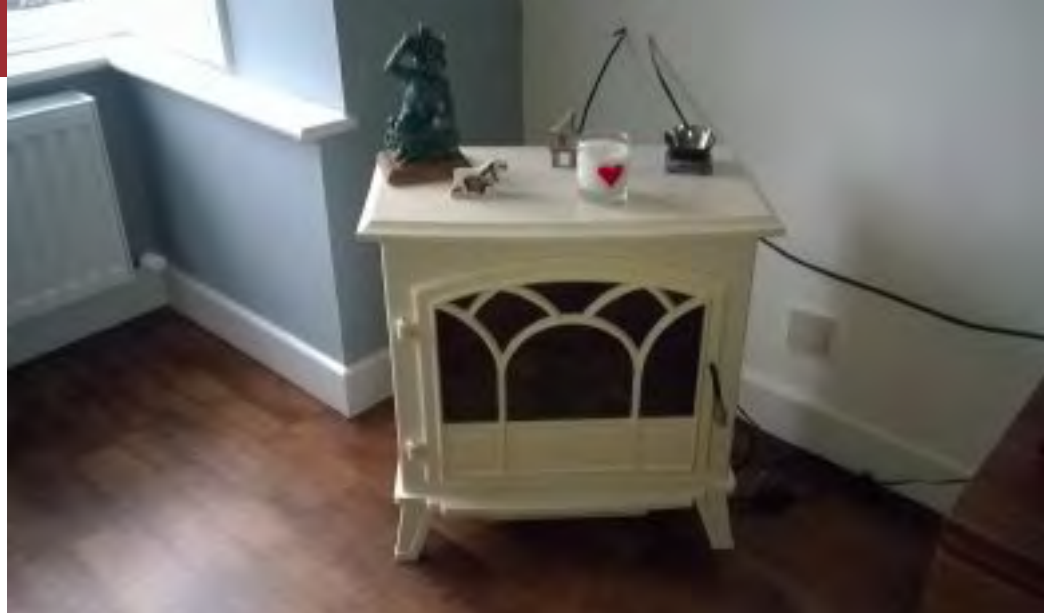
Fires attached to the wall were replaced in all rooms with mobile fires that can be lifted at short notice.

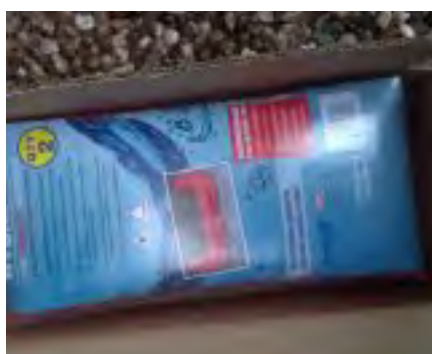
Absorbent packs swell up and block water.

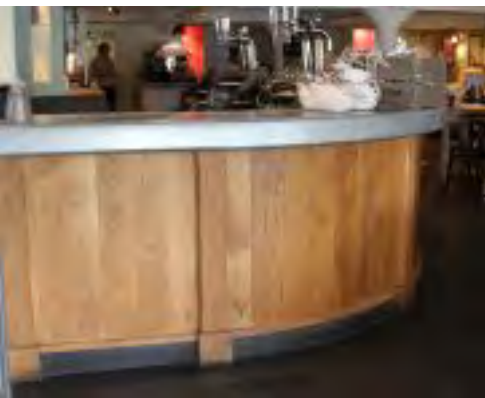
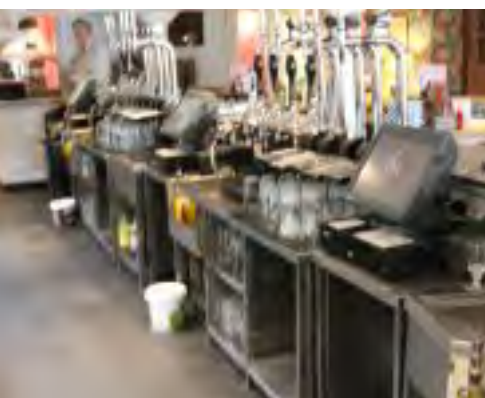
The bar is solid oak with stainless steel fittings and easily removable equipment.

- The floors all have a resin damp proof membrane beneath them, to prevent the water rising from underneath.
- The bar is solid oak and survived the 2015 flood. It has stainless steel fittings and easily removable equipment.

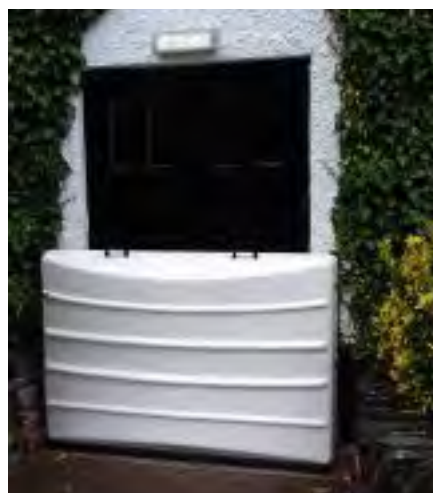
Door guards are fitted to external doors as a 'belt & braces' option.

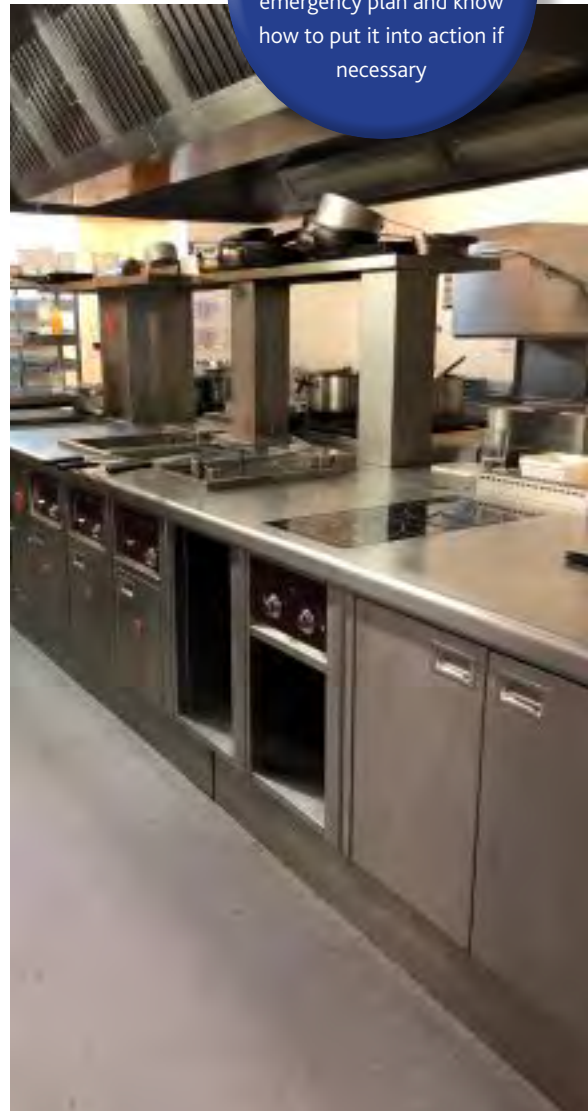
The motor can be removed from the stainless-steel kitchen 'Chave block' (cooking area).

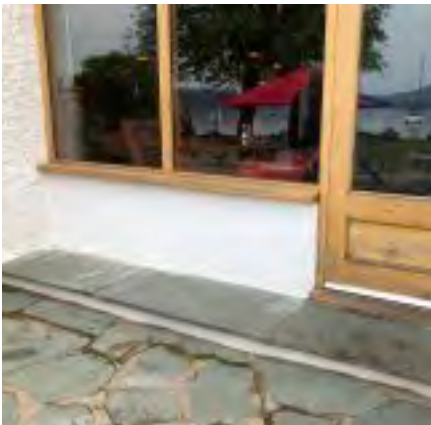
Windows have been raised a couple of feet.

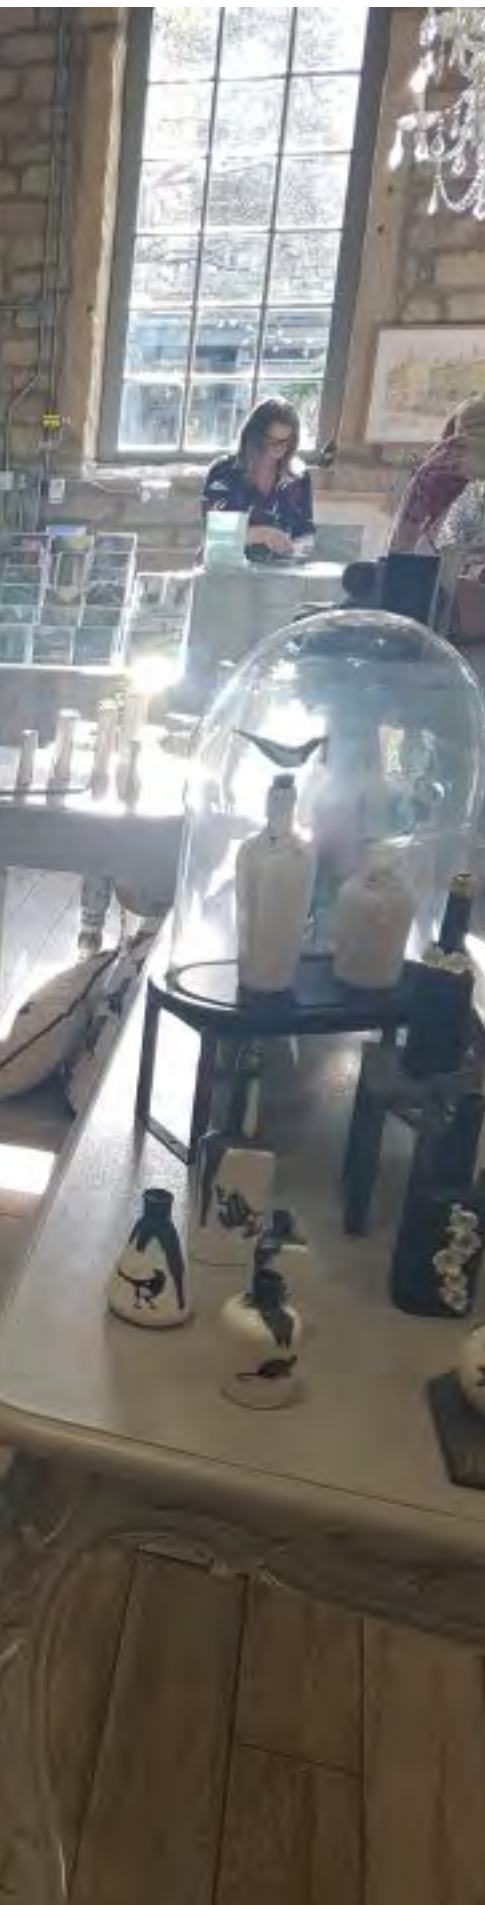
Floor surface is finished with porcelain tiles patterned to mimic floorboards.

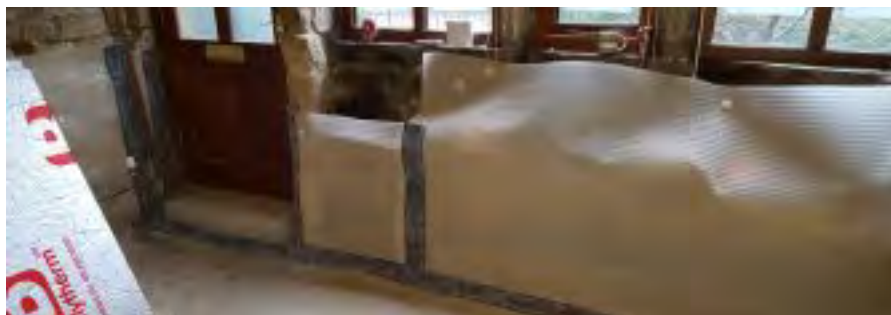
Waterproof membrane during installation.

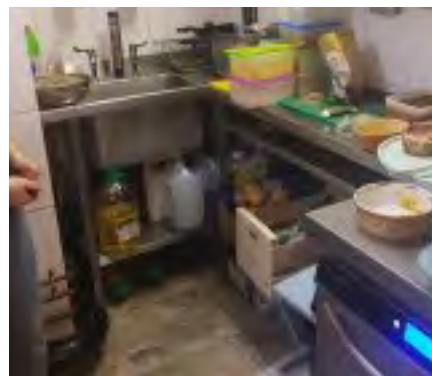
Kitchen is stainless steel and can be hosed down.

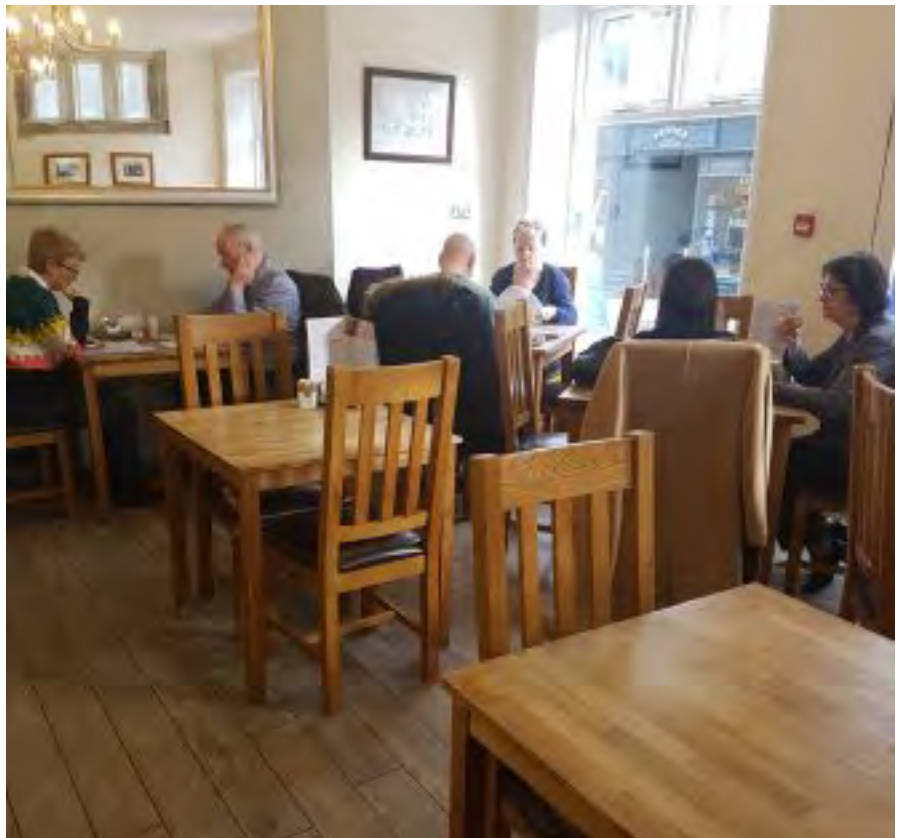
Ground floor was concreted and tiled with wood effect ceramic tiles.

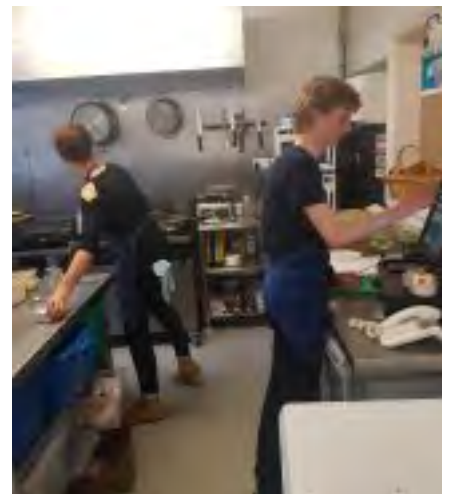
All kitchen equipment is stainless steel.
