6. ECOLOGICAL SIGNIFICANCE

7 ISSUES + PROBLEMS: POLICIES + OPPORTUNITIES

**7 ISSUES + PROBLEMS:
THE CONSTRUCTION OF THE CANAL**

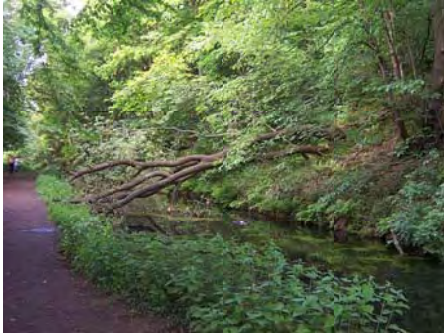
The wooded slopes above the Canal are not in County Council ownership, but management of overhanging trees is vital to avoid overshadowing, excessive leaf litter and, as shown above, blockages of the channel caused by fallen branches.

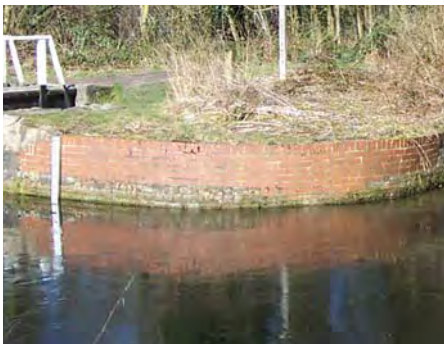
One of the few unsympathetic interventions: an original stone wall built up in brickwork at the junction with the Leewood Arm.

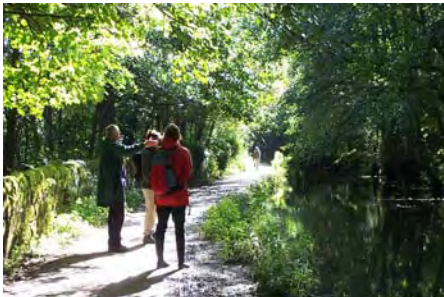
The level of tree cover in many places is damaging aquatic habitats, obscuring important historic views and causing a maintenance problem.

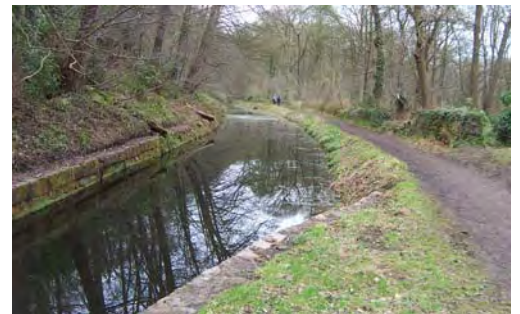
Generally stone edges to the Canal are found at wharfs and either side of bridges. Here, the Canal narrows for a wharf or crossing place some distance from any obvious activity or route.

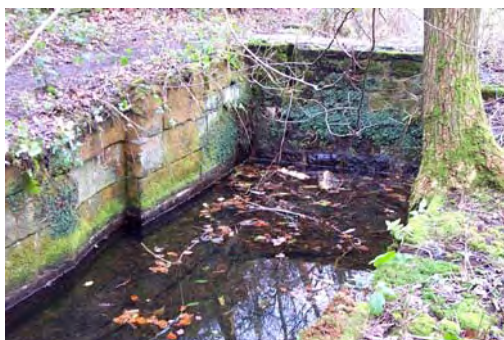
The stop lock at the junction of the main canal and the Leawood Arm, parts of which are under threat of imminent collapse. Between here and Lea Wharf much of the canal is completely dry.
