6. ECOLOGICAL SIGNIFICANCE

CROMFORD CANAL SITE OF SPECIAL SCIENTIFIC INTEREST

7 ISSUES + PROBLEMS: POLICIES + OPPORTUNITIES

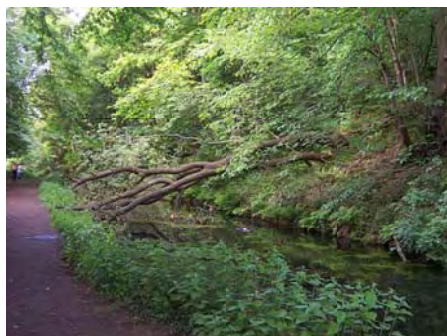
The wooded slopes above the Canal are not in County Council ownership, but management of overhanging trees is vital to avoid overshadowing, excessive leaf litter and, as shown above, blockages of the channel caused by fallen branches.

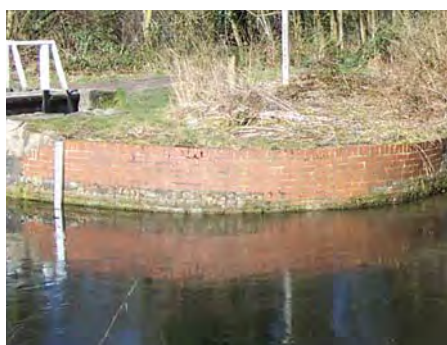
One of the few unsympathetic interventions: an original stone wall built up in brickwork at the junction with the Lea-wood Arm.

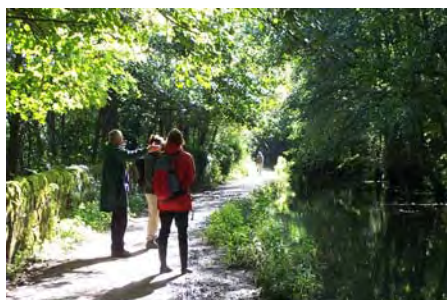
The level of tree cover in many places is damaging aquatic habitats, obscuring important historic views and causing a maintenance problem.

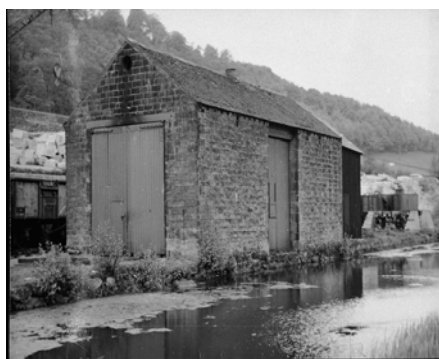
Loco shed (originally a transhipment shed) at High Peak Junction: demolished in the 1970s—one of the few lost structures on the Canal. Photo 1953.

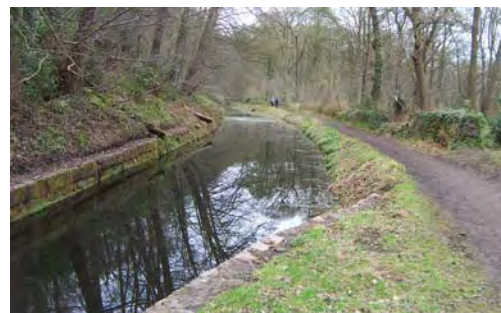
Generally stone edges to the Canal are found at wharfs and either side of bridges. Here, the Canal narrows for a wharf or crossing place some distance from any obvious activity or route.

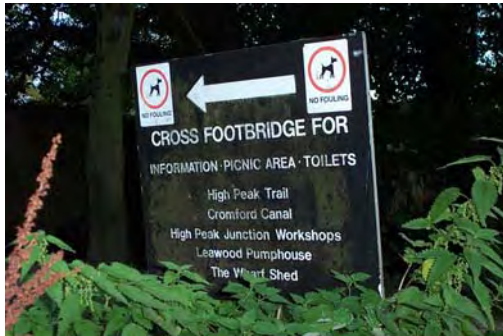
The quality of signage on the Canal is very mixed. Signage will need to be well planned, sensitively designed and allow for future adaptation and addition.

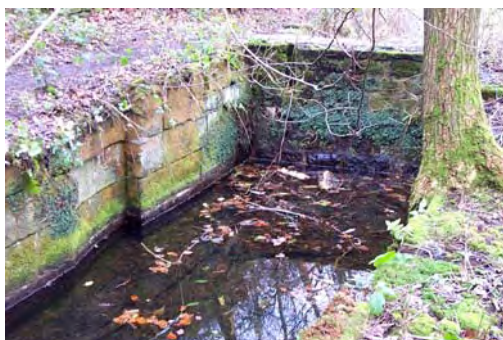
The stop lock at the junction of the main canal and the Leawood Arm, parts of which are under threat of imminent collapse. Between here and Lea Wharf much of the canal is completely dry.

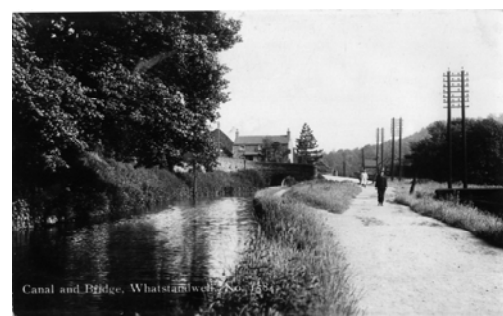
It is much easier to appreciate the site of the boat-building wharf at Whatstandwell from this old postcard which shows it free of trees.

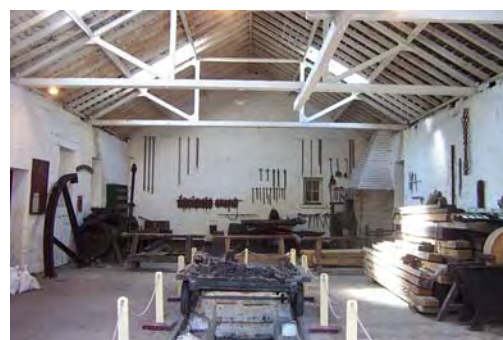
The interior of High Peak Junction Work-shops, preserved exactly as they were when the railway closed in 1967. They are open to the public but little-visited by the large numbers of people who pass through the Junction and buy snacks and souvenirs at the shop.

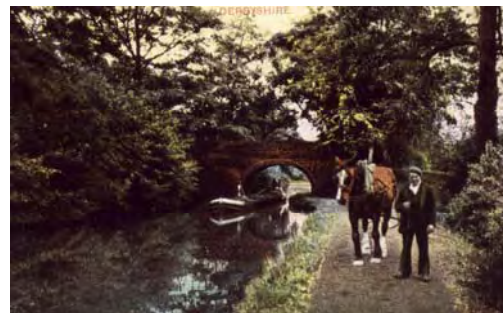
This postcard of a horse-drawn canal boat passing under Chase Bridge illustrates the width the towpath will have been along the length of the canal— wide enough for two horses to pass.

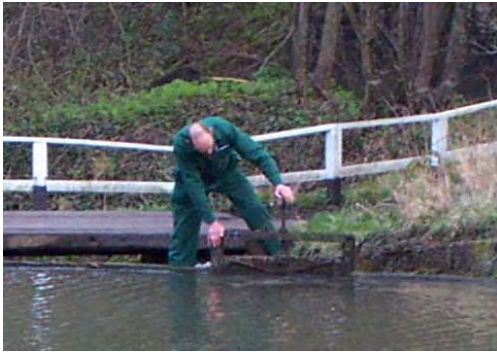
Following heavy rainfall the rangers are on call day and night to adjust the sluices to avoid overtopping or breaching of the canal walls: a catastrophic occurrence both for the canal structure and for adjoining owners.

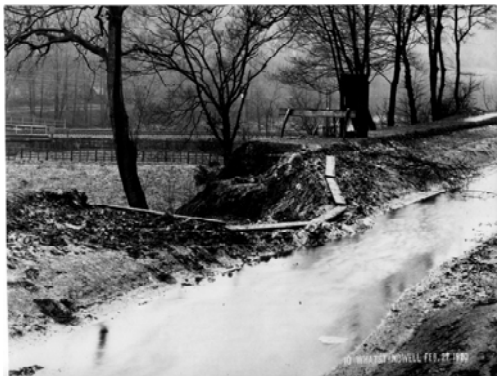
Demonstration of the necessity of vigilant maintenance: the Canal overtopped its banks at Lea Wood in 1920 where a steep embankment supports the channel as it rounds the hill.

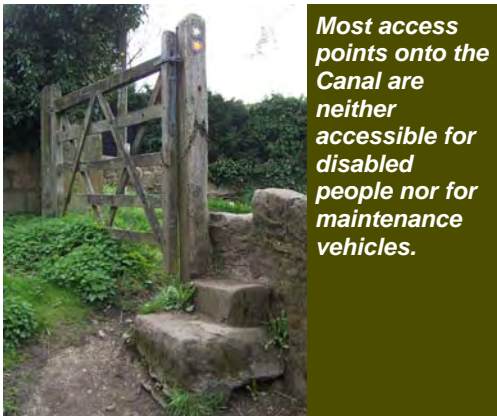
Most access points onto the Canal are neither accessible for disabled people nor for maintenance vehicles.

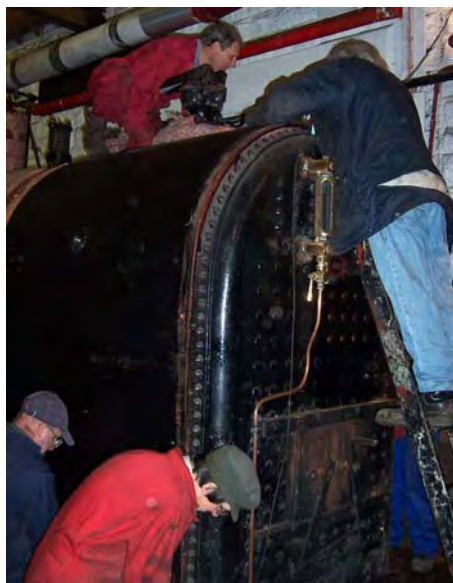
Members of the Leawood Pump volunteer group working on one of the boilers. The group maintain all the machinery as well as putting the pump in steam on regular open days.

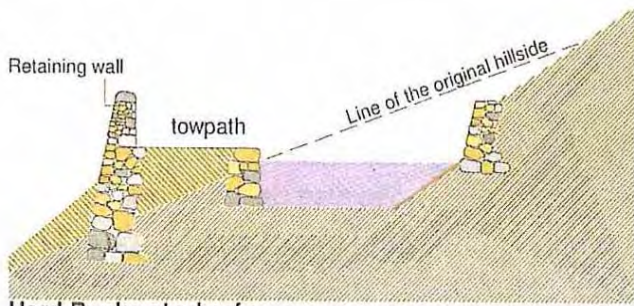
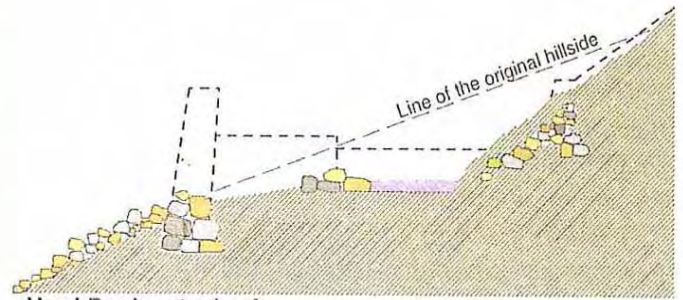
Hard Banks at wharfs

The parapet wall to the towpath has been reduced or taken away in places

DIAGRAMS SHOWING TYPICAL SECTIONS THROUGH THE CANAL STRUCTURE

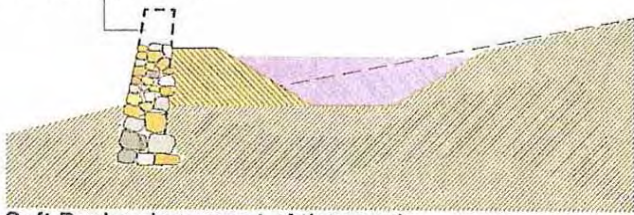
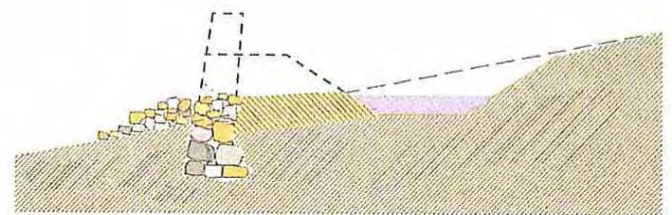
Soft Banks along most of the canal

THE POSSIBLE CONSEQUENCES OF RETAINING WALL FAILURE ON THE DOWNHILL SIDE

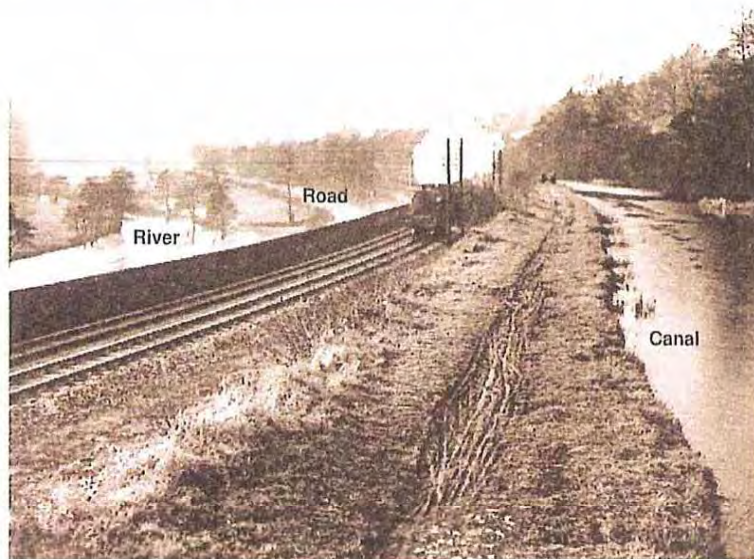
DIAGRAMS SHOWING THE TERRACING CONSTRUCTED TO SQUEEZE IN THE THREE TRANSPORT ROUTES ALONG THE STEEP SIDES OF THE RIVER VALLEY

The railway in the days of steam

Tree growth here is particularly damaging to the retaining structures

The Railway squeezed between road and canal in 1849

The Canal 1794

A6, the original Turnpike Road of 1817

The River Derwent
