## 3. Derwent Catchment

### 3.1 Derwent Catchment Event Hydrology

## **3.2 Community Impacts - Lilac Way**

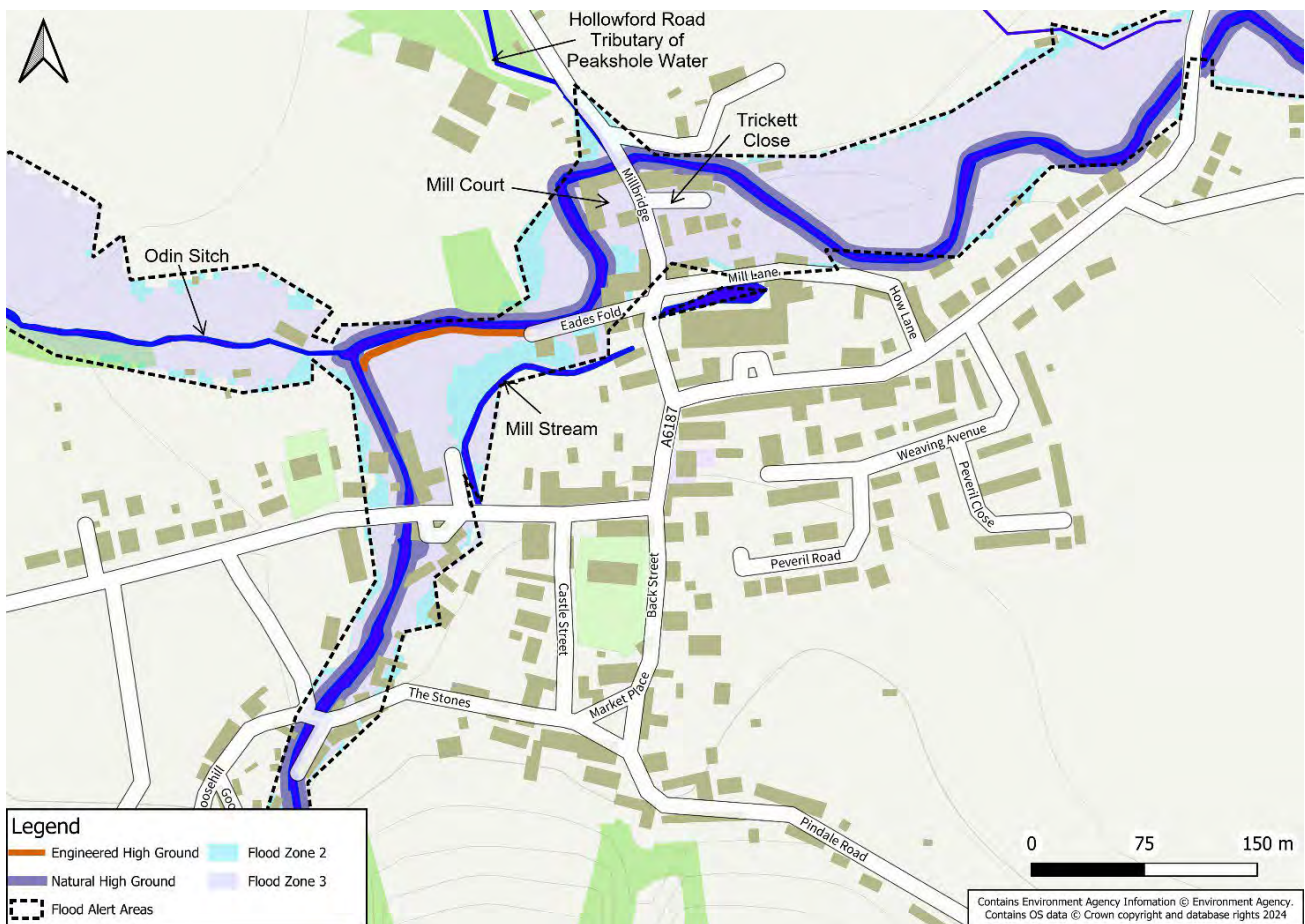
Figure 3-50: Castleton flood risk management arrangements.

The Environment Agency's [Asset Information and Maintenance Programme \(data.gov.uk\)](https://environment.data.gov.uk/asset-management/) shows there are currently no formal flood defences in the community. The only asset in Castleton that the Environment Agency maintain is a flap valve in the visitor centre car park. The flap valve prevents water from Peakshole Water backing up into the surface water drainage network when river levels are high. There is a small wall that has been built on the Riverside Path to fill a gap between a drystone wall and the wall of a property. The drystone walls in Castleton are not flood defence walls or flood risk management assets. Figure 3-50 shows the flood risk management arrangements for Castleton.

The maintenance of all the watercourses within Castleton is the responsibility of the riparian owners.

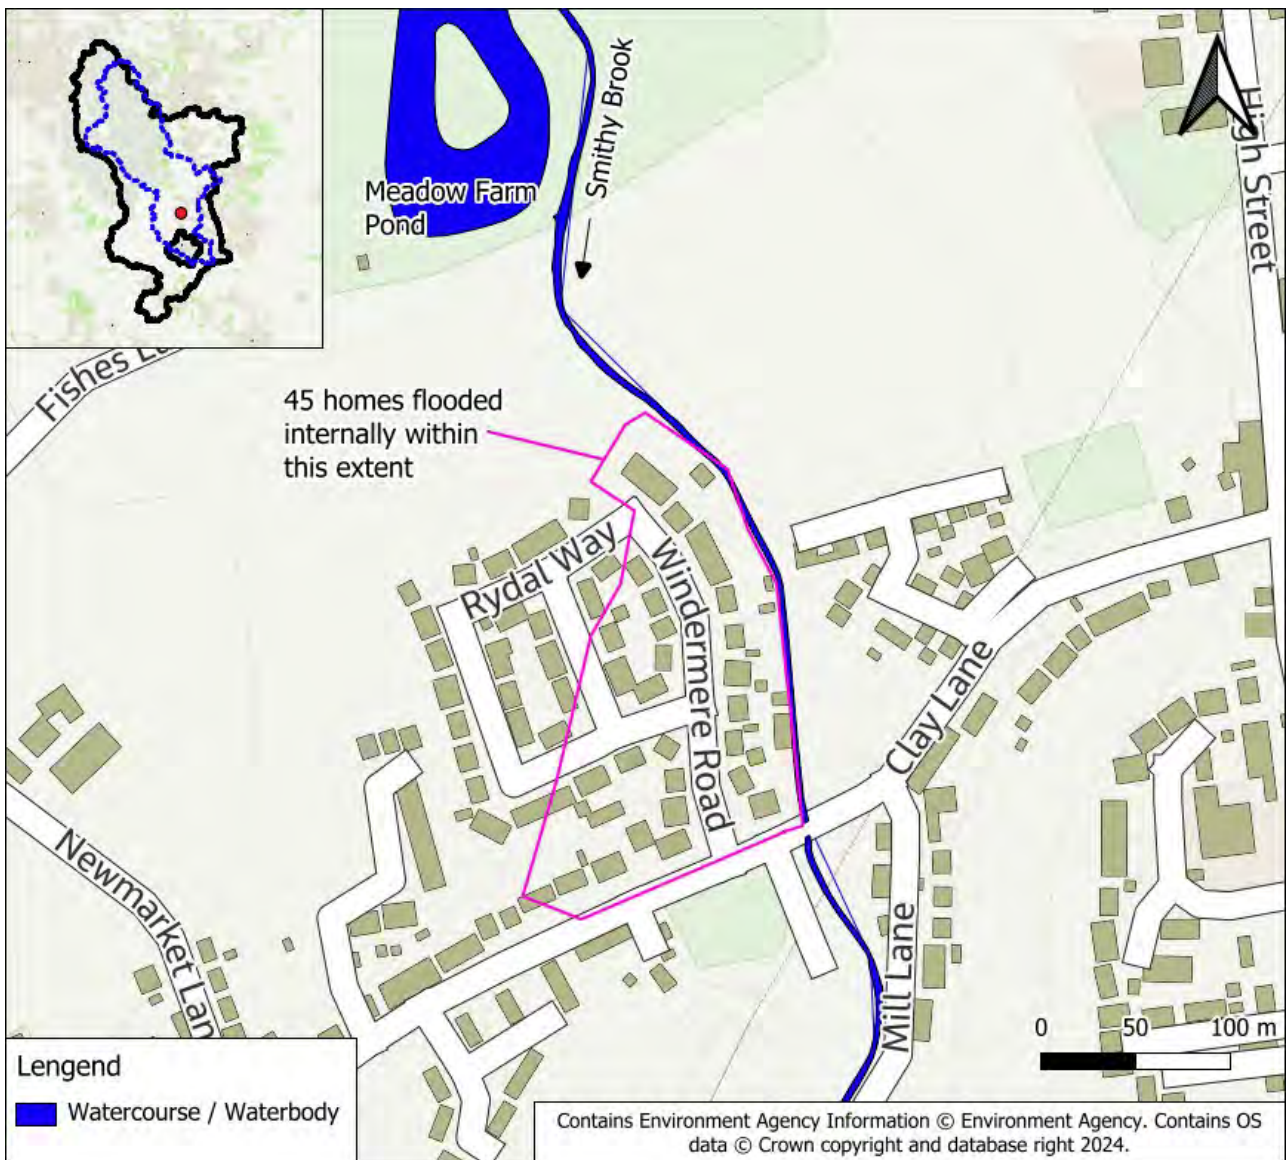
Figure 3-51: Overview map of Clay Cross community.

Forty-five residential properties flooded internally in Clay Cross as a result of Storm Babet. Clay Cross is a town in north-east Derbyshire, approximately 8km south of Chesterfield. The community sits to the west of Smithy Brook, also known as Press Brook. Smithy Brook is a tributary of the River Amber and is designated an ordinary watercourse. Figure 3-51 shows an overview of the community affected.

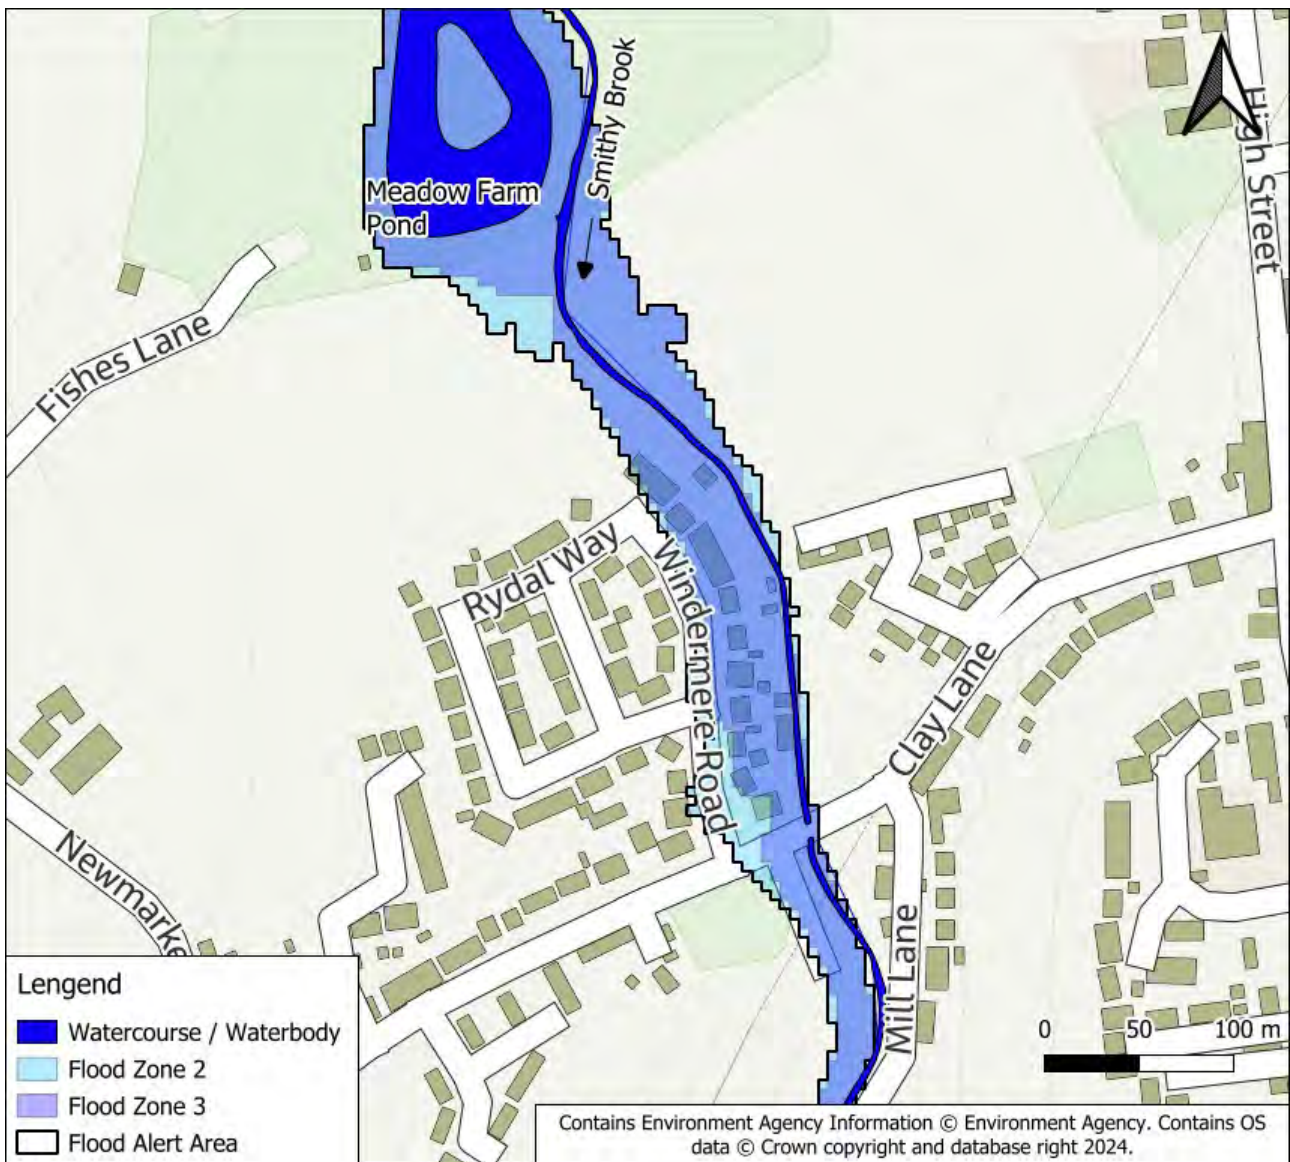
Figure 3-52: Flood Zones 2 and 3 at Clay Cross

The Flood Map for Planning (<https://flood-map-for-planning.service.gov.uk/>) shows all properties that flooded were located in Flood Zone 2 or 3. Properties on the east of Windermere Road are within Flood Zone 3. Flood Zone 3 means the properties have a greater than 1% AEP of flooding from rivers. Flood Zone 2 extends across Windermere Road, to some of the properties on the west side of the road and on Clay Lane. Flood Zone 2 means properties have between a 1% and 0.1% AEP of river flooding. Figure 3-52 shows the Flood Zones described.

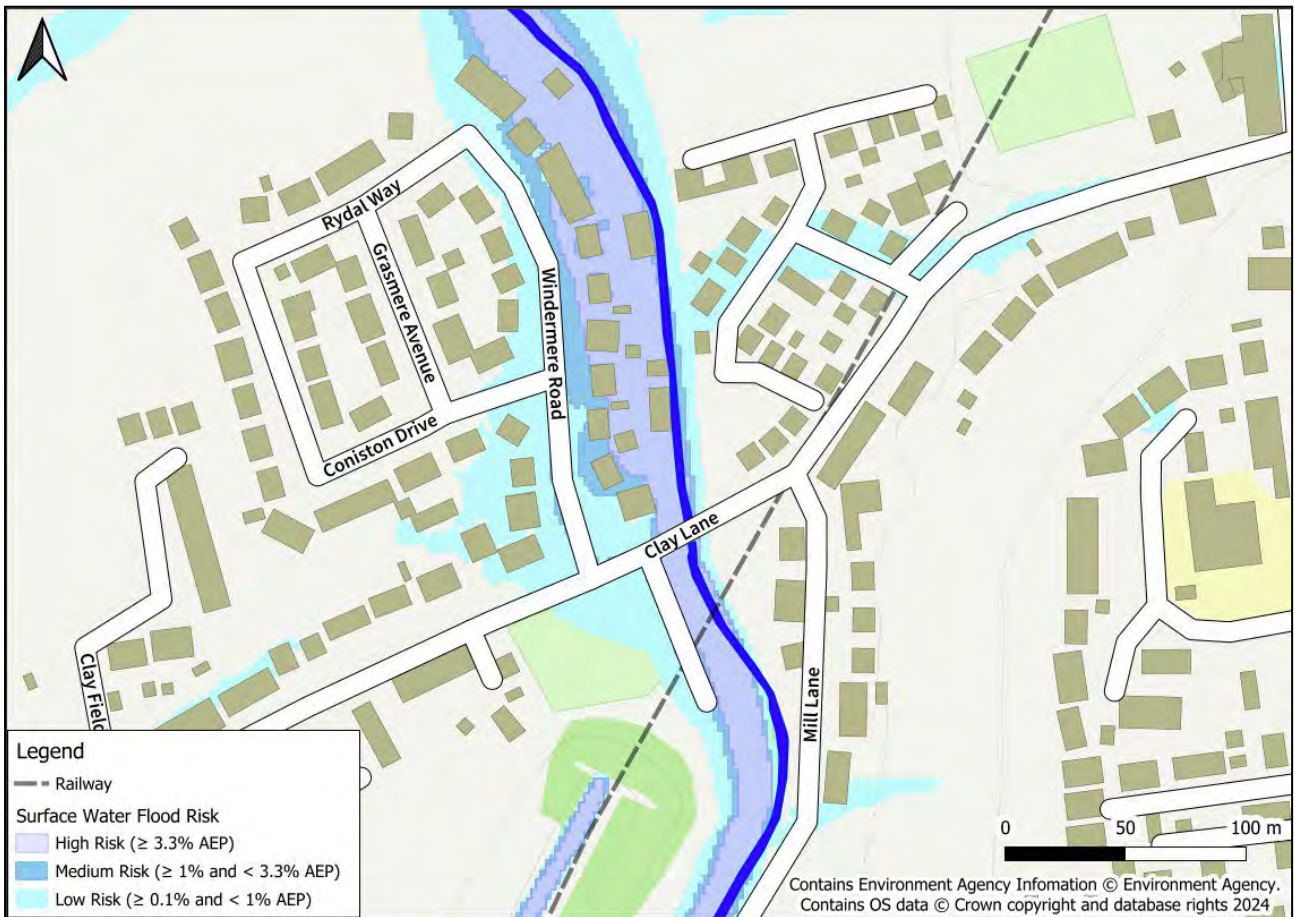
**Figure 3-53: Map showing the chance in any given year of flooding from surface water at Clay Cross (Source: Long Term Flood Risk Map).**

Additionally, the Long Term Flood Risk Map (<https://check-long-term-flood-risk.service.gov.uk/postcode>) shows the majority of the properties on the east side of Windermere Road have at least a medium (between 1% and 3.3% AEP) risk of surface water flooding, with some of the properties being at a high (more than 3.3% AEP) risk of surface water flooding. The majority of the properties internally flooded on the west side of Windermere Road are at low (between 0.1% and 1% AEP) risk of surface water flooding. Figure 3-53 shows the surface water flood risk described.
