4. Don and Rother Catchment

4.1 Don and Rother Catchment Event Hydrology

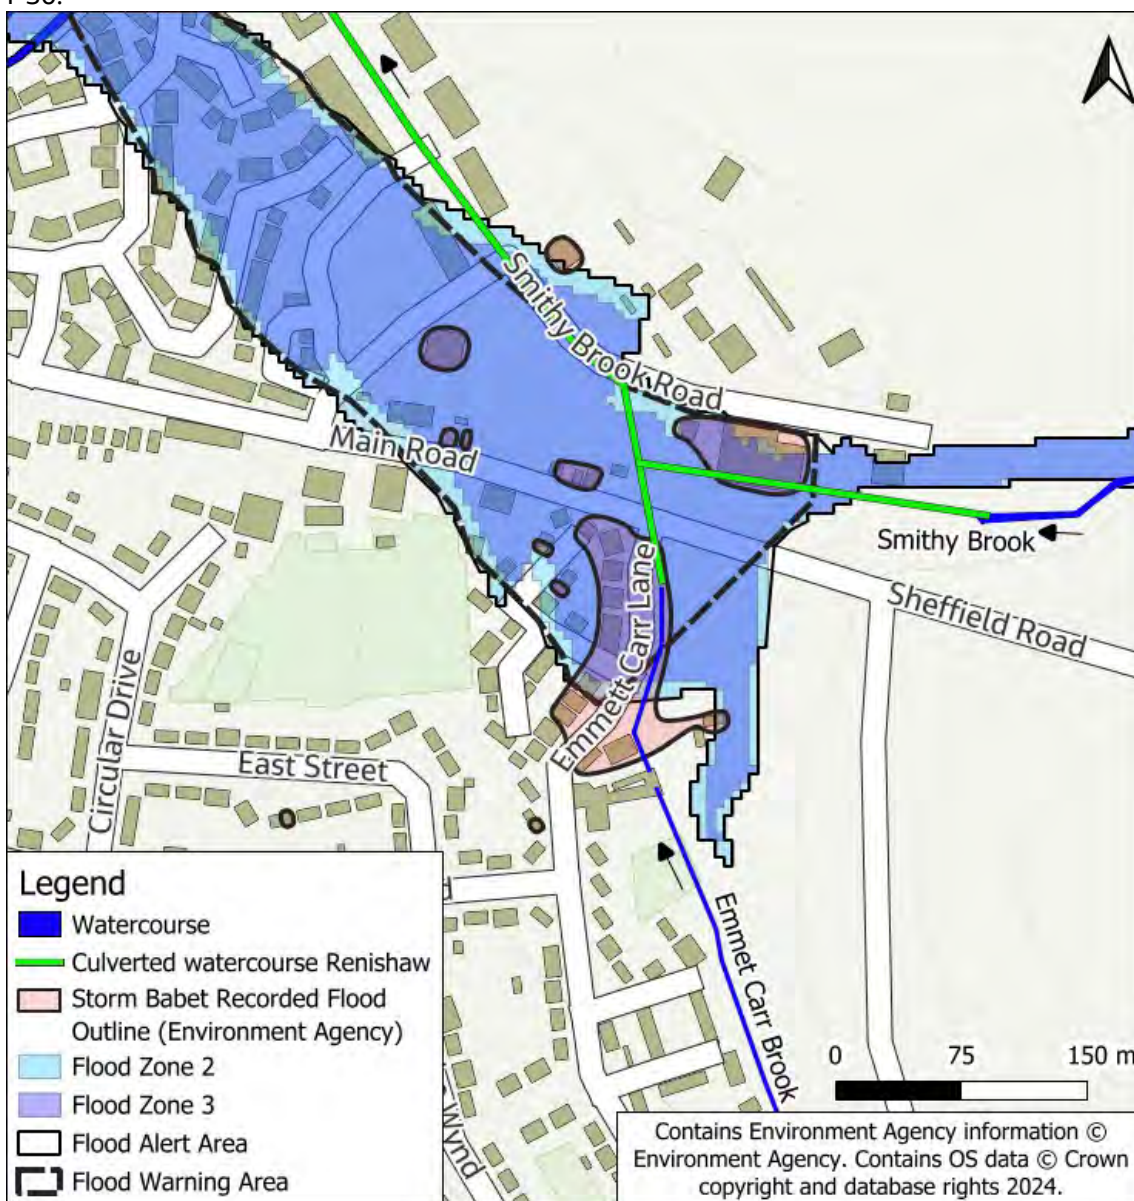
Figure 4-30: Flood Map for Planning Flood Zones 2 and 3 extents and Flood Alert and Flood Warning areas at Renishaw.

The Flood Map for Planning (<https://flood-map-for-planning.service.gov.uk/>) shows that the majority of flooded properties within this community are in Flood Zone 3. Areas in Flood Zone 3 have a greater than 1% AEP of flooding from rivers. The extents of Flood Zone 2 and Flood Zone 3 at Renishaw are shown in Figure 4-30.

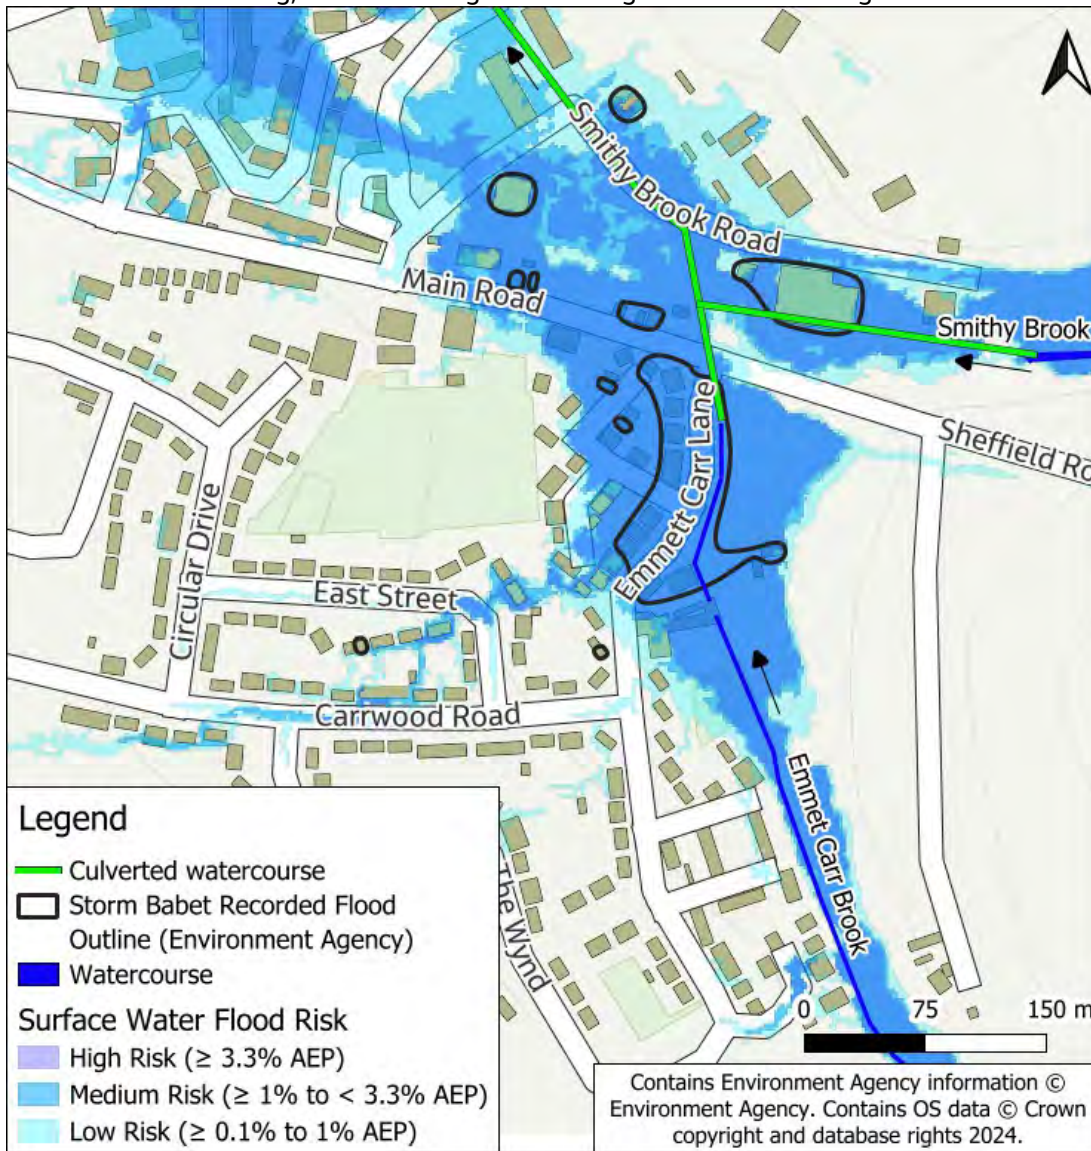
Figure 4-31: Map showing the chance in any given year of flooding from surface water at Renishaw (Source: Long Term Flood Risk Map).

Additionally, based on the Long Term Flood Risk Map (<https://check-long-term-flood-risk.service.gov.uk/postcode>) the majority of the properties at risk from the watercourses also have a high risk of surface water flooding, as shown in Figure 4-31. High risk is defined as greater than 3.3% AEP of flooding.

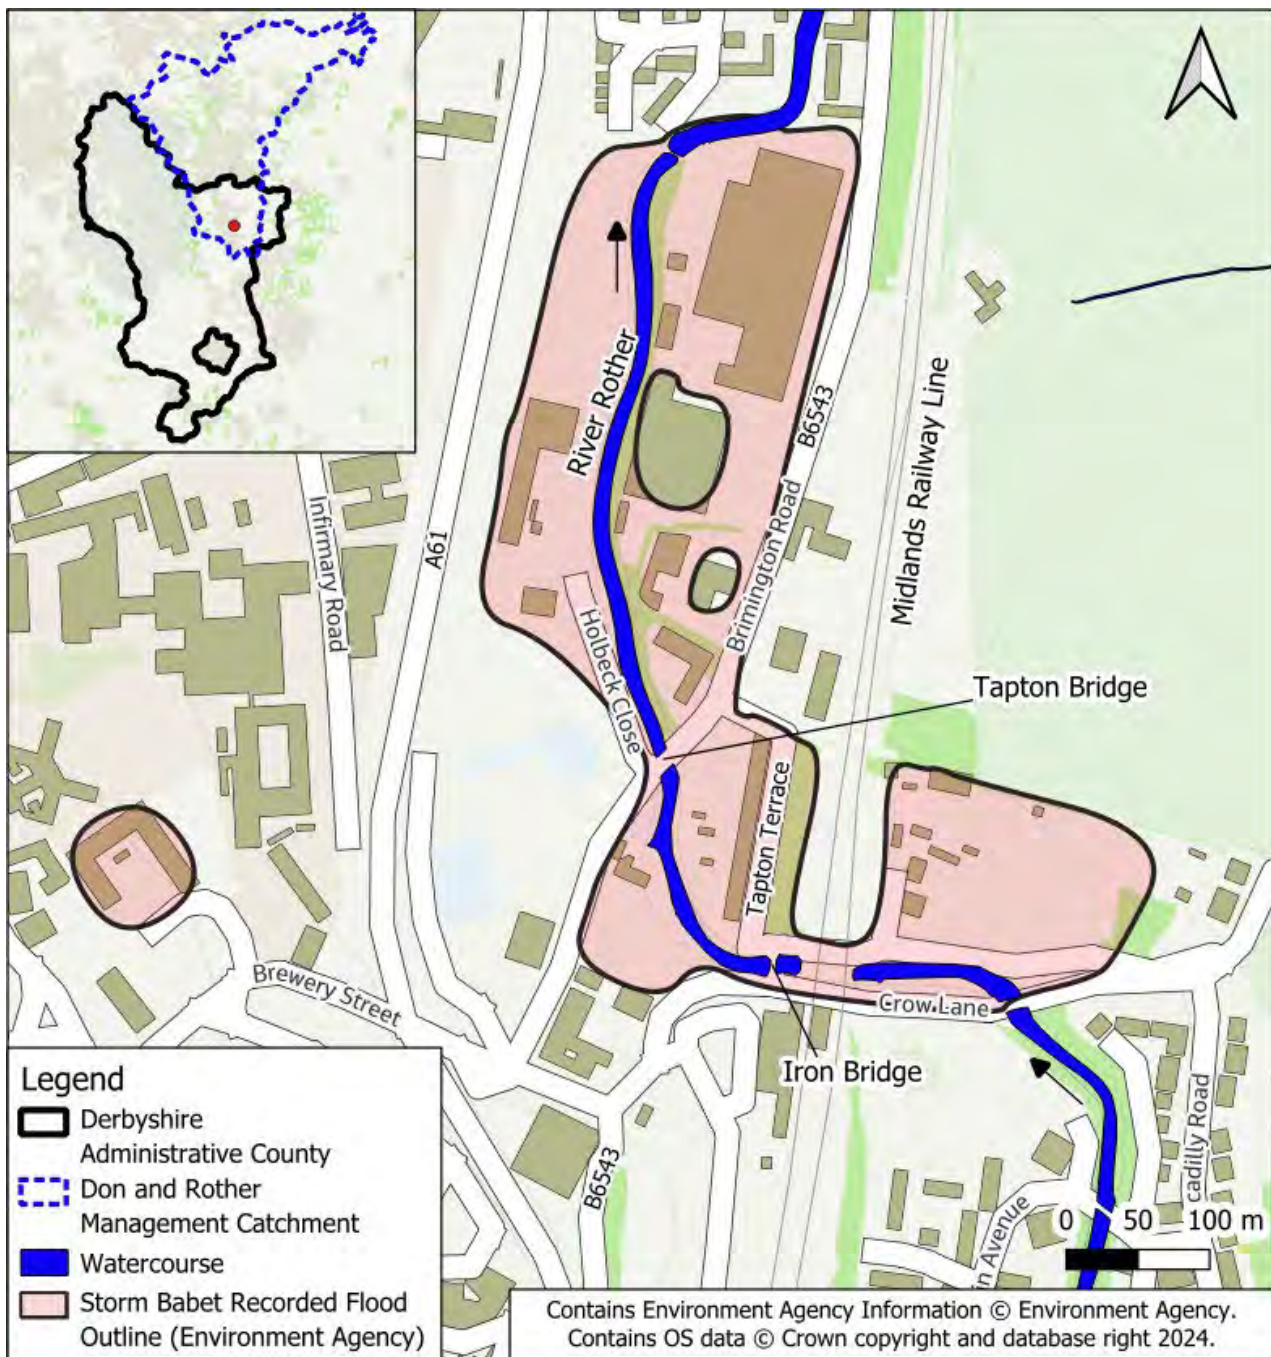
Figure 4-35: Overview map of Tapton Terrace and the area surrounding it.

Twenty-six residential properties in Tapton Terrace and seventeen non-residential properties on Crow Lane and Brimington Road, located approximately 750m from Chesterfield town centre, suffered internal flooding as a result of Storm Babet. Also, tragically, one resident lost their life. Figure 4-35 below shows the area where the main group of properties flooded, around the River Rother. The River Rother is a main river that flows through the centre of the community.

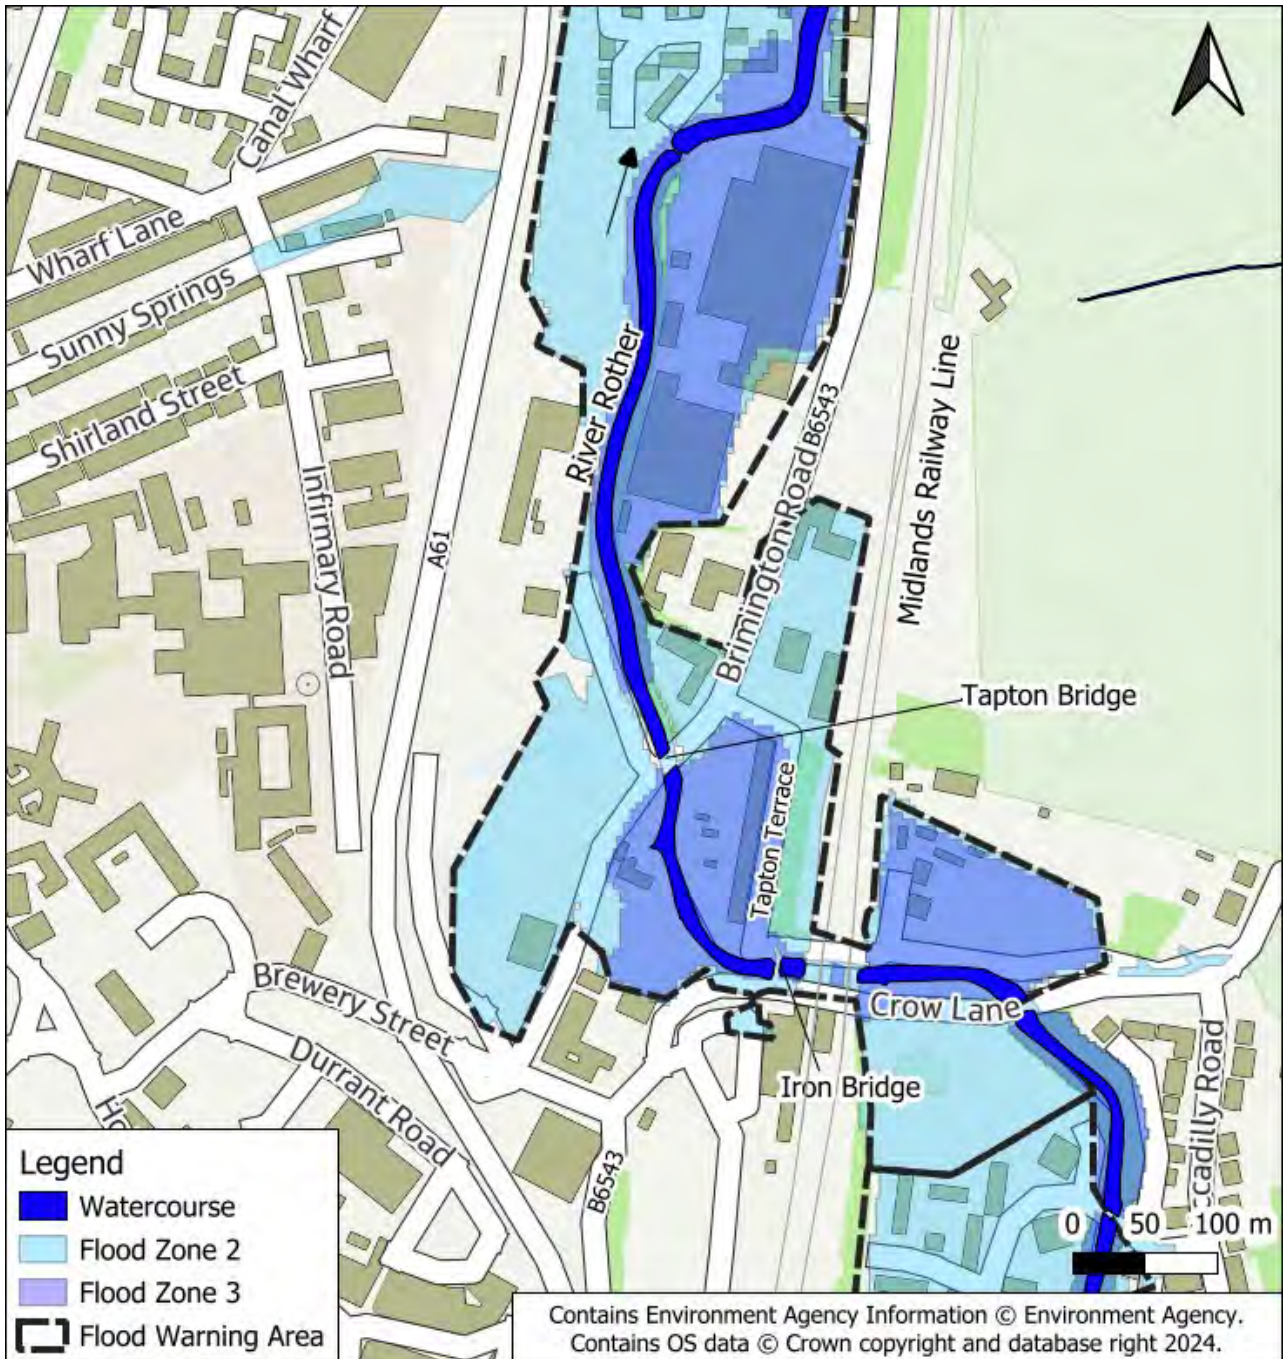
Figure 4-36: Flood Map for Planning Flood Zones and areas of natural high ground in the vicinity of Tapton Terrace.

as shown in Figure 4-36. Flood Zone 3 means the properties have a greater than 1% AEP of flooding from the river. One of the non-residential properties is located in Flood Zone 2, which means it has between a 1% and 0.1% AEP of flooding. Four non-residential properties are located in Flood Zone 1, which means they have less than a 0.1% AEP of flooding from the river.

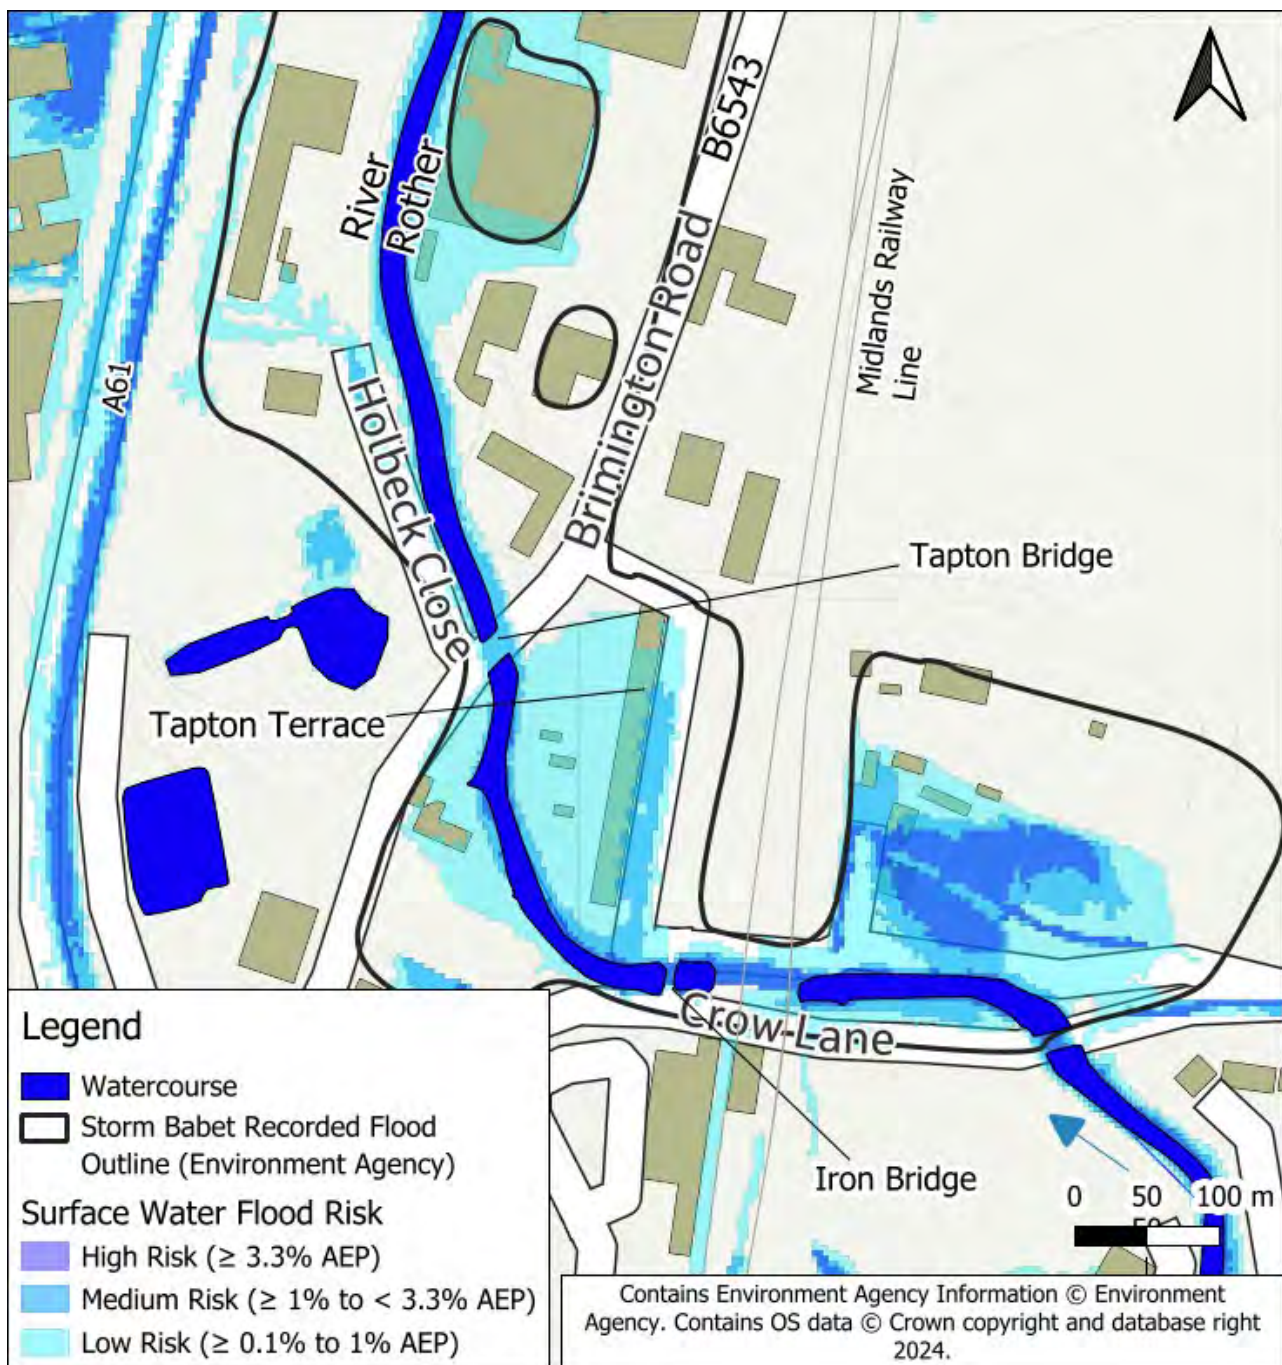
Figure 4-37: Map showing the chance in any given year of flooding from surface water at Tapton Terrace and the surrounding area (Source: Long Term Flood Risk Map). The community is not located within or nearby any nationally designated environmental sites.

Additionally, some homes in the community have a medium risk of surface water flooding, based on the Long Term Flood Risk Map (<https://check-long-term-flood-risk.service.gov.uk/postcode>). Medium risk is defined as between 1% and 3.3% AEP of flooding. Figure 4-37 shows the surface water flood risk for the community based on the national mapping referred to above.

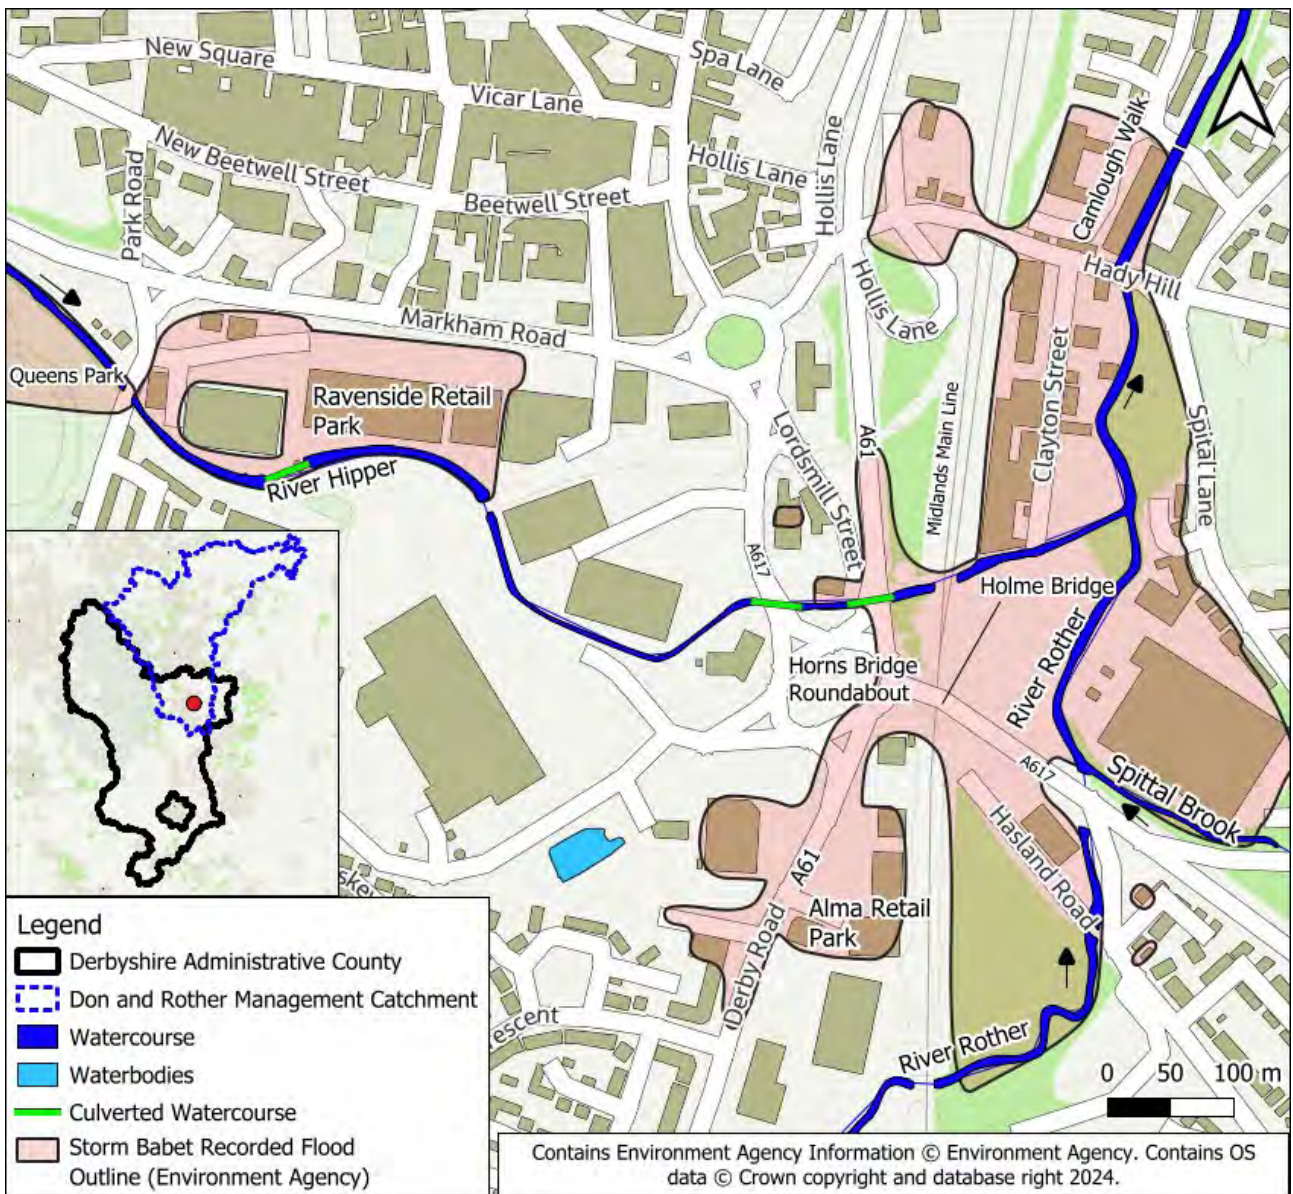
Figure 4-39: Central Chesterfield overview map.

Forty-nine homes and thirty businesses in central Chesterfield suffered internal flooding as a result of Storm Babet. Figure 4-39 below shows the areas that were flooded, and includes Camlough Walk, Spital Lane, Hasland Road, Alma Retail Park, Ravenside Retail Park, Clayton Street and Hollis Lane. Three watercourses pass through this community: the River Rother, a main river; the River Hipper, a main river, and Spital Brook, an ordinary watercourse.

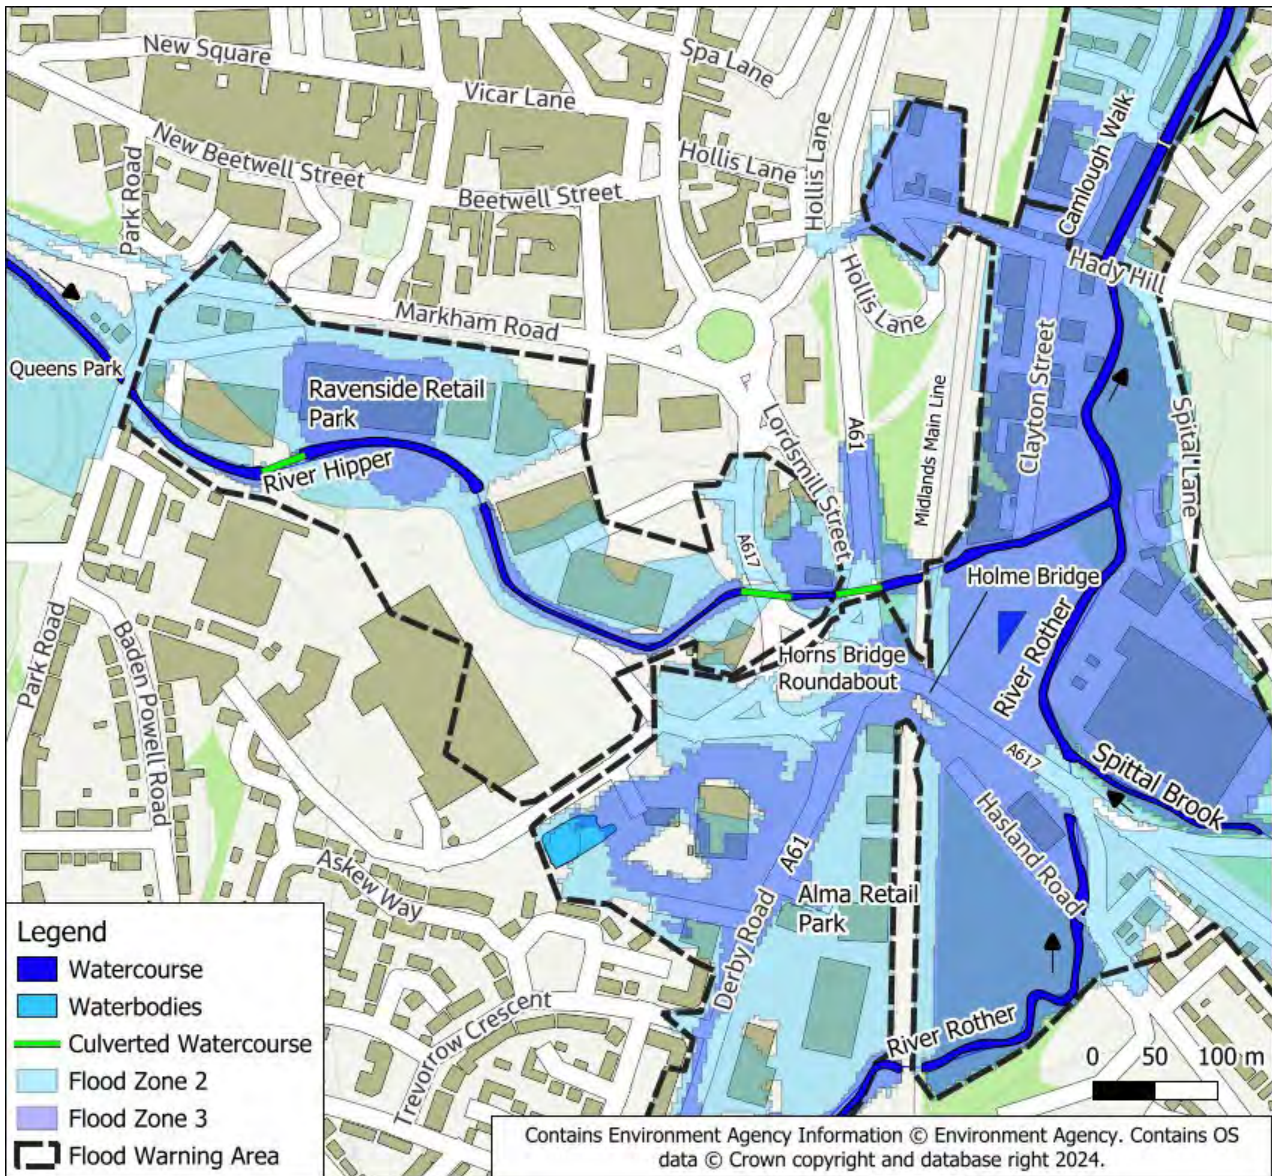
Figure 4-40: Flood zones and flood risk management assets at Central Chesterfield.

The Flood Map for Planning (<https://flood-map-for-planning.service.gov.uk/>) shows that several of the flooded homes within this community are in Flood Zone 3. Flood Zone 3 means the properties are within the floodplain and have a greater than 1% AEP of flooding from rivers. Flood zones and flood risk management assets at Central Chesterfield are shown in Figure 4-40.

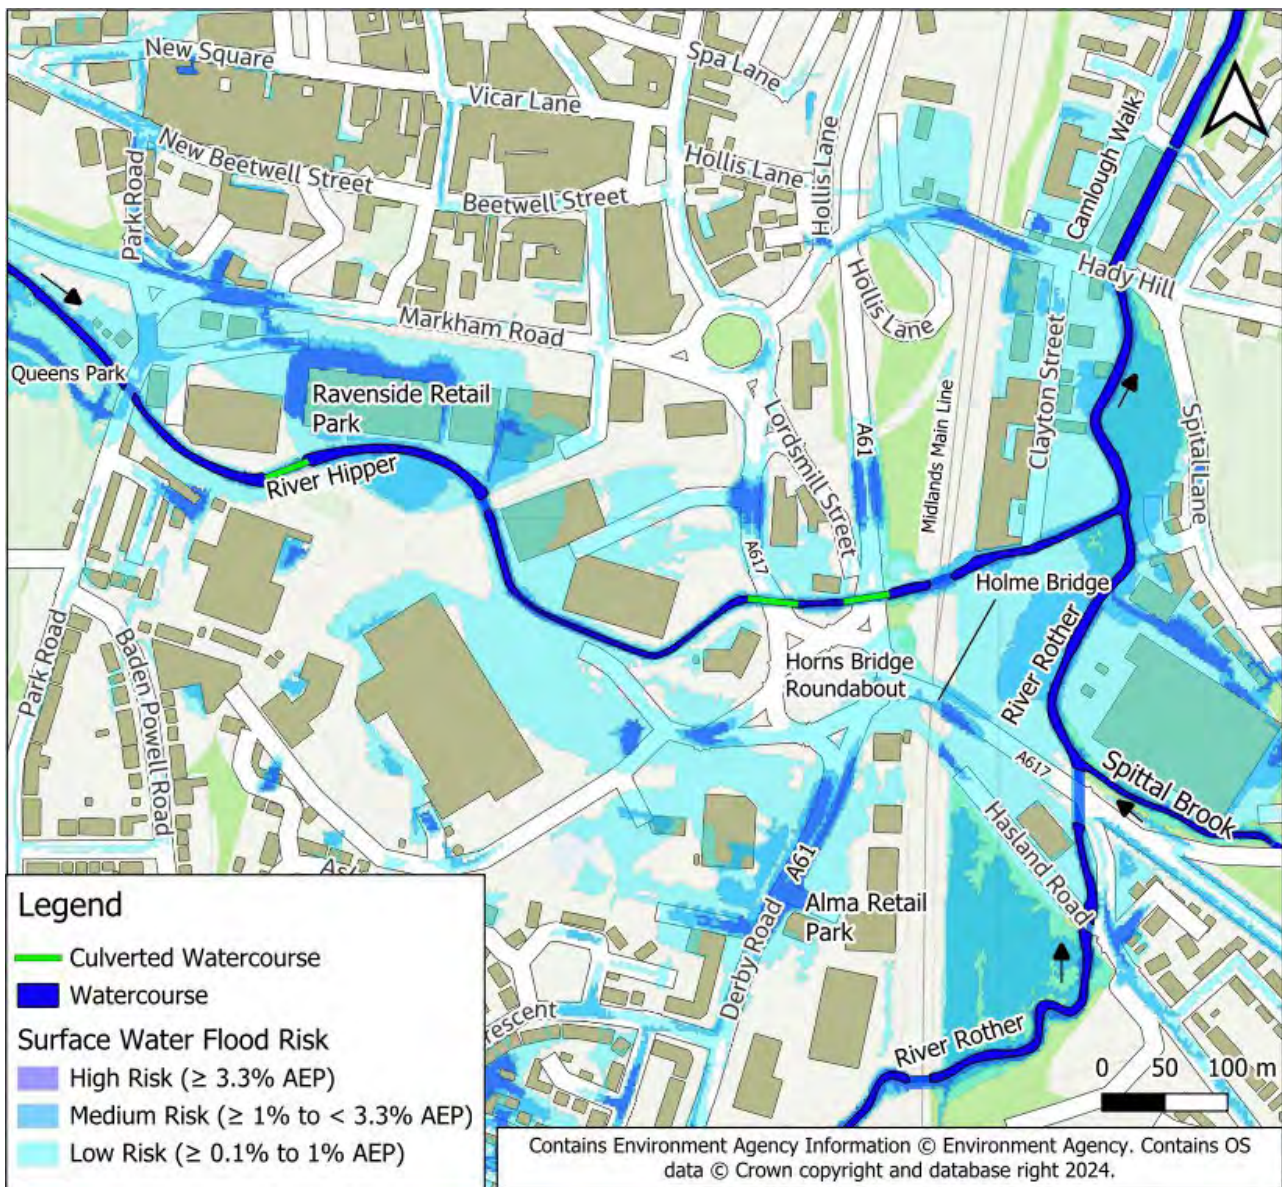
Figure 4-41: Map showing the chance in any given year of flooding from surface water at the Central Chesterfield community (Source: Long Term Flood Risk Map).

Additionally, some properties near Queens Park, Ravenside Retail Park, and isolated stretches of the A61 and A617 have a high risk of surface water flooding, based on the Long Term Flood Risk Map (<https://check-long-term-flood-risk.service.gov.uk/postcode>). High risk is defined as greater than 3.3% AEP of flooding. A large proportion of Central Chesterfield has a low risk of surface water flooding. Low risk is defined as between a 1% and 0.1% AEP of flooding. Figure 4-41 shows the risk of surface water flooding at Central Chesterfield.

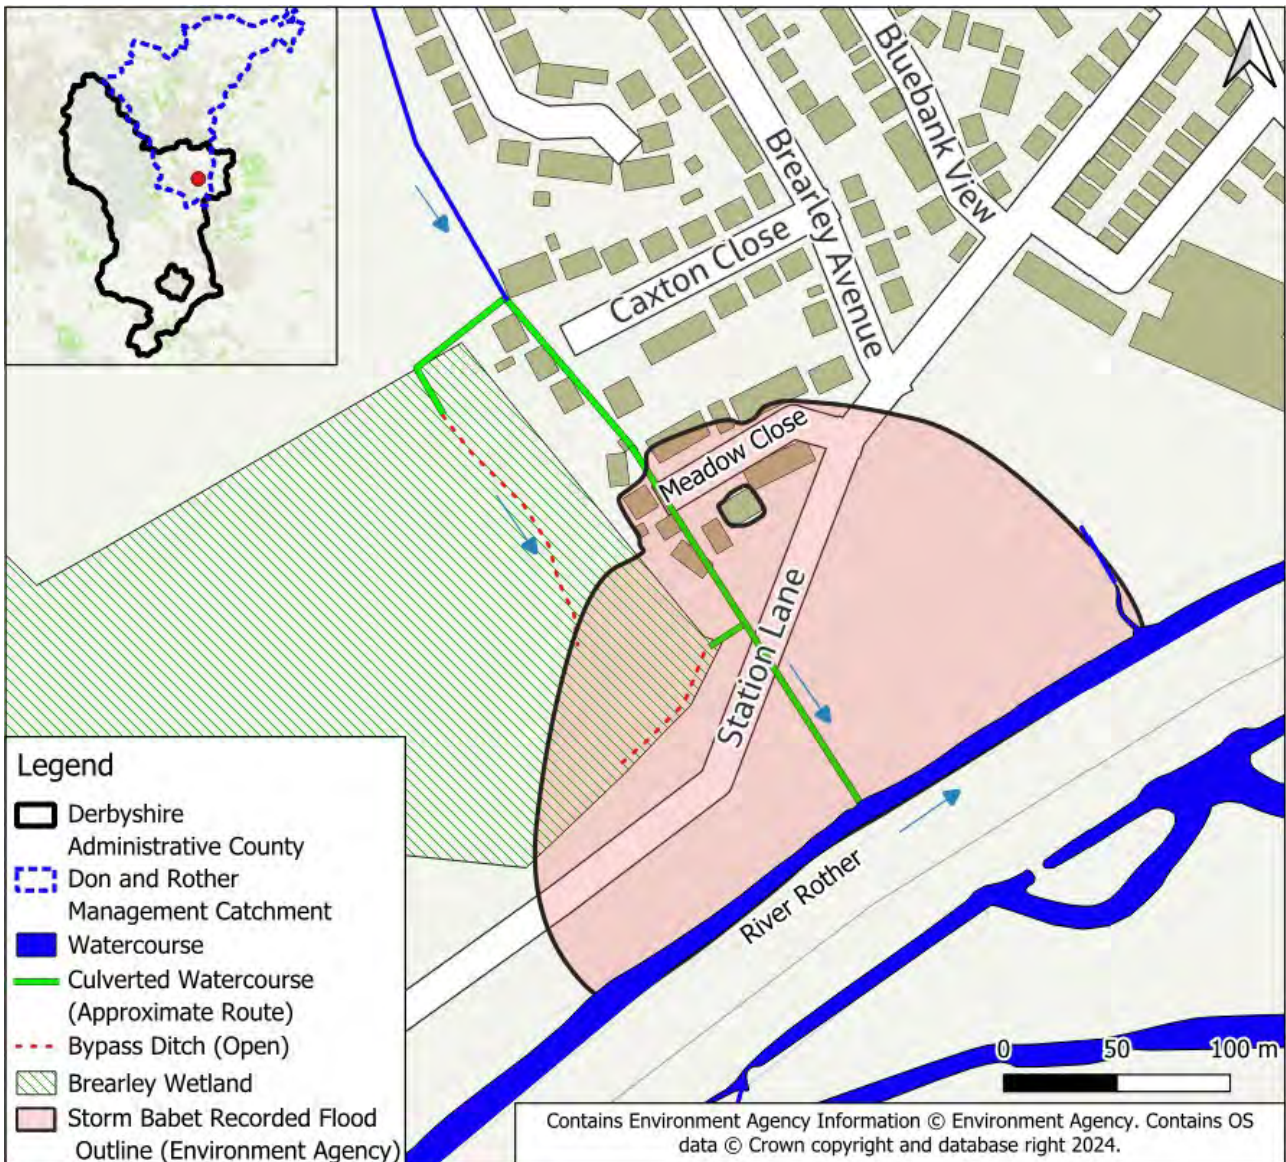
Figure 4-47: Overview map of Meadow Close community.

Fifteen properties in Meadow Close, a cul-de-sac in New Whittington, approximately 4.5km north of Chesterfield, suffered internal flooding as a result of Storm Babet. Figure 4-47 below shows the area where the properties flooded. The River Rother flows eastwards approximately 150m south of the community, with the Midlands Railway Line and Chesterfield Canal parallel to the River Rother to the south. An ordinary watercourse passes southwards as an open channel through Brearley Park to the west of the community, before becoming culverted and flowing beneath Caxton Close and Meadow Close. The watercourse then flows through the field south of Meadow Close, beneath Station Lane, before joining the River Rother. Upstream of Meadow Close, some of the ordinary watercourse flow is diverted westwards during periods of higher flows and feeds into the wetland area to the west and then on to the River Rother.

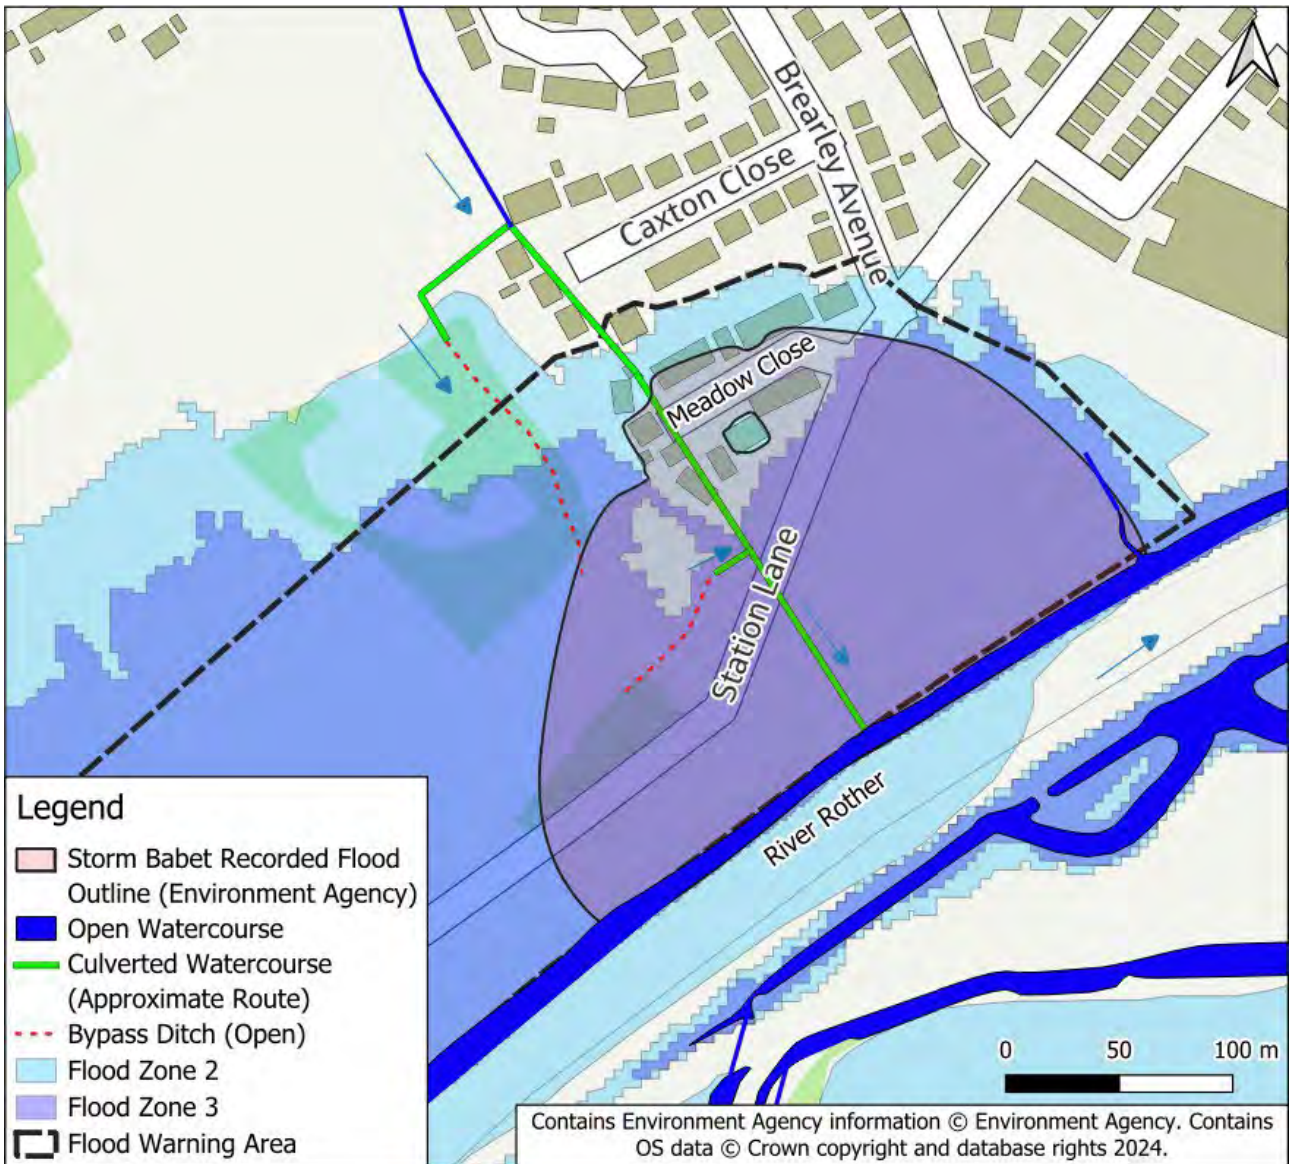
Figure 4-48: Flood Zones and flood risk management arrangements in the vicinity of Meadow Close.

The Flood Map for Planning (<https://flood-map-for-planning.service.gov.uk/>) shows that all of the flooded homes within this community are in Flood Zone 2, as shown in Figure 4-48. Areas in Flood Zone 2 have between a 1% and 0.1% AEP of river flooding.

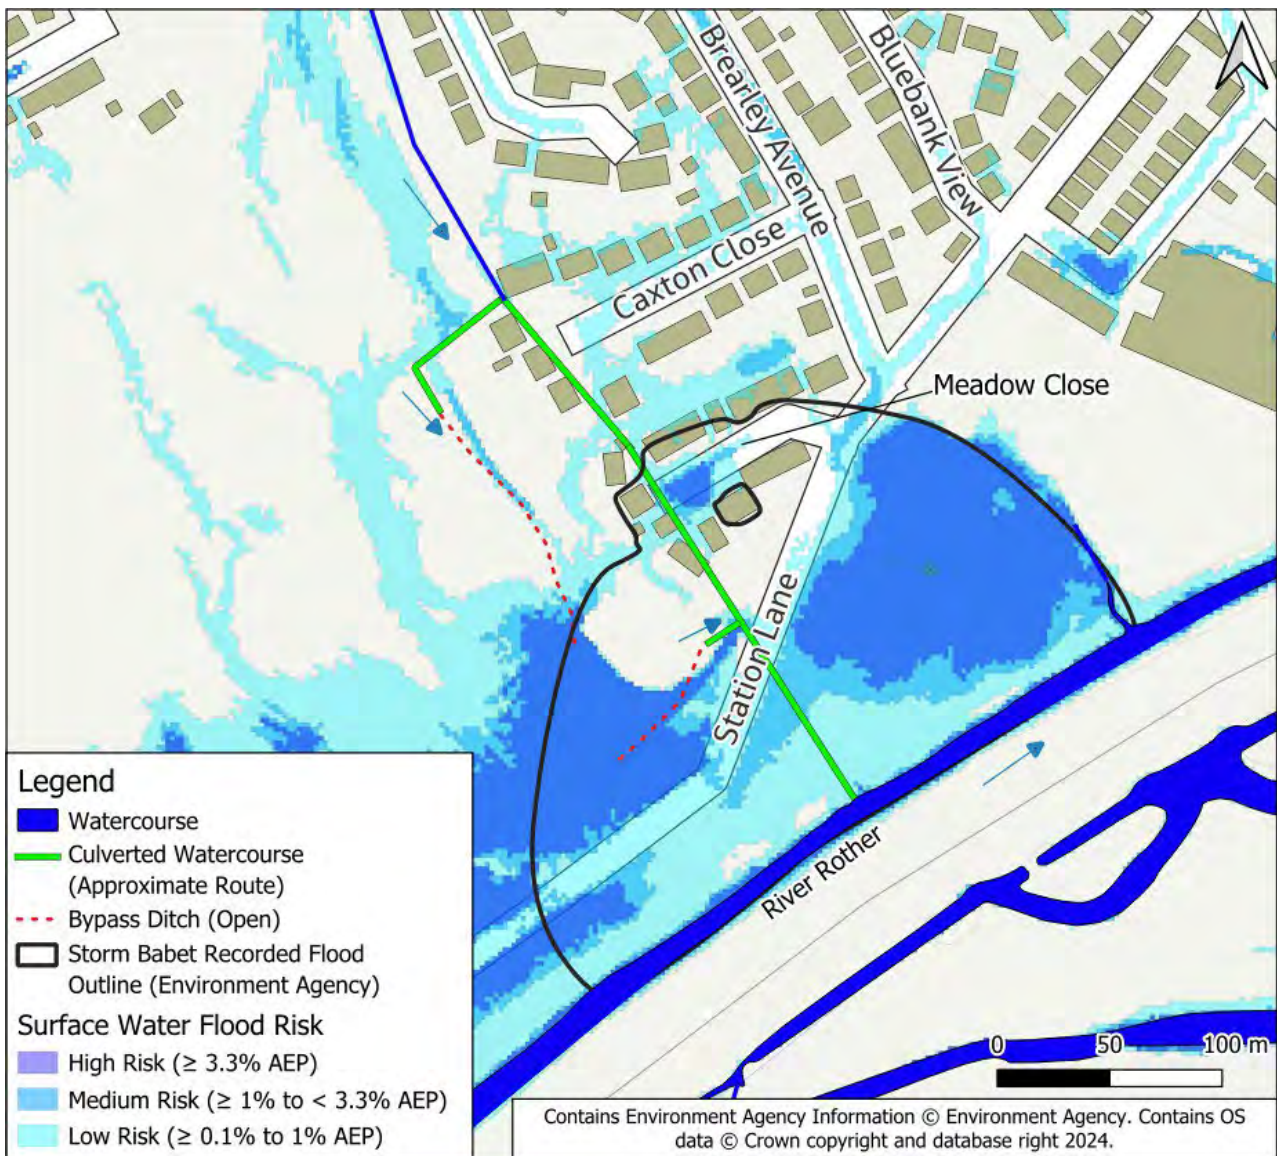
Figure 4-49: Map showing the chance in any given year of flooding from surface water at Meadow Close and its surrounding area (Source: Long Term Flood Risk Map).

Additionally, some homes on Meadow Close have a low risk of surface water flooding, based on the Long Term Flood Risk Map (<https://check-long-term-flood-risk.service.gov.uk/postcode>). Low risk is defined between a 1% and 0.1% AEP of flooding. Figure 4-49 shows the surface water flood risk for the community based on the national mapping referred to above.

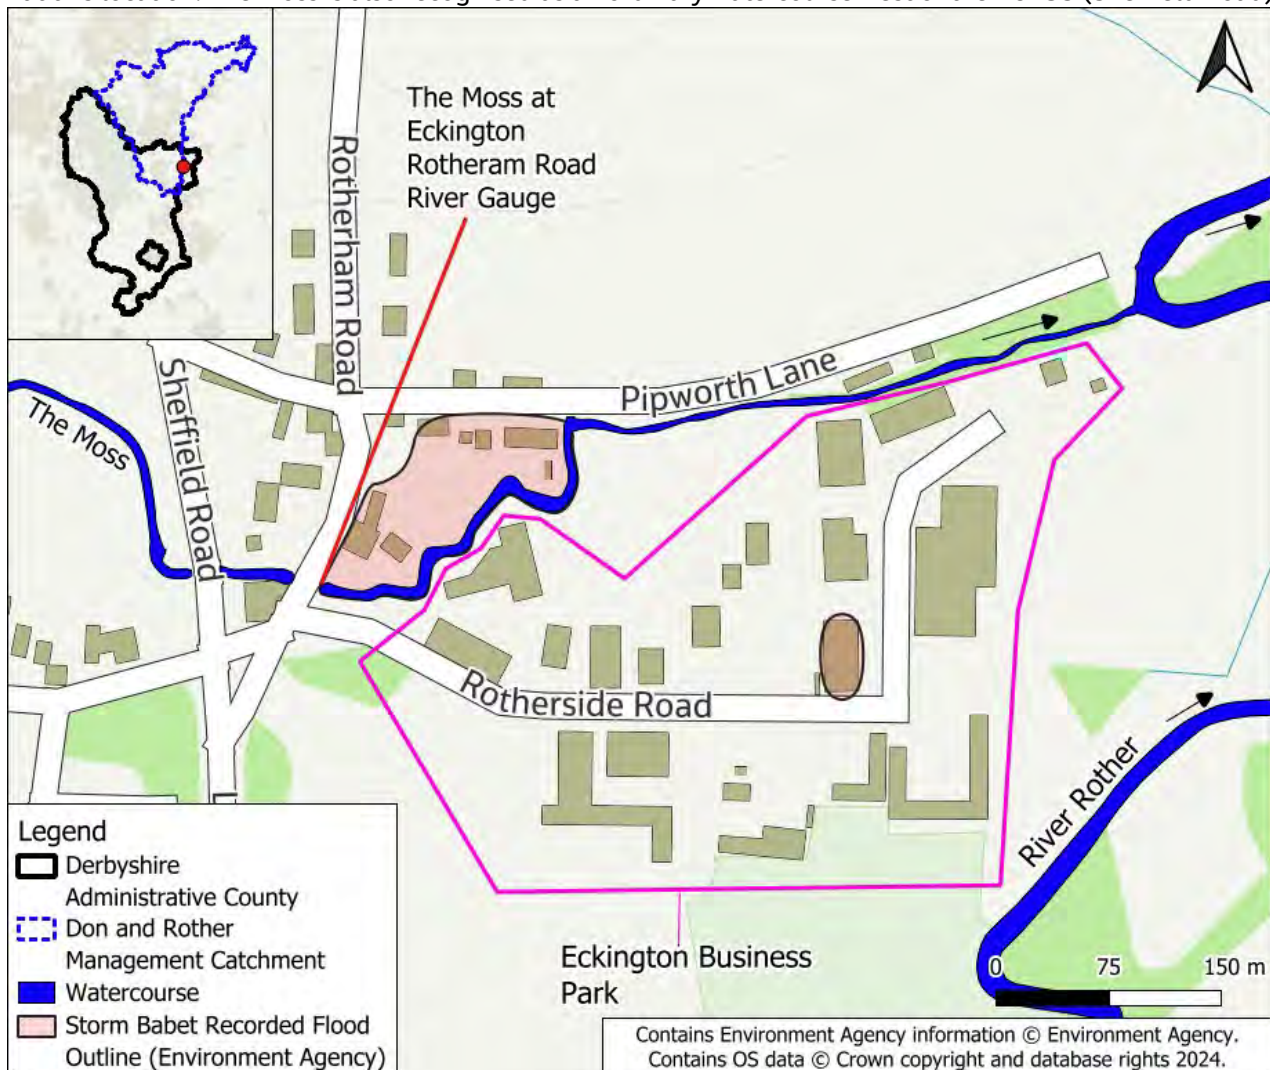
Figure 4-51: Overview Map of Eckington.

Eight properties, including five residential properties and three commercial properties, in Eckington, north-east Derbyshire suffered internal flooding as a result of Storm Babet. Figure 4-51 below shows the area where the properties flooded, to the north of a river called The Moss. The Moss flows from west to east through the community and is a tributary to the River Rother. Both The Moss and River Rother are classified as main rivers at this location. The Moss is also recognised as an ordinary watercourse west of the A6135 (Sheffield Road).

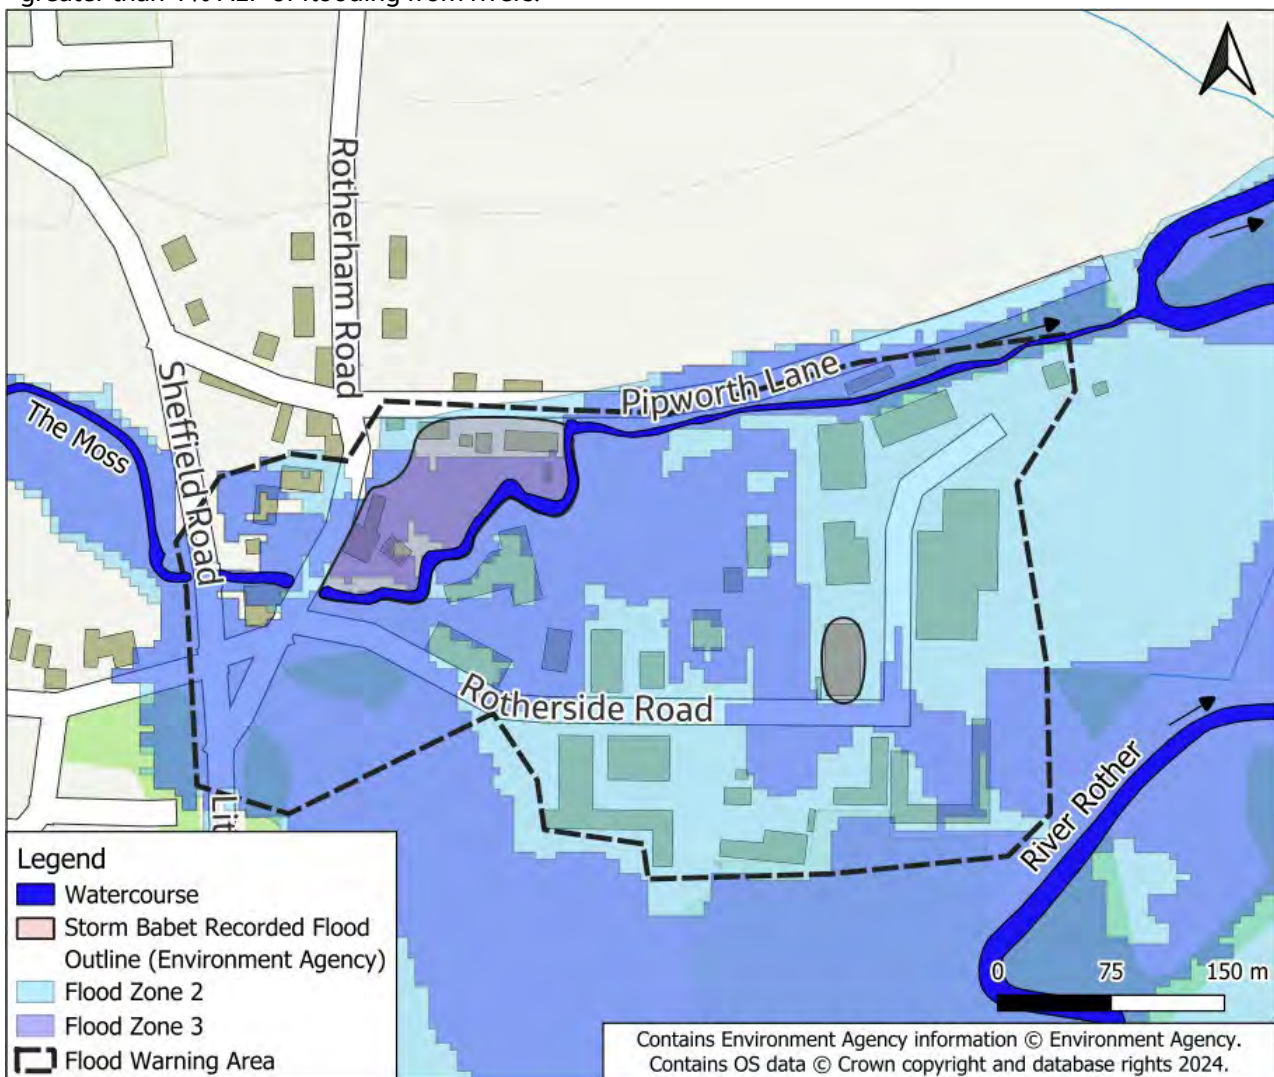
Figure 4-52: Current flood risk management strategies within Eckington.

The Flood Map for Planning (<https://flood-map-for-planning.service.gov.uk/>) shows that all of the flooded homes within this community are in Flood Zone 2 and some are in Flood Zone 3, see Figure 4-52. Areas in Flood Zone 2 have between a 1% and 0.1% AEP of river flooding. Flood Zone 3 means the properties have a greater than 1% AEP of flooding from rivers.

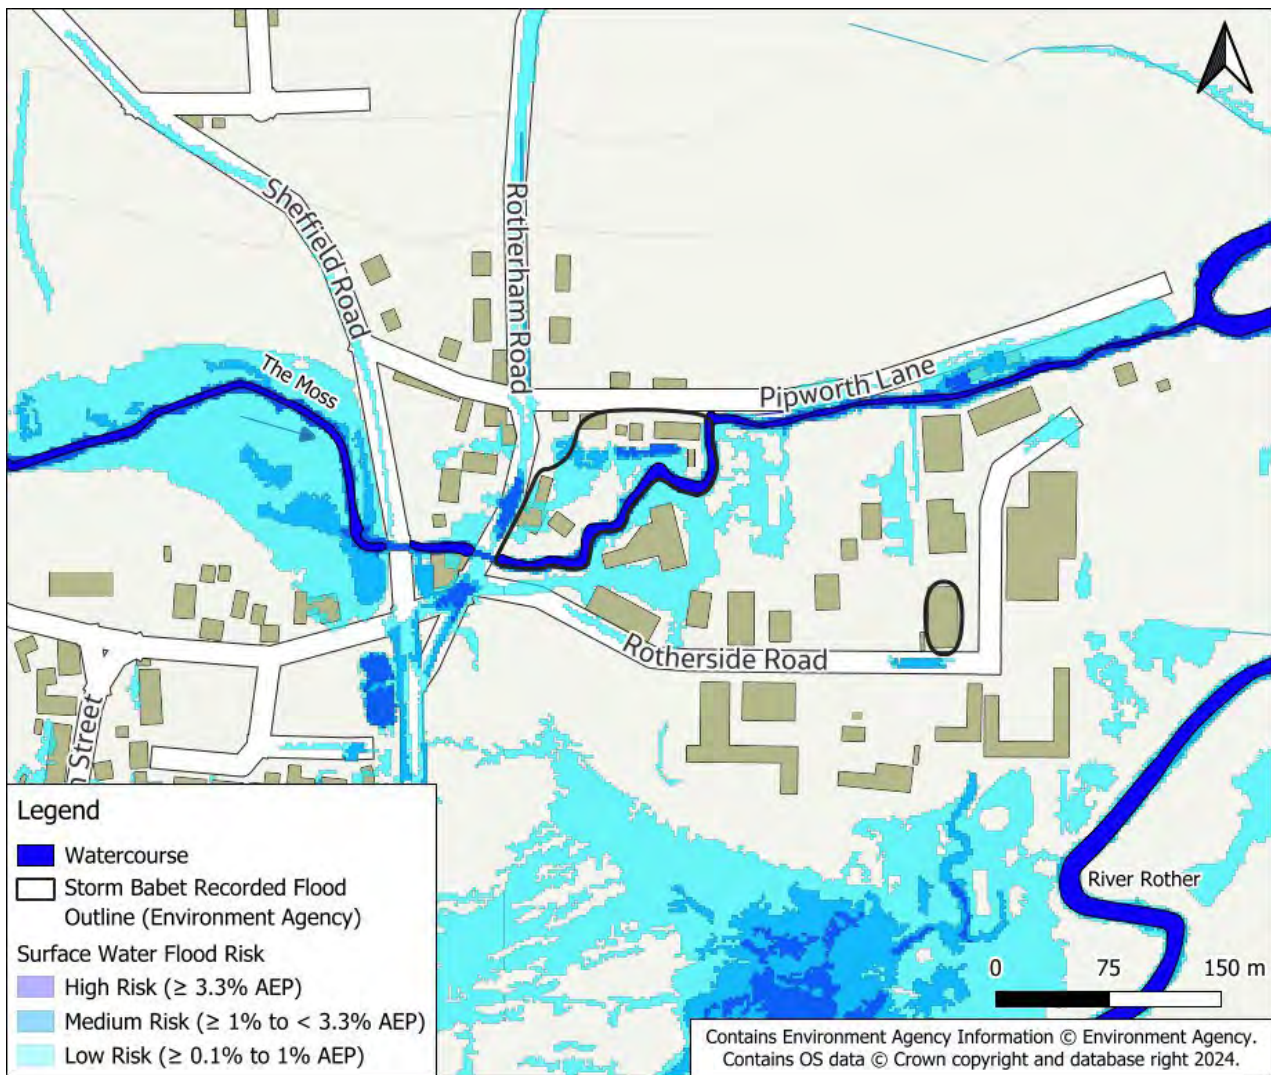
Figure 4-53: Map showing the chance in any given year of flooding from surface water at Eckington (Source: Long Term Flood Risk Map).

Based on the Long Term Flood Risk Map (<https://check-long-term-flood-risk.service.gov.uk/postcode>) there is only a low risk of surface water flooding. Low risk is defined as between 0.1% and 1% AEP of flooding.

Figure 4-53 shows the surface water flood risk for the community based on the national mapping referred to above.
