## 7. Trent Lower and Erewash Catchment

### 7.1 Trent Lower and Erewash Event Hydrology

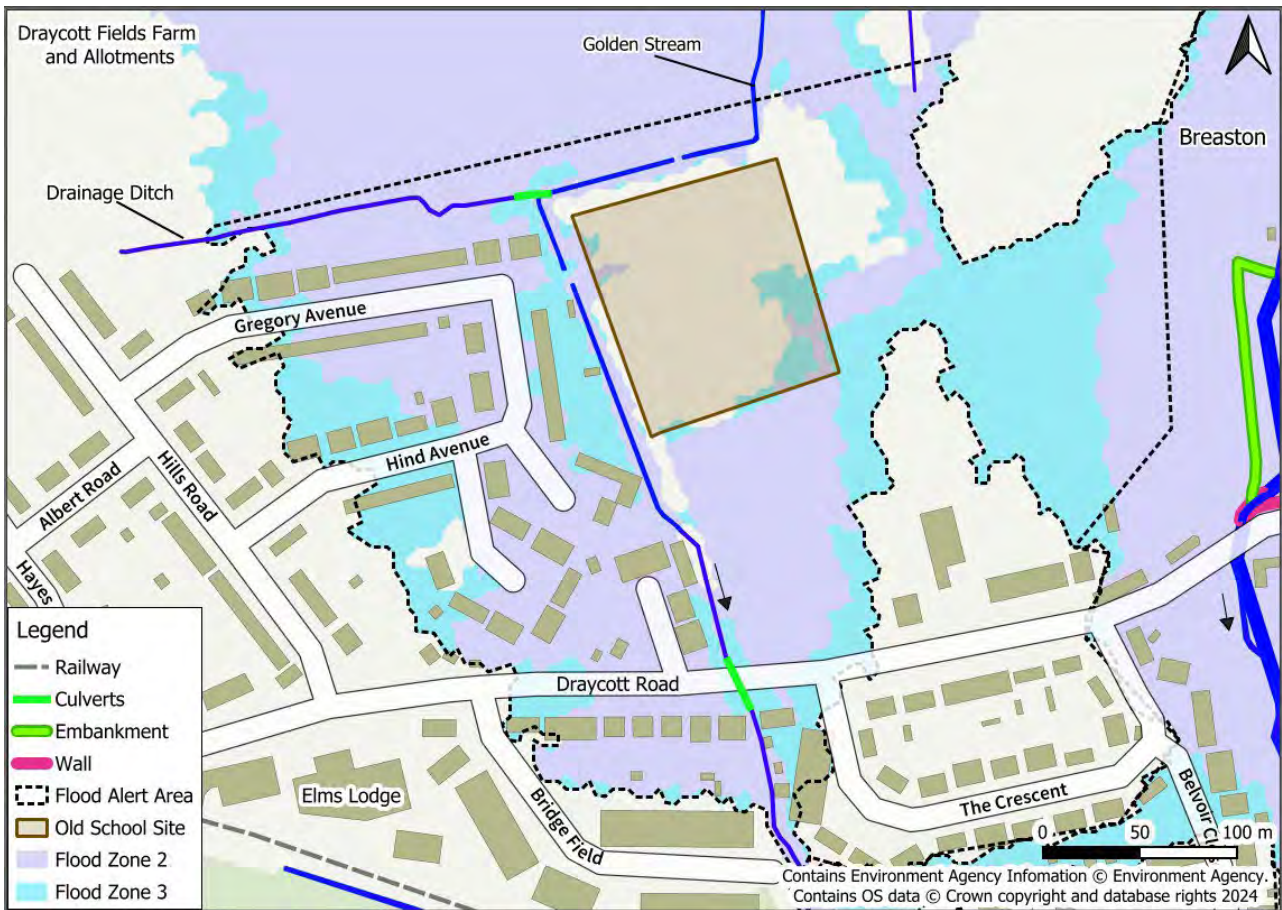
Figure 7-3: Local flood risk management assets, river flooding flow routes and Flood Zones at the Breaston community.

The Flood Map for Planning (<https://flood-map-for-planning.service.gov.uk/>) shows that all of the flooded homes within this community are at least in Flood Zone 2. Areas in Flood Zone 2 have between a 1% and 0.1% AEP of river flooding. Forty-two homes within the community, and four non-residential properties, are located within Flood Zone 3, see Figure 7-3. Flood Zone 3 means the properties are within the floodplain and have a greater than 1% AEP of flooding from rivers.

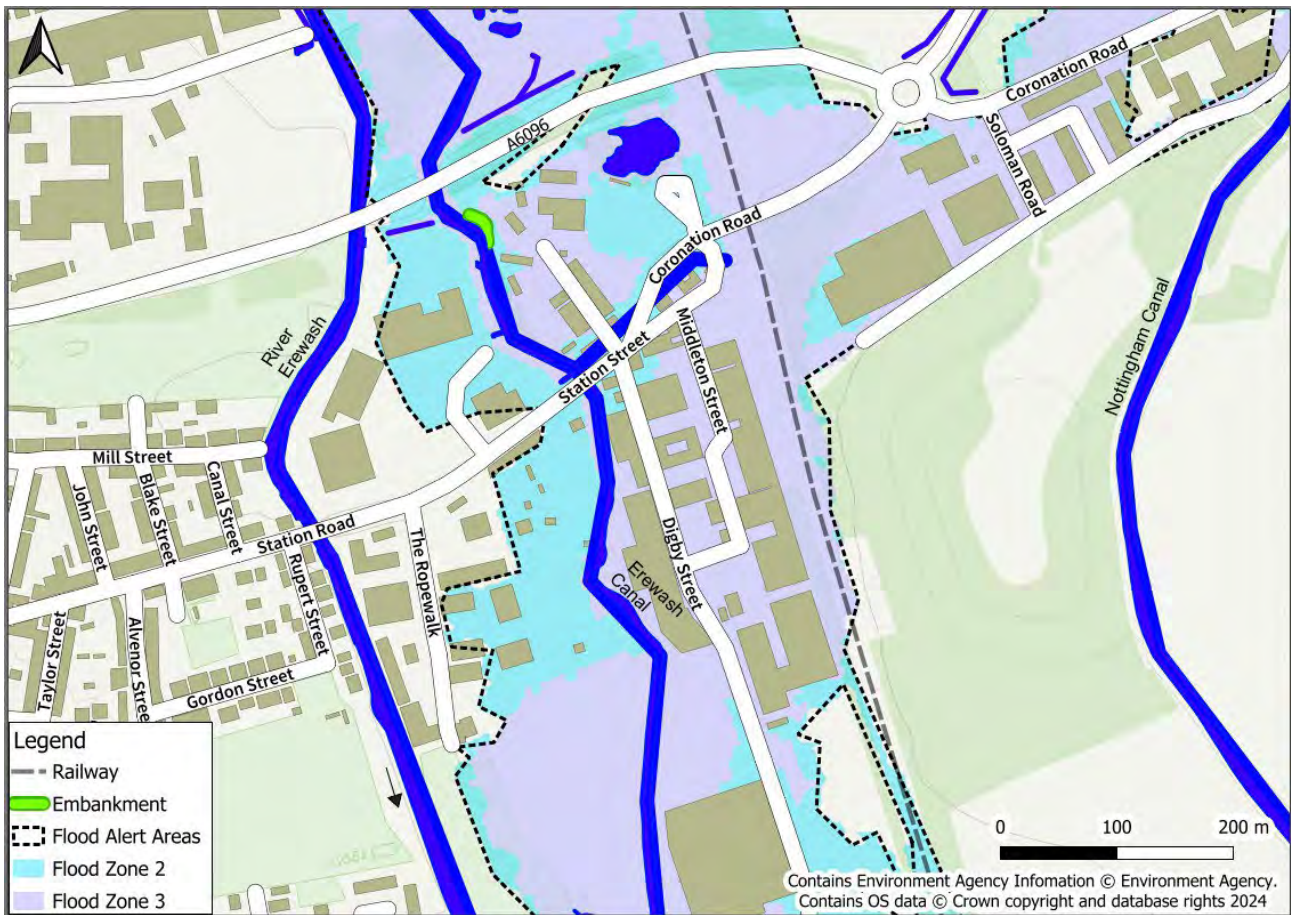
**Figure 7-7: Local Flood Risk Management Assets and Flood Zones.**

The Environment Agency Historic Flood Map indicates that some properties located along Digby Street, Station Street and Wentworth Street that flooded during Storm Babet have flooded previously. The Flood Map for Planning (<https://flood-map-for-planning.service.gov.uk/>) shows that all of the flooded homes within this community, aside from those along Station Road, are at least in Flood Zone 2. Areas in Flood Zone 2 have between a 1% and 0.1% AEP of river flooding. However, the majority of properties within the community are located within Flood Zone 3, see Figure 7-7. Flood Zone 3 means the properties have a greater than 1% AEP of flooding from rivers.

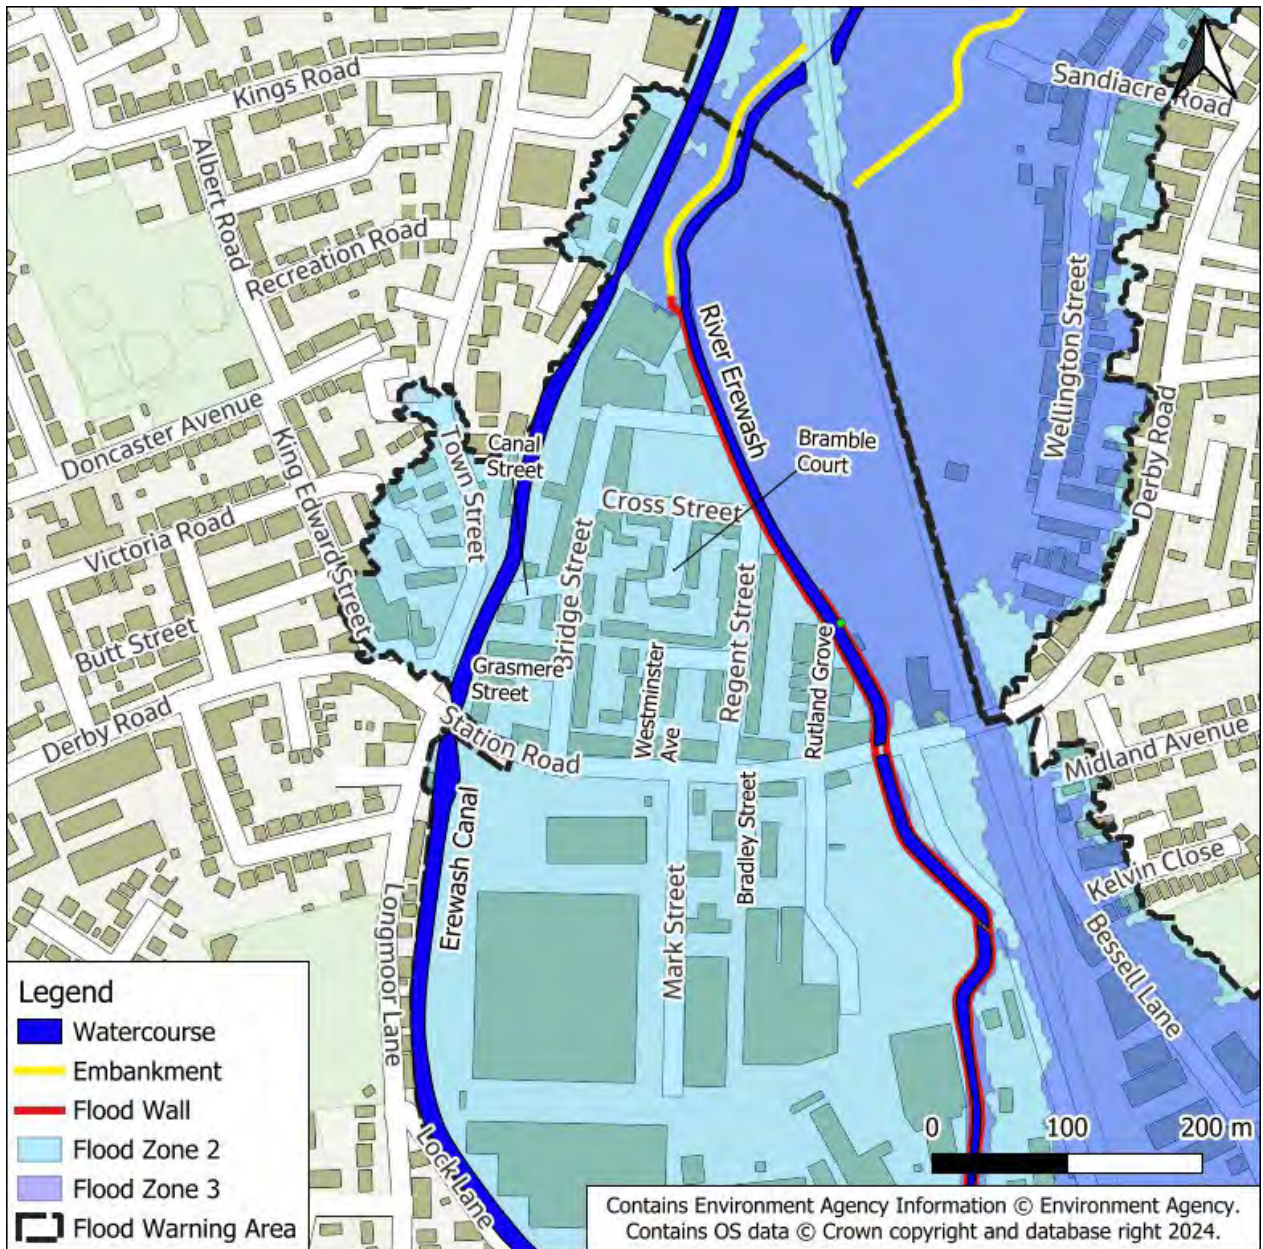
Figure 7-11: Current flood risk arrangements and flood zones at the community.

The Flood Map for Planning (<https://flood-map-for-planning.service.gov.uk/>) shows that all of the flooded properties within this community are in Flood Zone 2. Areas in Flood Zone 2 have between a 1% and 0.1% AEP of river flooding. Additionally, some homes have a high risk of surface water flooding, based on the Long Term Flood Risk Map (<https://check-long-term-flood-risk.service.gov.uk/postcode>). High risk is defined as greater than 3.3% AEP of flooding. Flood zones at Sandiacre are shown in Figure 7-11.

The Environment Agency's Asset Information and Maintenance Programme (<https://environment.data.gov.uk/asset-management/>) shows that there are three flood defence walls along the west bank of the River Erewash. The flood walls north of Station Road were constructed in the 1960s and the flood wall south of Station Road was constructed in 2012. These are all maintained by the Environment Agency. They provide a Standard of Protection up to a 1% AEP flood event. The east bank of the River Erewash also has flood defence walls that are maintained by the Environment Agency. Figure 7-11 shows the current flood risk arrangements for the community.

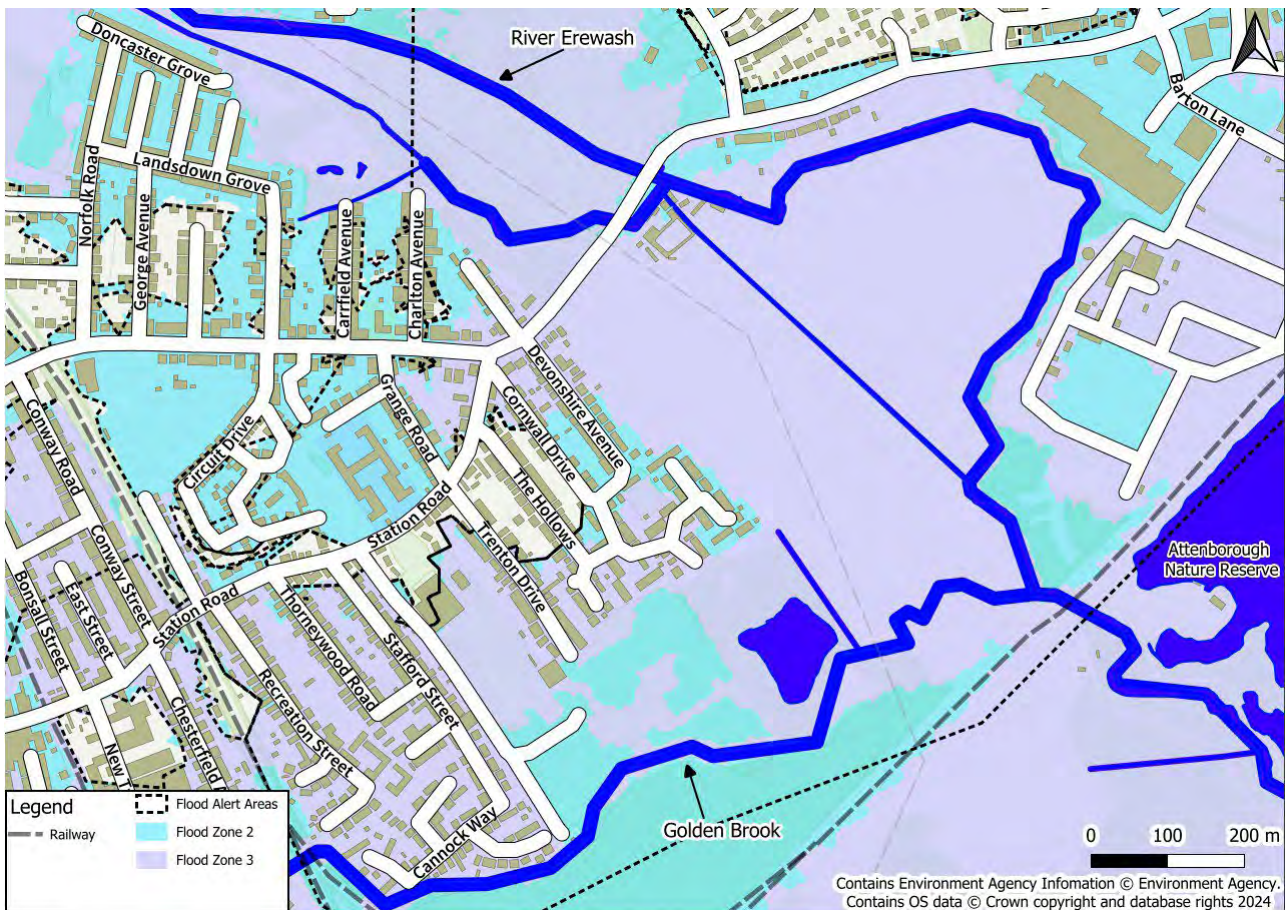
Figure 7-16: Flood Zones and Flood Alert area for the Long Eaton community.

The Flood Map for Planning (<https://flood-map-for-planning.service.gov.uk/>) shows that 97 of the 100 properties that flooded within this community are in Flood Zone 2, as shown in Figure 7-16 below. Areas in Flood Zone 2 have between a 1% and 0.1% AEP of river flooding. Thirteen properties within the community are located within Flood Zone 3, which means that they have a greater than 1% AEP of flooding from rivers.

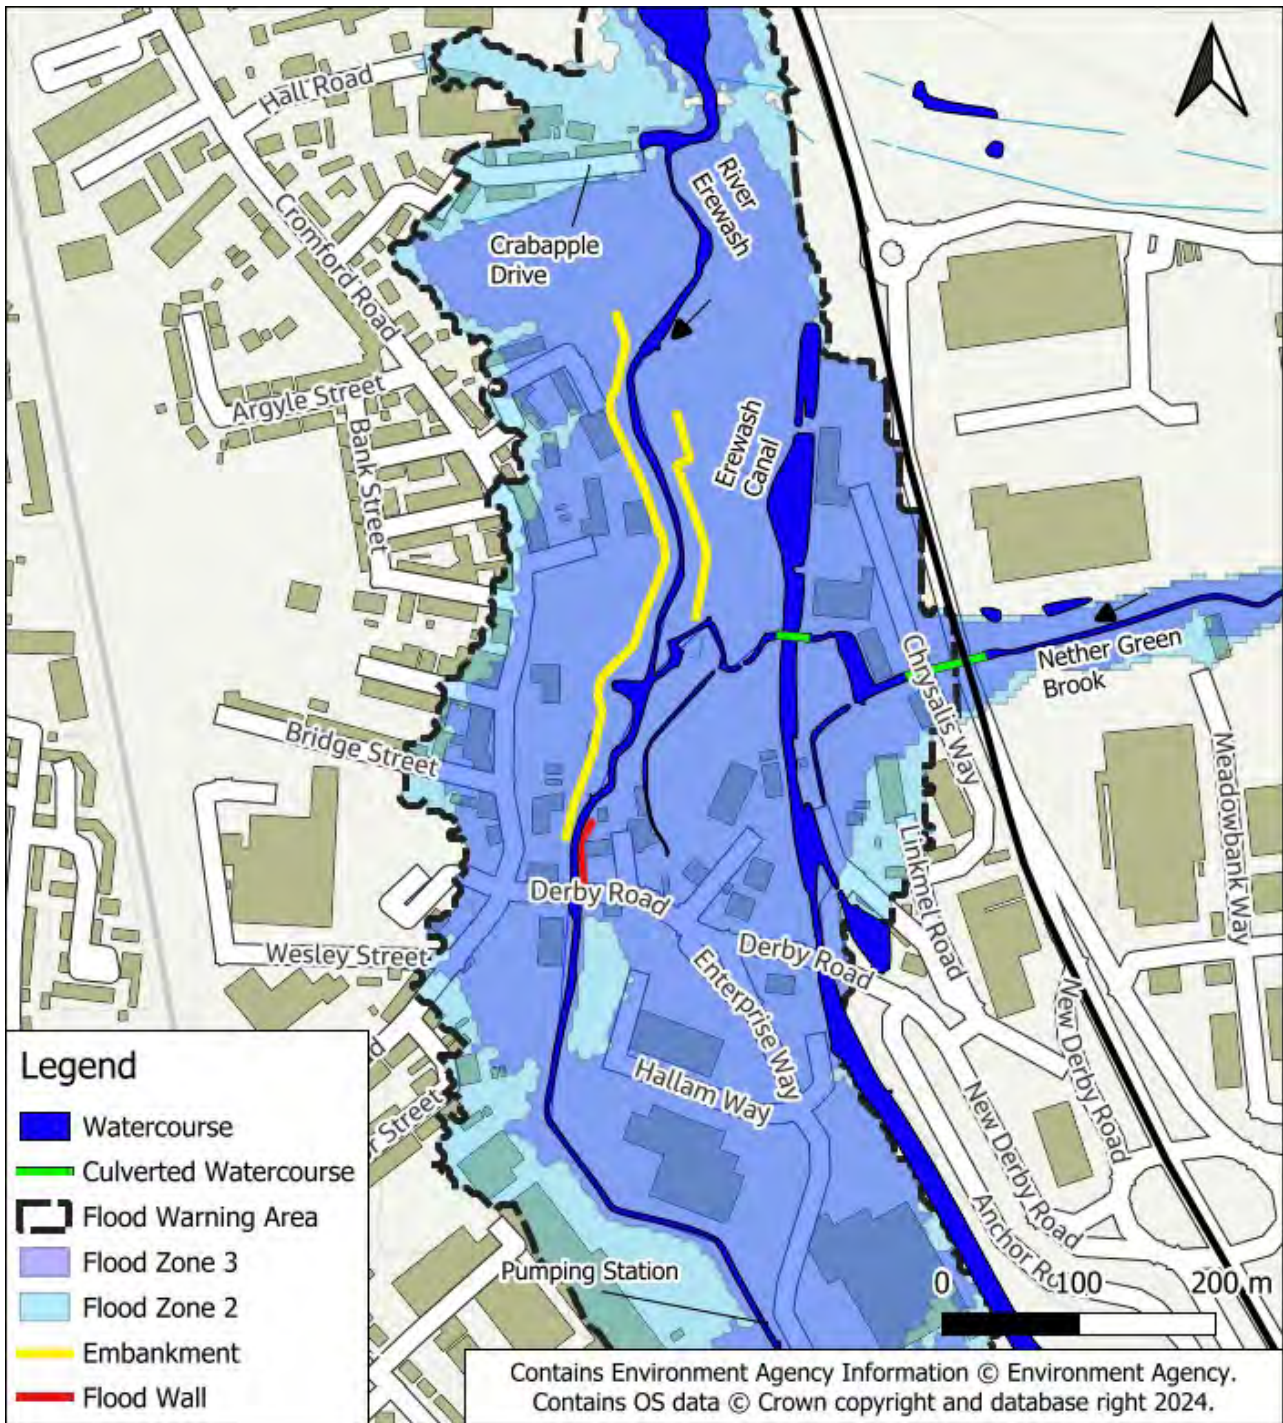
Figure 7-19: Local Flood Risk Management Assets and Flood Zones for the Langley Mill community.

The Flood Map for Planning (<https://flood-map-for-planning.service.gov.uk/>) shows that twenty-one residential and twenty-nine non-residential properties that flooded internally during Storm Babet are located within Flood Zone 2. The remaining properties are located in Flood Zone 3. Flood Zone 3 means the properties have a greater than 1% AEP of flooding from rivers. Flood Zone 2 means the properties have a lower probability of flooding from rivers of between a 1% and 0.1% AEP. Figure 7-19 below demonstrates the Flood Zones.

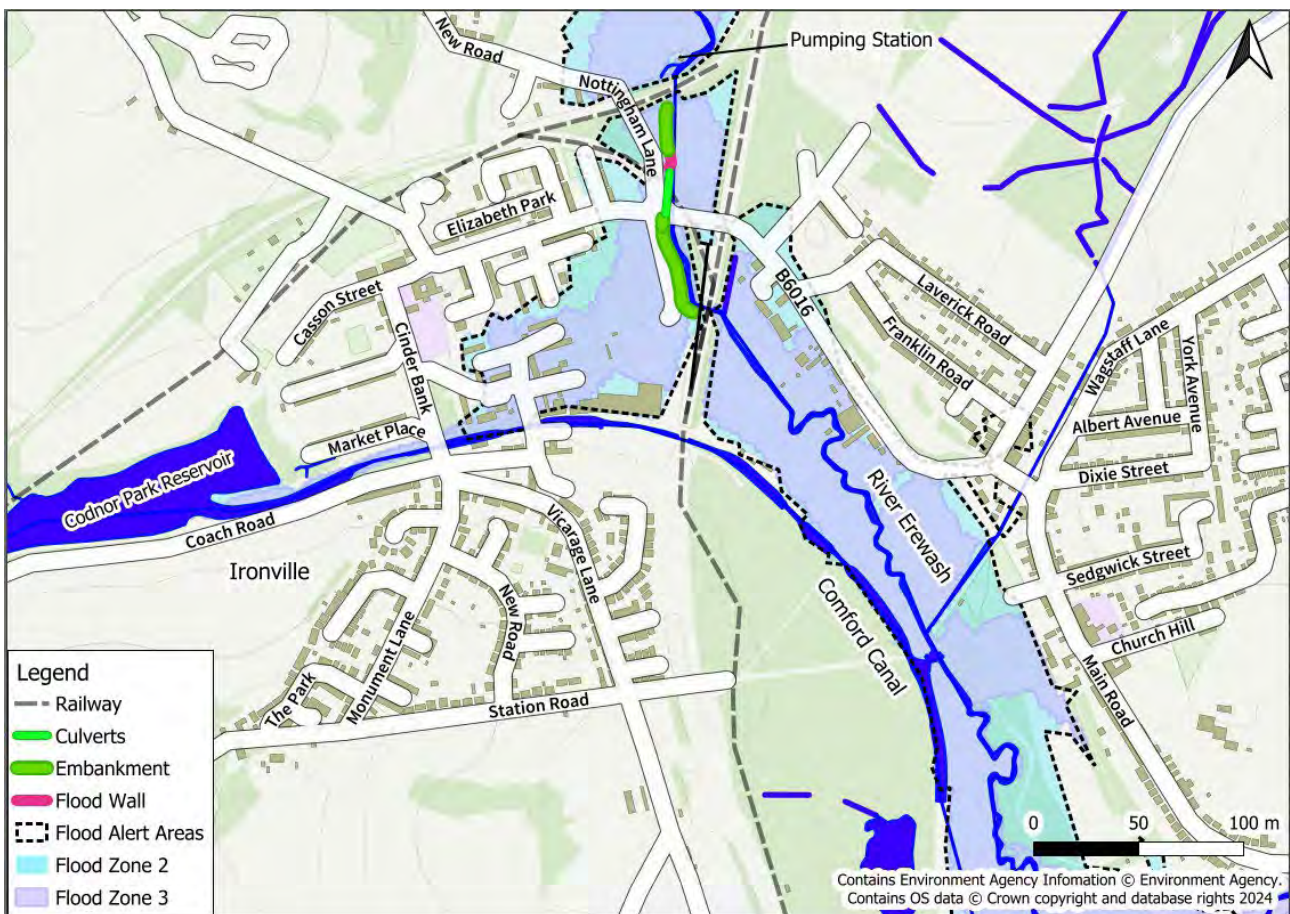
Figure 7-24: Local Flood Risk Management Assets, Flood Zones and flow directions for the Ironville community.

The Flood Map for Planning (<https://flood-map-for-planning.service.gov.uk/>) shows that all twenty-two homes, are located within Flood Zone 3. Flood Zone 3 means the properties have a greater than 1% Annual Exceedance Probability (AEP) of flooding from rivers. Figure 7-24 shows the Flood Zones in the Ironville community.

The Environment Agency's Asset Information and Maintenance Programme (<https://environment.data.gov.uk/asset-management/>) shows there are formal flood defence assets within the community. These defences reduce the flood risk to the Ironville community from the River Erewash, upstream and downstream of Victoria Street, the B6016. The Environment Agency maintain these assets. Figure 7-24 shows the current flood risk management arrangements within the area.

Embankments are the primary flood defence with a total length of 220m. A floodwall, 29m in length, is also located upstream of the community, north of Victoria Street (B6016). The Environment Agency have inspected all assets post flood event and assessed they all meet the required condition standard.

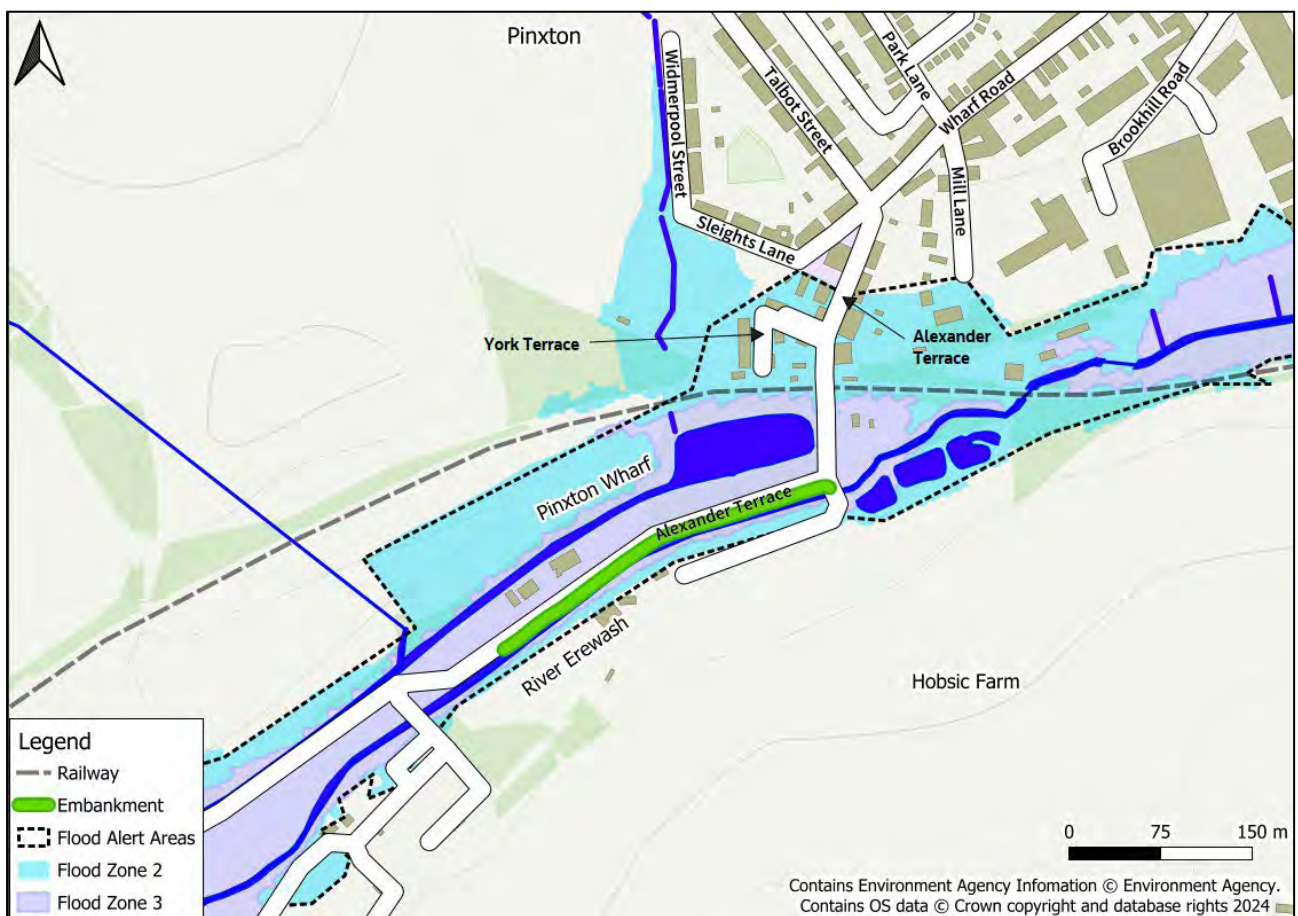
Figure 7-27: Current flood risk arrangements for the Pinxton community.

The Flood Map for Planning (<https://flood-map-for-planning.service.gov.uk/>) shows that all the flooded homes within this community are in Flood Zone 2. All the properties are within Flood Zone 2. Flood Zone 2 means the properties have a low probability of flooding from rivers (between a 1% and 0.1% AEP). Flood Zone 2 and Flood Zone 3 at Pinxton is shown in Figure 7-27.

Figure 7-27 shows the existing flood risk management arrangements. There is a 304m long flood defence embankment on the north bank of the River Erewash that runs from the Alexandra Terrace bridge to the STW. However, it only provides a 50% AEP standard of protection. The Environment Agency maintain this asset, but it is in very poor condition according to the Environment Agency Asset Information and Maintenance Programme system. The culvert indicated on Figure 7-27 is not Environment Agency owned and therefore the responsibility of the riparian owner.

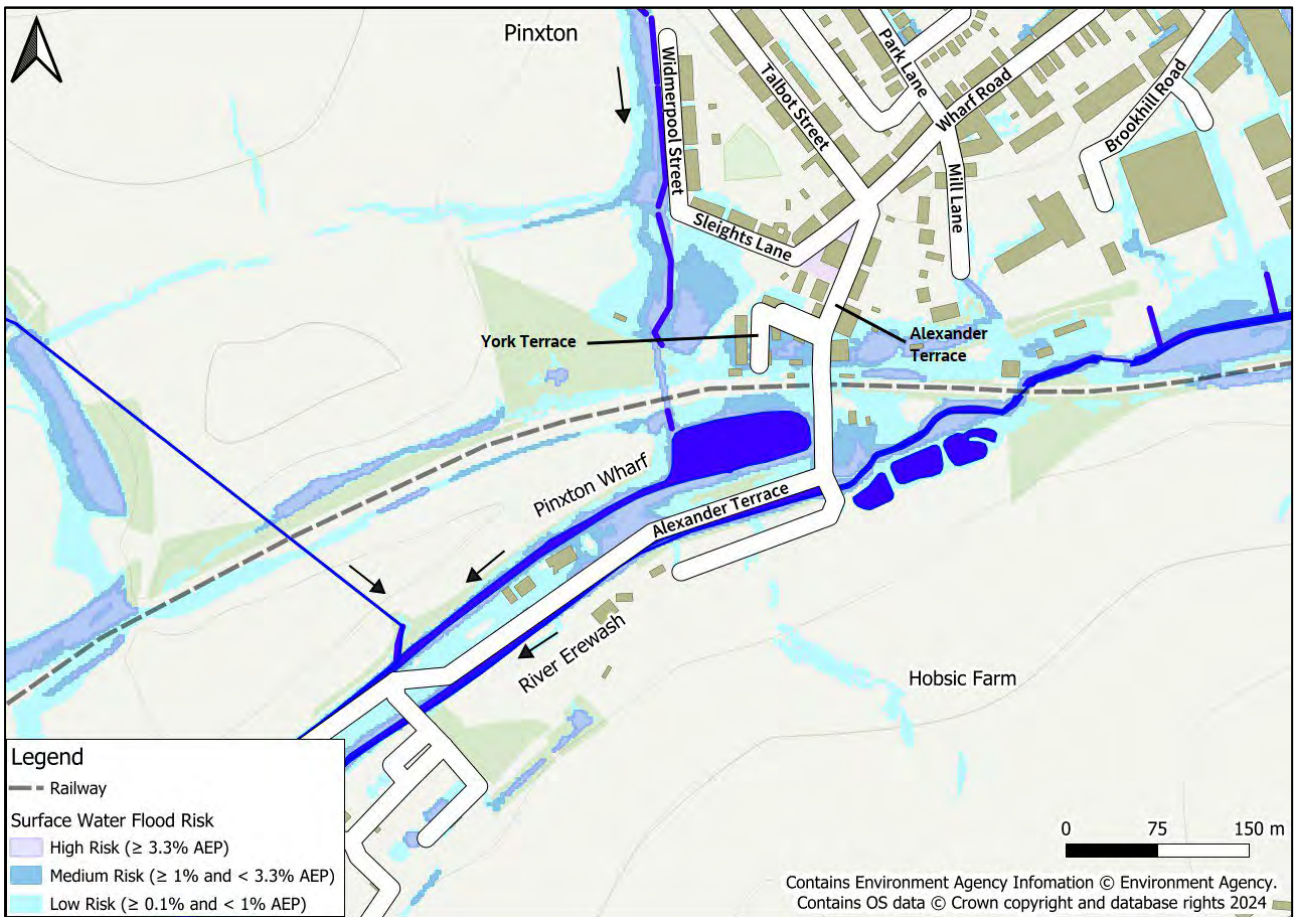
Figure 7-28: Map showing the chance in any given year of flooding from surface water at Pinxton (Source: Long Term Flood Risk Map).

The Environment Agency Long Term Flood Risk Map (<https://check-long-term-flood-risk.service.gov.uk/postcode>) indicates that all the properties flooded are at risk of flooding from surface water. Some properties on Alexander Terrace and York Terrace are at high risk of flooding from surface water, meaning more than 3.3% AEP. Figure 7-28 shows the surface water flood risk mentioned.

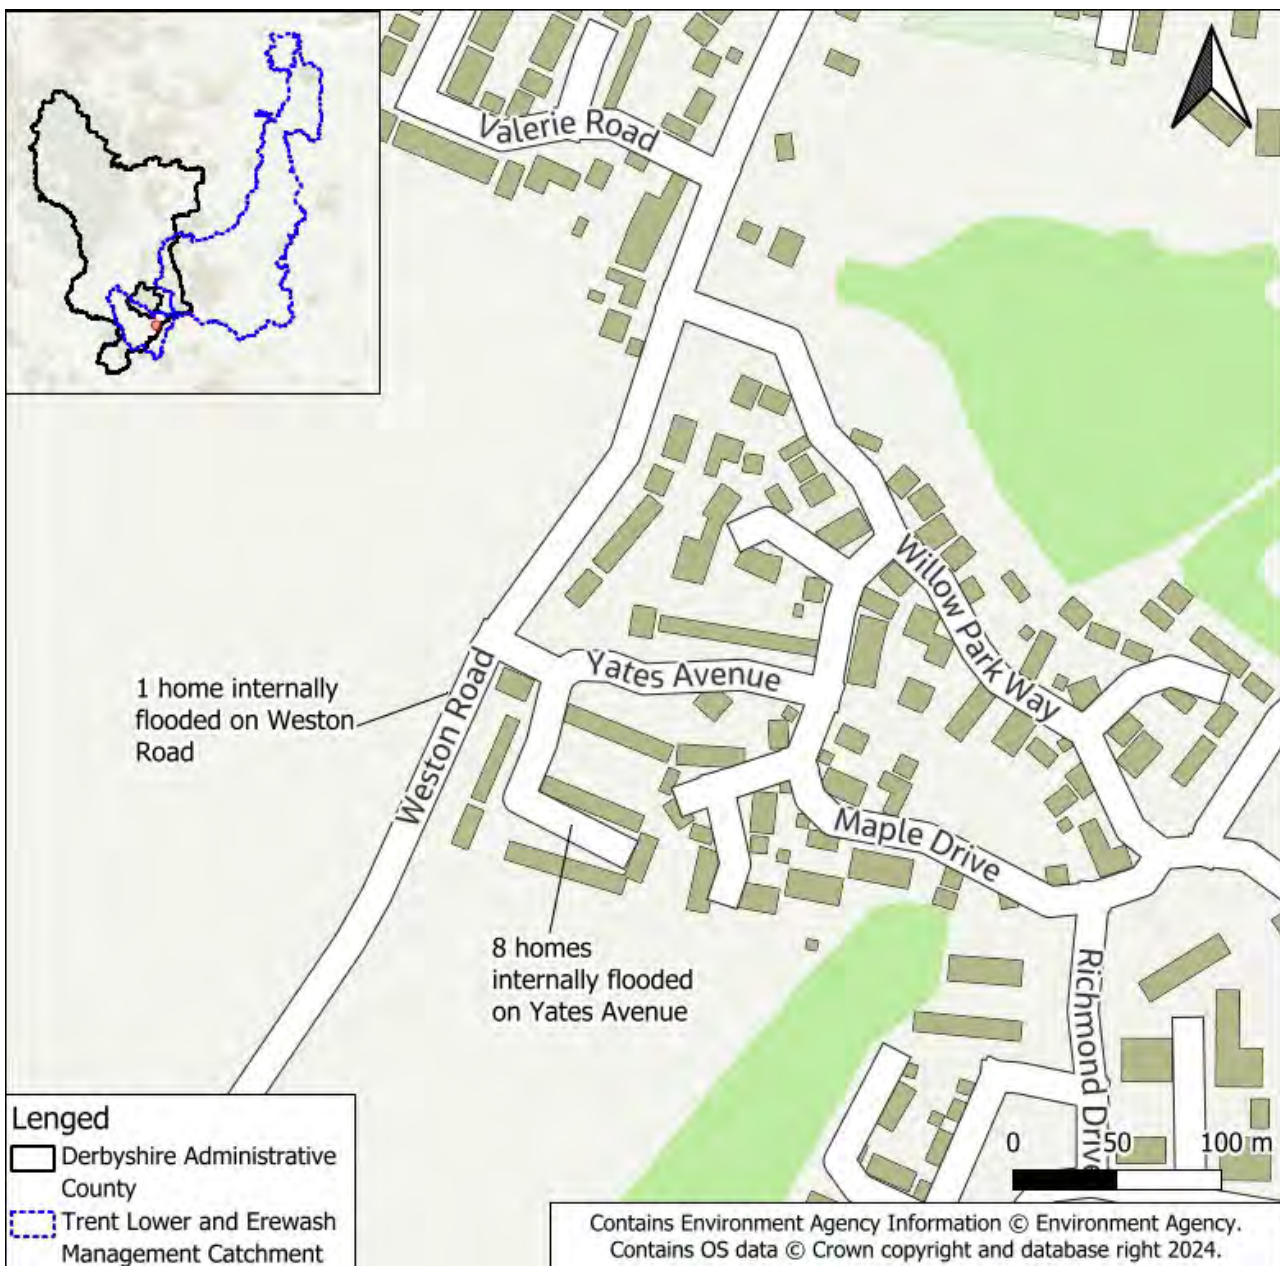
Figure 7-31: Local Flood Risk Management Assets and Flood Zones for the Langley Mill community.

Nine residential properties suffered from internal flooding in Aston-on-Trent as a result of Storm Babet. Aston-on-Trent is in South Derbyshire. Both the Trent and Mersey Canal and River Trent are located approximately 1 to 3km to the south and east of the village. The River Trent is designated as a main river. Figure 7-31 shows the Aston-On-Trent community.

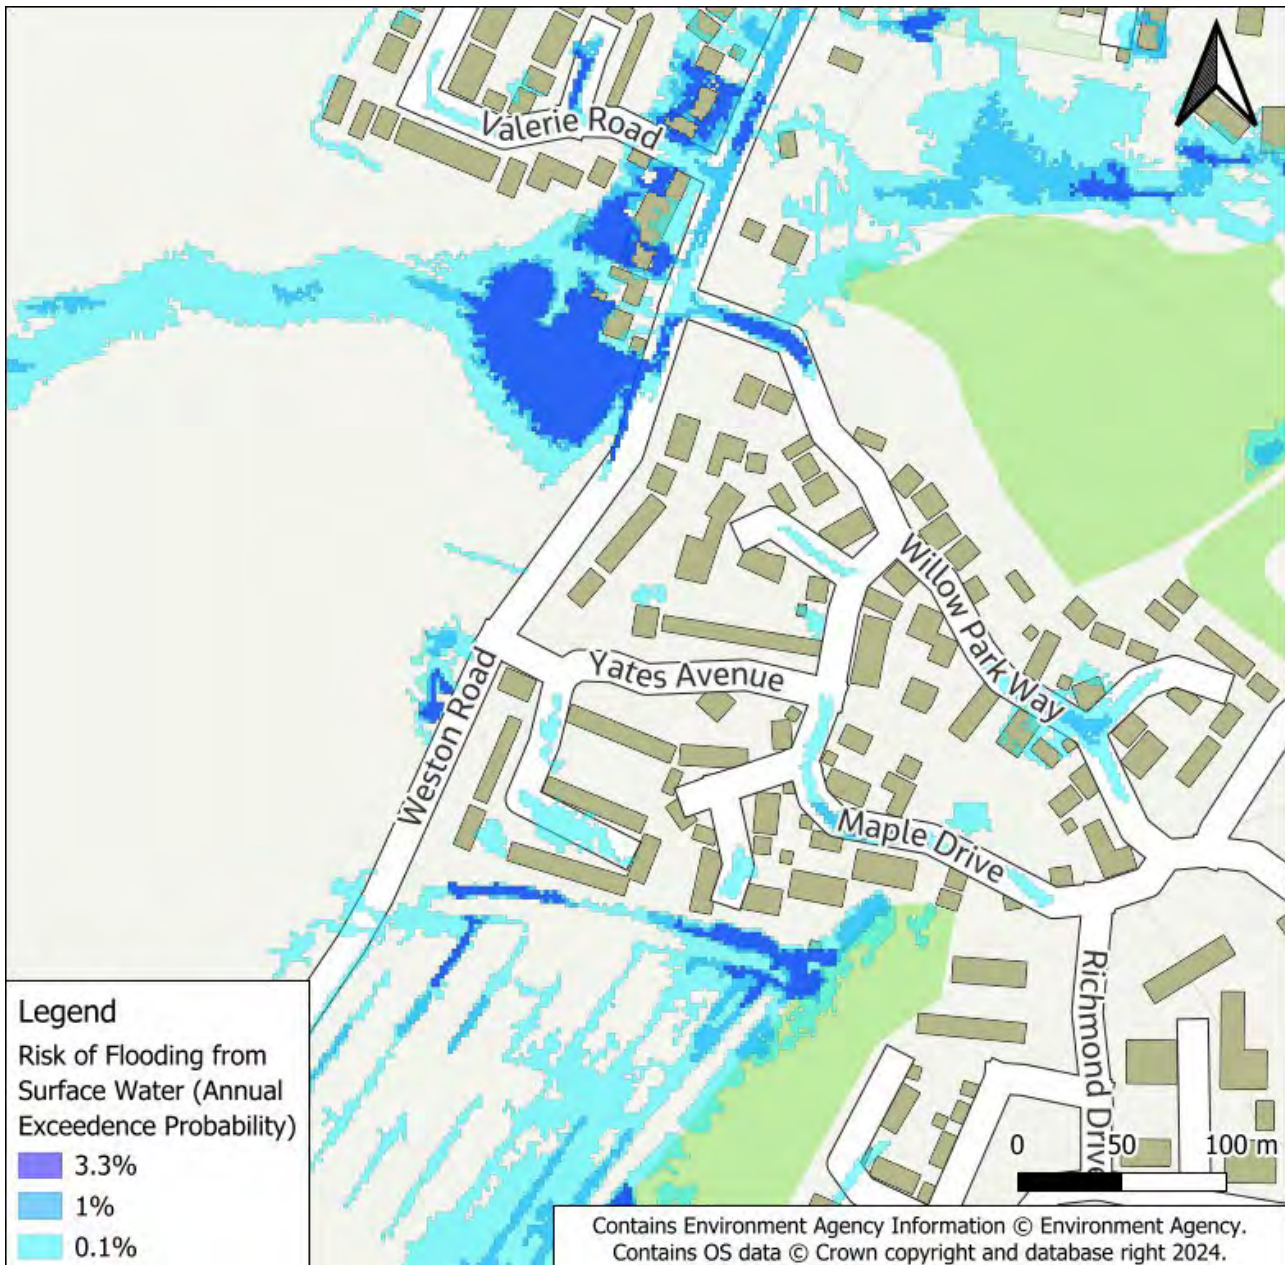
Figure 7-32: Map showing the chance in any given year of flooding from surface water at Aston-on-Trent (Source: Long Term Flood Risk Map).

The Long Term Flood Risk Map (<https://check-long-term-flood-risk.service.gov.uk/postcode>) shows a high likelihood of surface water flood risk to areas of Weston Road, Yates Avenue and Valerie Road with some properties having a more than 3.3% Annual Exceedance Probability (AEP) of surface water flood risk. This is shown in Figure 7-32 below.
