3. Derwent Catchment

3.1 Derwent Catchment Event Hydrology

3.2 Community Impacts - Lilac Way

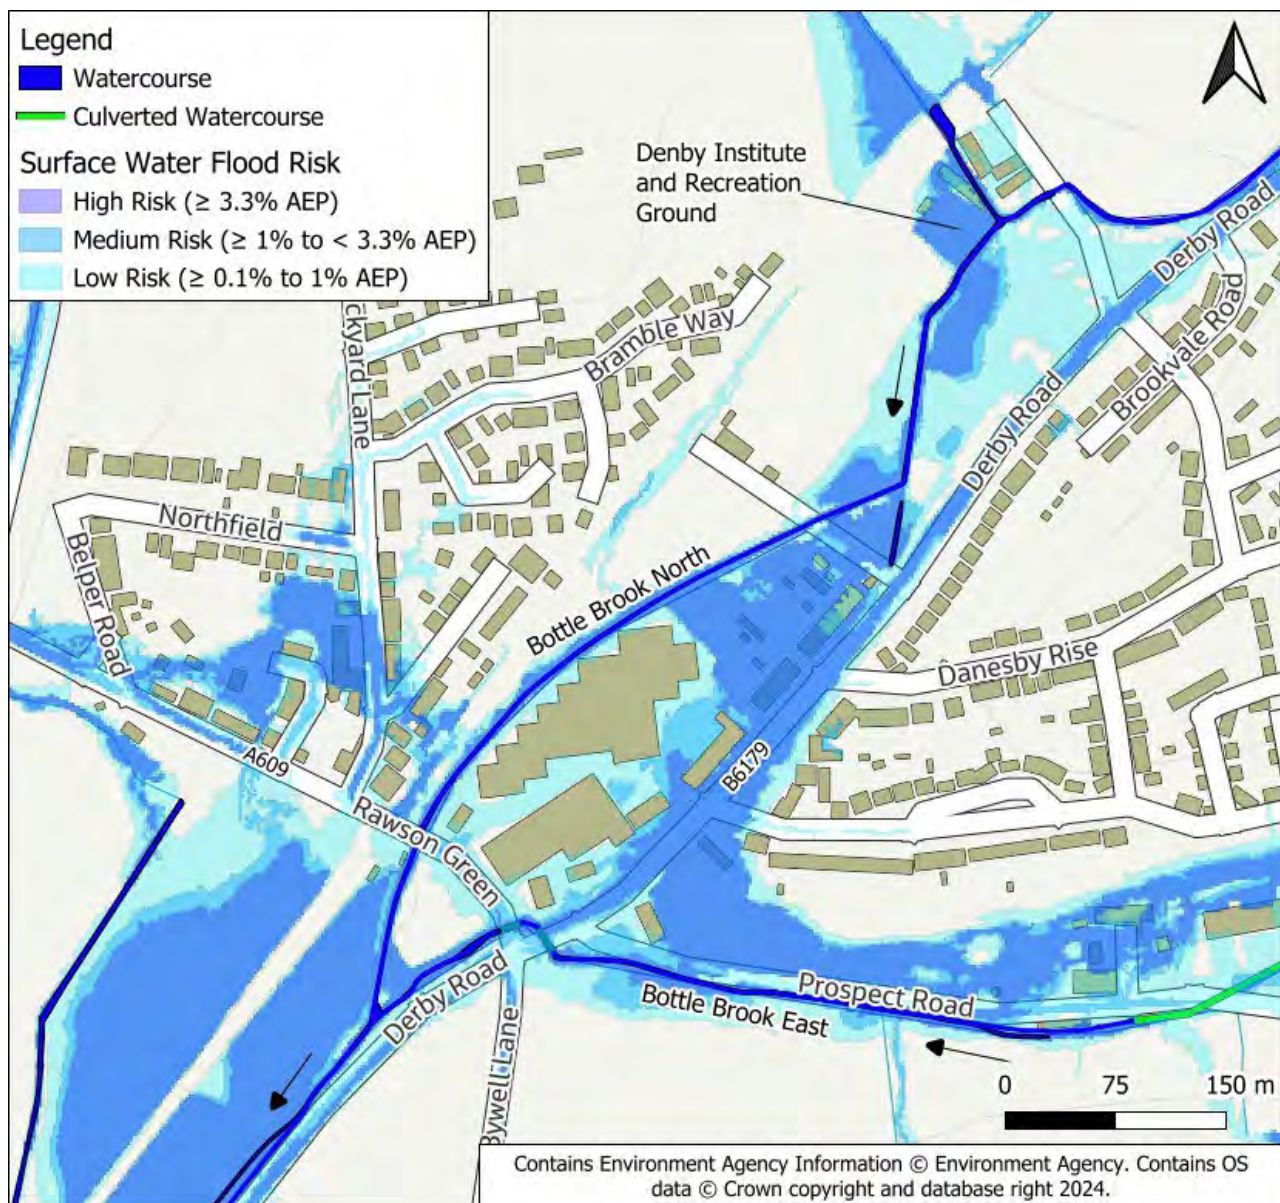
Figure 3-23: Map showing the chance in any given year of flooding from surface water at Denby Bottles. (Source: Long Term Flood Risk Map)

Additionally, based on the Long Term Flood Risk Map (<https://check-long-term-flood-risk.service.gov.uk/postcode>), much of Denby Bottles and Rawson Green is at a high risk of surface water flooding, meaning more than a 3.3% AEP. This surface water map includes all properties that suffered internal flooding during Storm Babet. Figure 3-23 shows the chance in any given year of flooding from surface water at Denby Bottles.

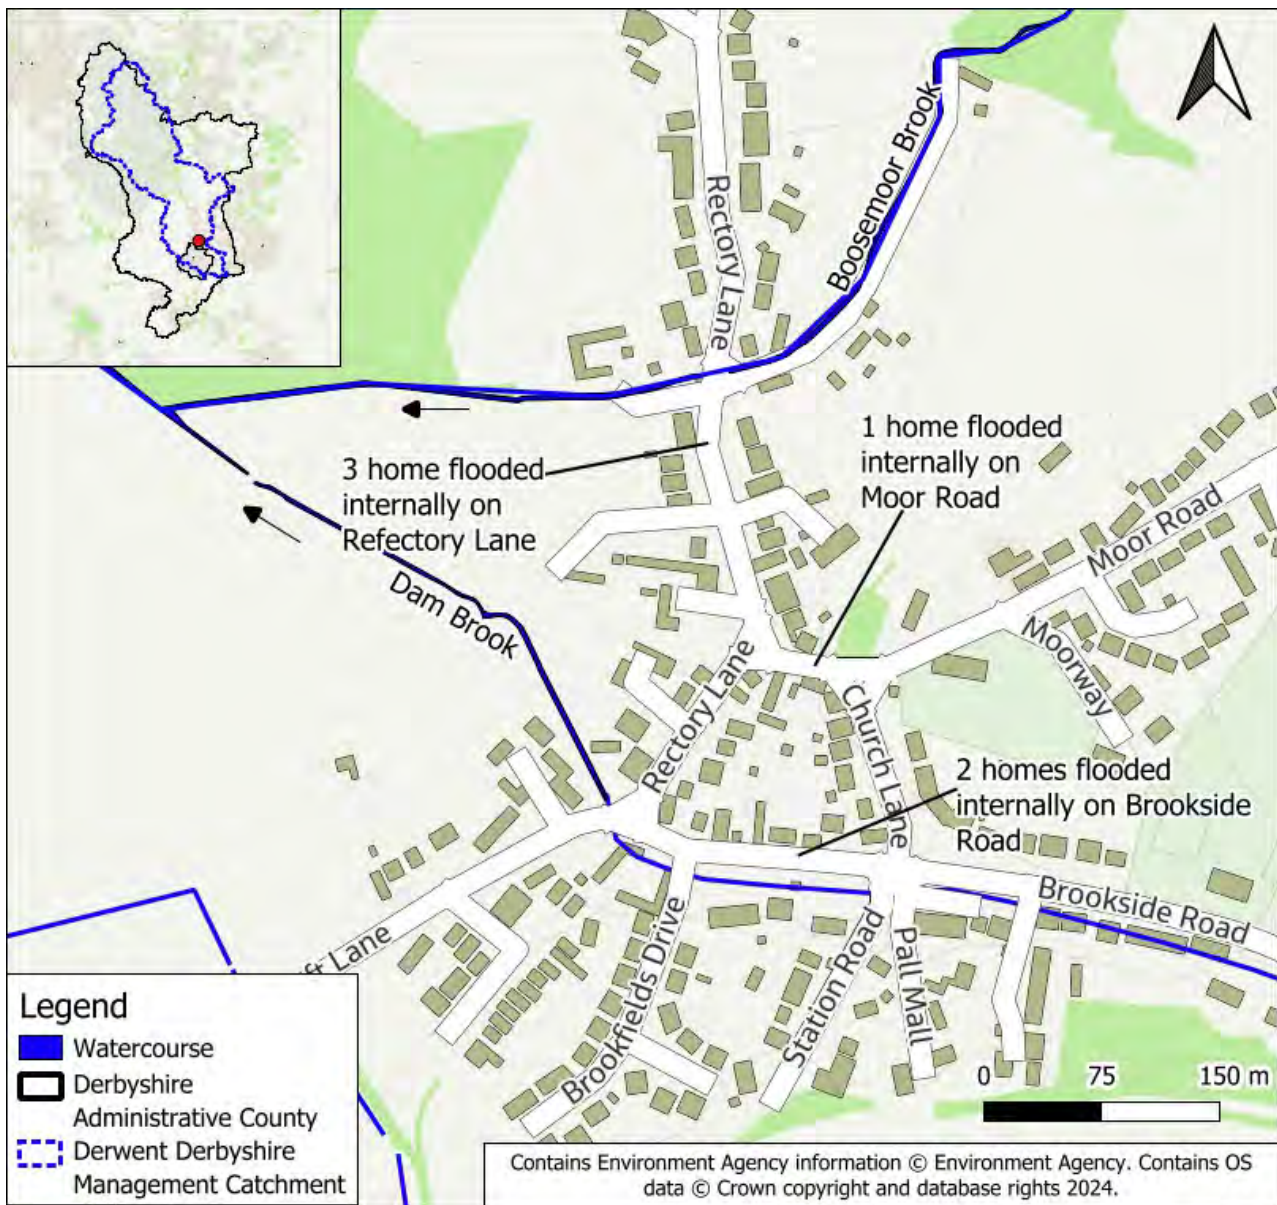
Figure 3-25: Overview Map of Breadsall community.

Breadsall is a village and civil parish in the Borough of Erewash in Derbyshire, England. Six residential properties suffered internal flooding across the village in Storm Babet. Figure 3-25 shows an overview of the Breadsall community.

The area flooded is close to Dam Brook and Boosemoor Brook, which are ordinary watercourses and tributaries of the River Derwent. Dam Brook and Boosemoor Brook both flow through Breadsall in a westward direction towards the River Derwent. Dam Brook is south of Boosemoor Brook. The River Derwent is approximately 1km to the west of Breadsall. Flooding was a result of Dam Brook and Boosemoor Brook reaching capacity and overflowing their banks during Storm Babet.

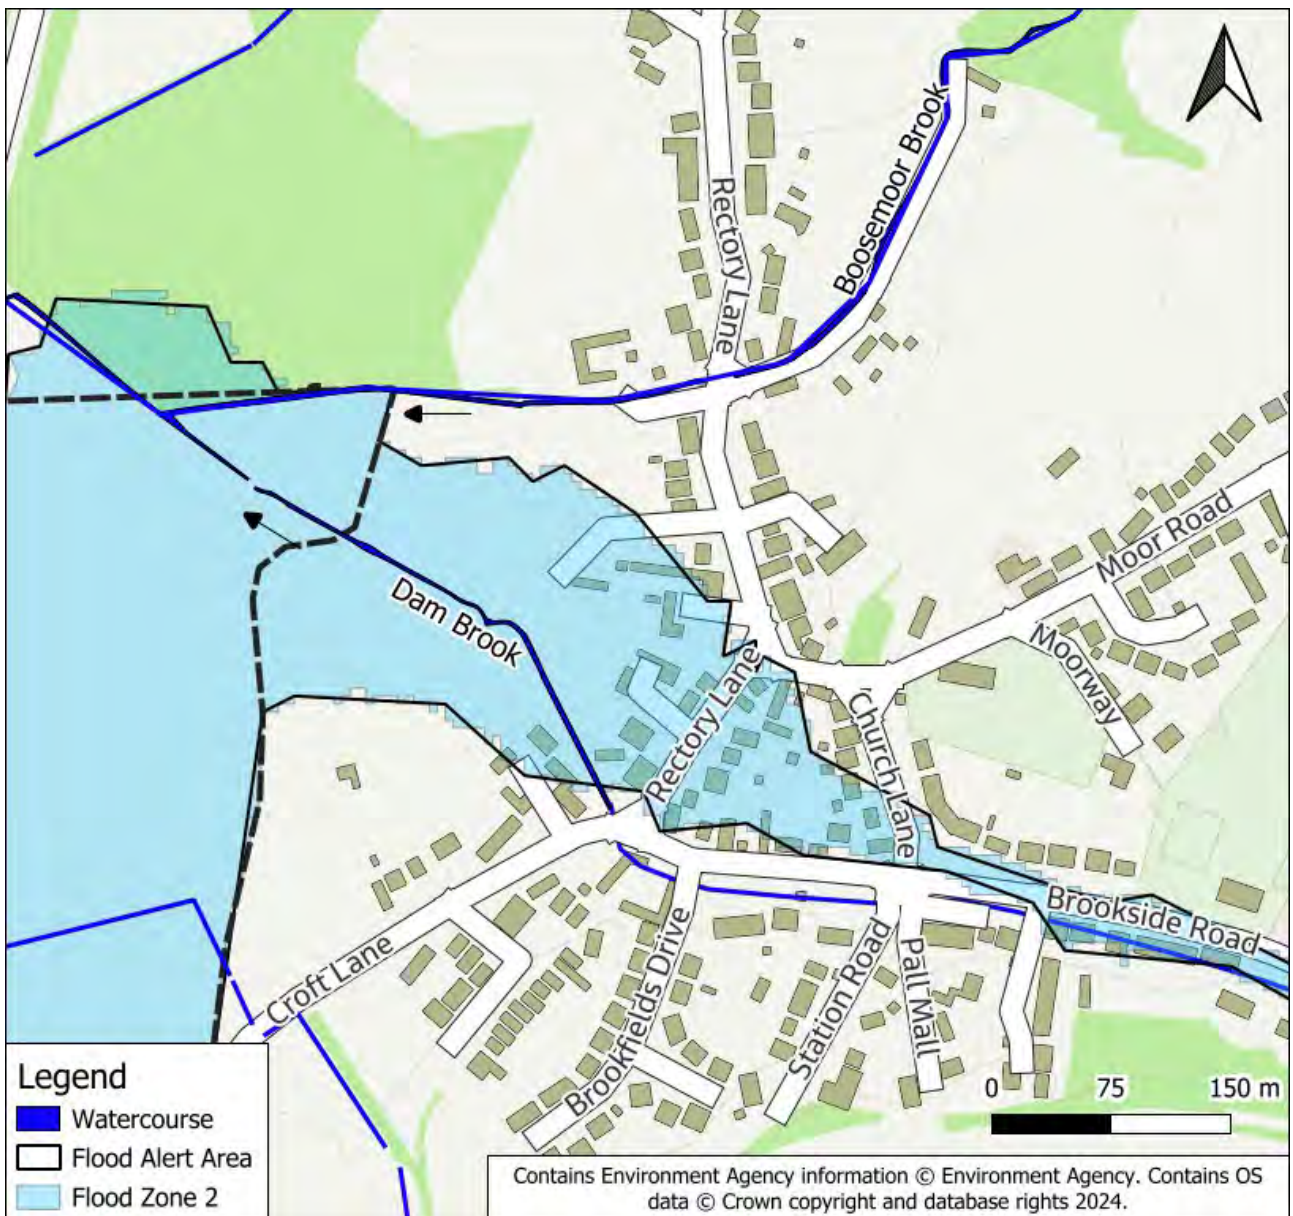
Figure 3-26: Flood Zone 2 and Flood Alert area coverage at Breadsall.

The Flood Map for Planning (<https://flood-map-for-planning.service.gov.uk/>) shows that all the flooded homes within this community are in Flood Zone 2 extending into the village. Properties in Flood Zone 2 have between a 1% and 0.1% Annual Exceedance Probability (AEP) of river flooding. Figure 3-26 shows the extent of Flood Zone 2 to at Breadsall.

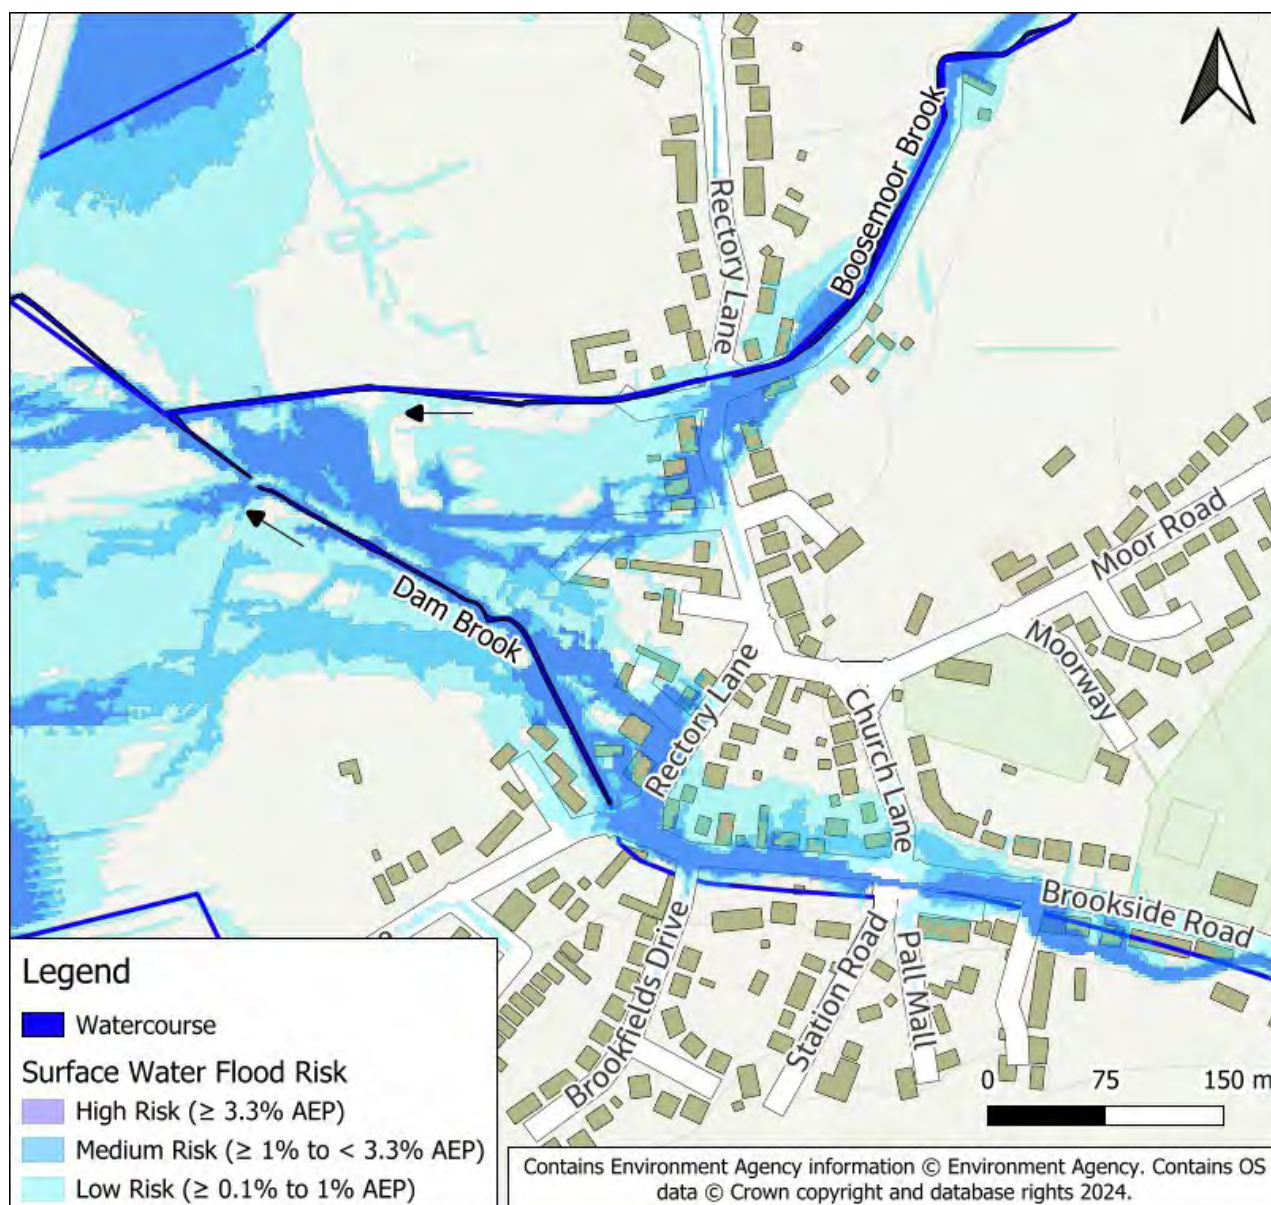
Figure 3-27: Map showing the chance in any given year of flooding from surface water at Breadsall (Source: Long Term Flood Risk Map)

All the properties that were internally flooded are at high risk (more than 3.3%) chance of surface water flooding based on the Long Term Flood Risk Map (<https://check-long-term-flood-risk.service.gov.uk/postcode>). The main source of surface water risk is likely to be related to local topography and drainage networks being unable to discharge to Dam Brook and Boosemoor Brook during heavy rainfall events. Figure 3-27 shows the chance in any given year of flooding from surface water at Breadsall.

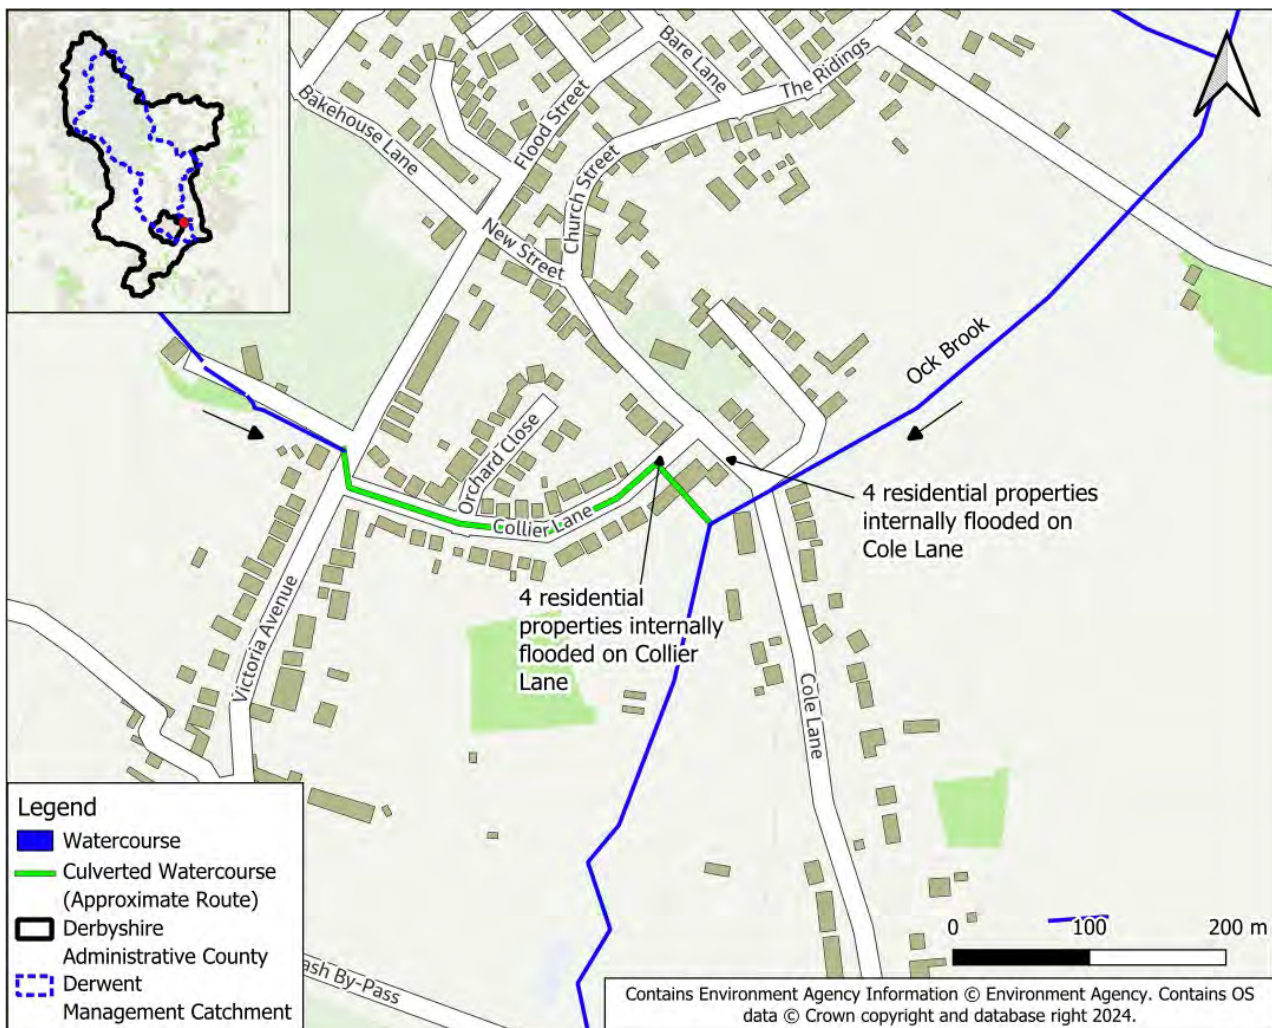
Figure 3-30: Map of the Ockbrook community where internal property flooding occurred.

Figure 3-30 below shows the community affected by flooding.

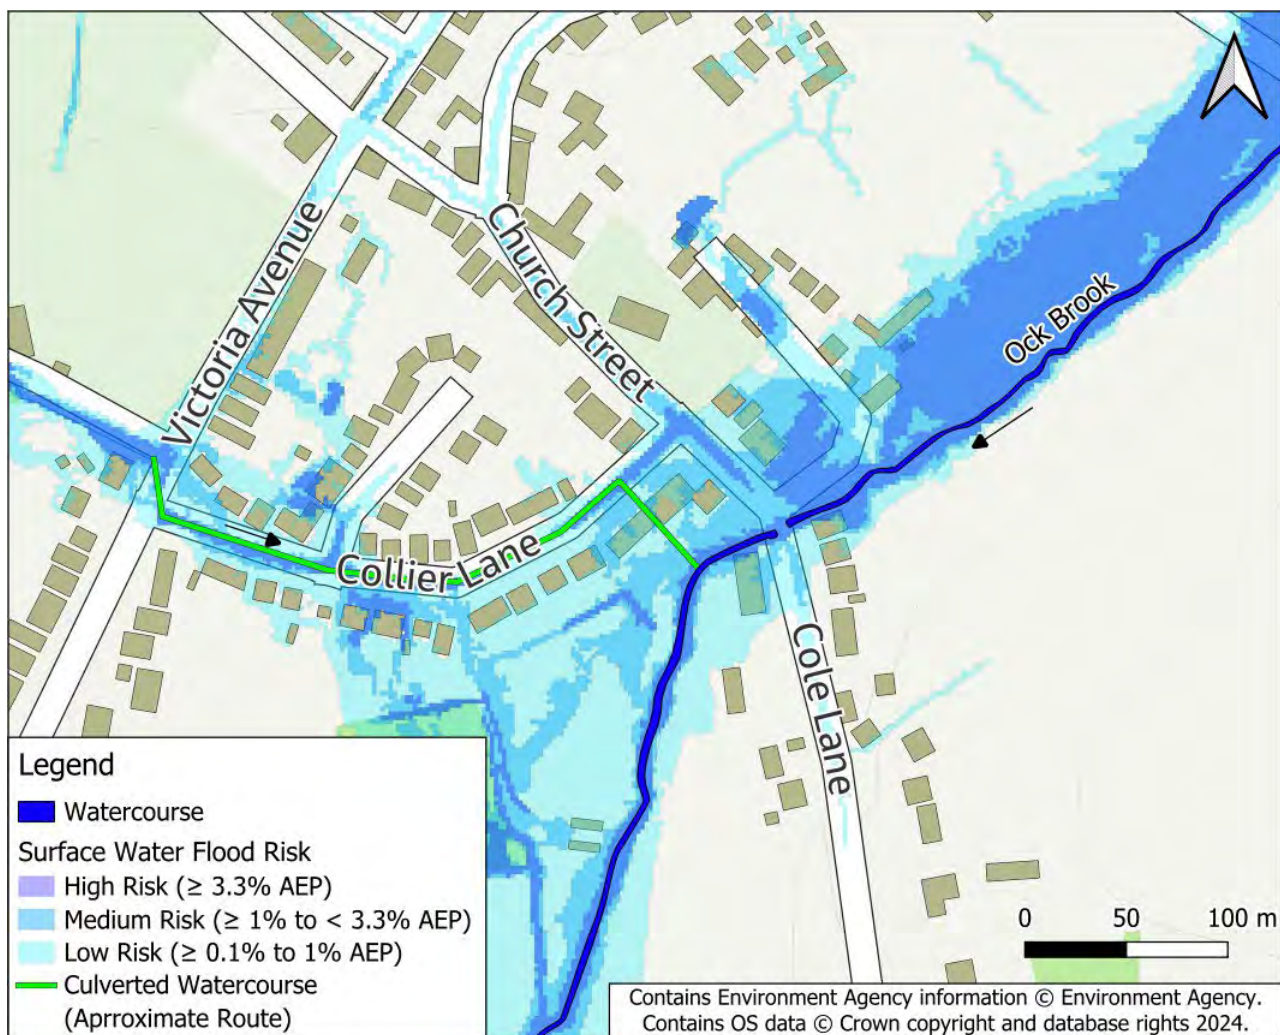
Figure 3-31: Map showing the chance in any given year of flooding from surface water at Ockbrook (Source: Long Term Flood Risk Map)

Based on the Long Term Flood Risk Map (<https://check-long-term-flood-risk.service.gov.uk/postcode>), the homes on Cole Lane and Collier Lane both have a mix of high (more than 3.3% AEP) and medium (between 1% and 3.3% AEP) chance of surface water flooding. Figure 3-31 shows the surface water flood risk described.

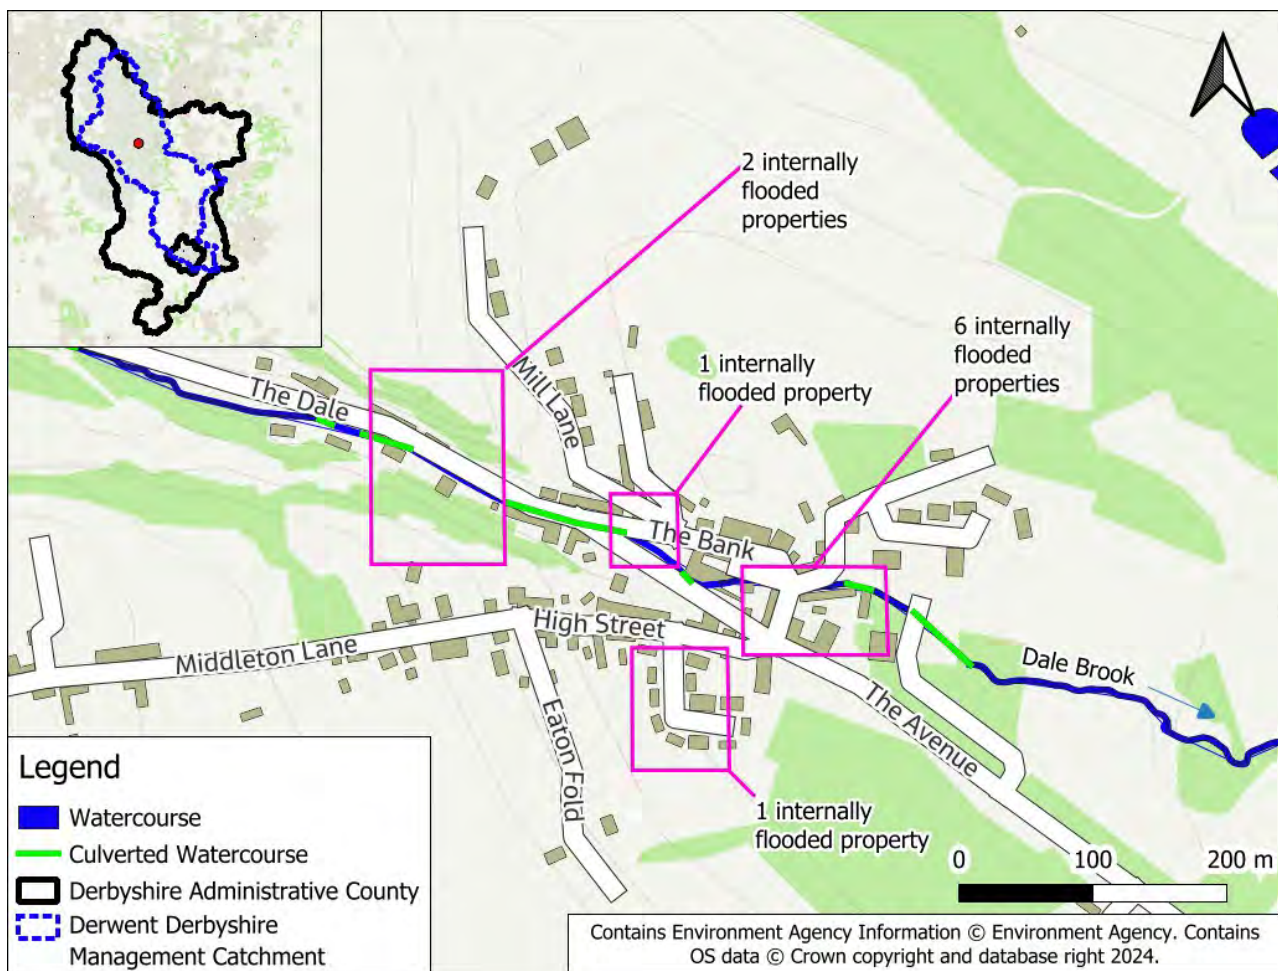
Figure 3-33: Overview of Stoney Middleton

Stoney Middleton is a village in the Derbyshire Dales, England. A group of ten properties suffered internal flooding as a result of Storm Babet. Seven of the properties were residential and the other three were non-residential. The area flooded is close to Dale Brook, which flows from west to east through the village. Dale Brook flows into Stoke Brook, which is a tributary of the River Derwent to the east. All watercourses listed are designated main rivers. Figure 3-33 below shows the location of the affected community.

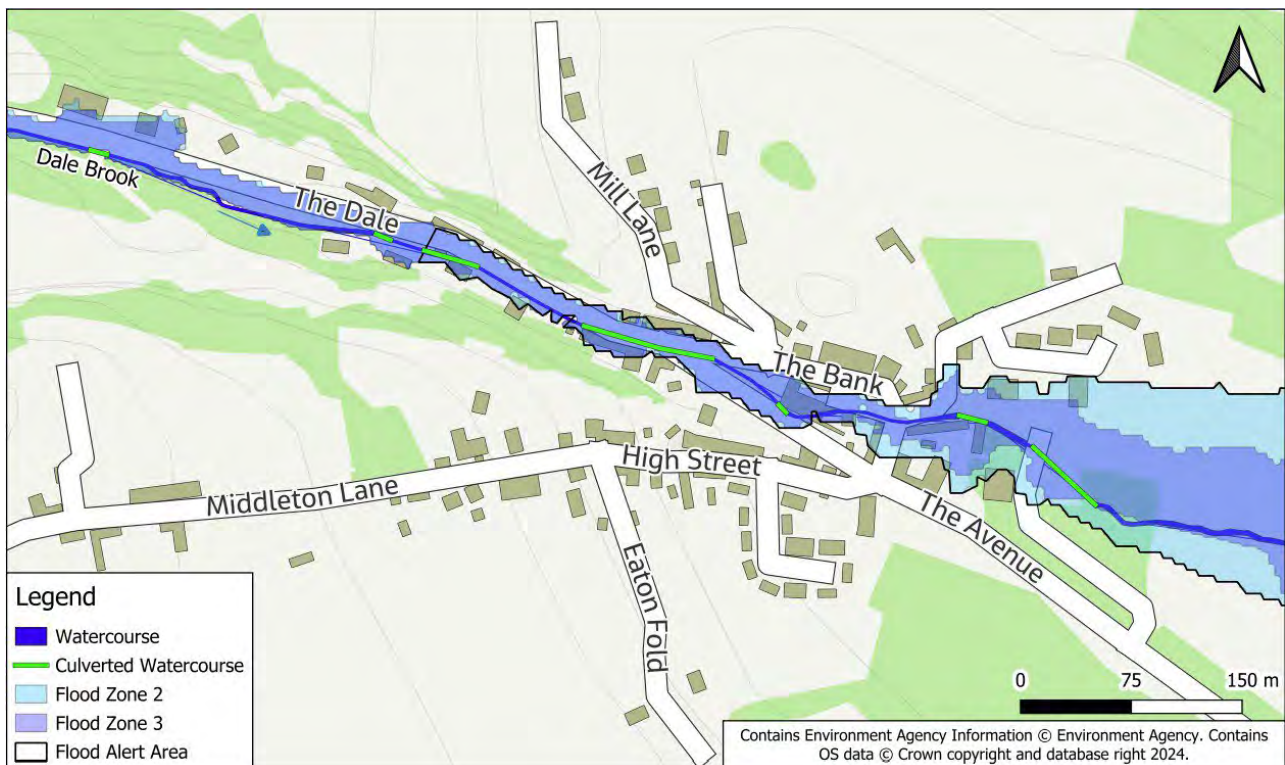
Figure 3-34: Extent of Flood Zones at Stoney Middleton

The Flood Map for Planning (<https://flood-map-for-planning.service.gov.uk/>) shows that all the flooded homes within this community are in Flood Zone 3 and Flood Zone 2, except one at Denman Crescent. Flood Zone 3 means the properties have a greater than 1% AEP of flooding from rivers. Flood Zone 2 means the properties have between a 1% and 0.1% AEP of flooding from rivers. The flooded property on Denman Crescent is higher up the hillside and is in Flood Zone 1 which means it has less than a 0.1% AEP of river flooding. Figure 3-34 demonstrates the Flood Zone extents.

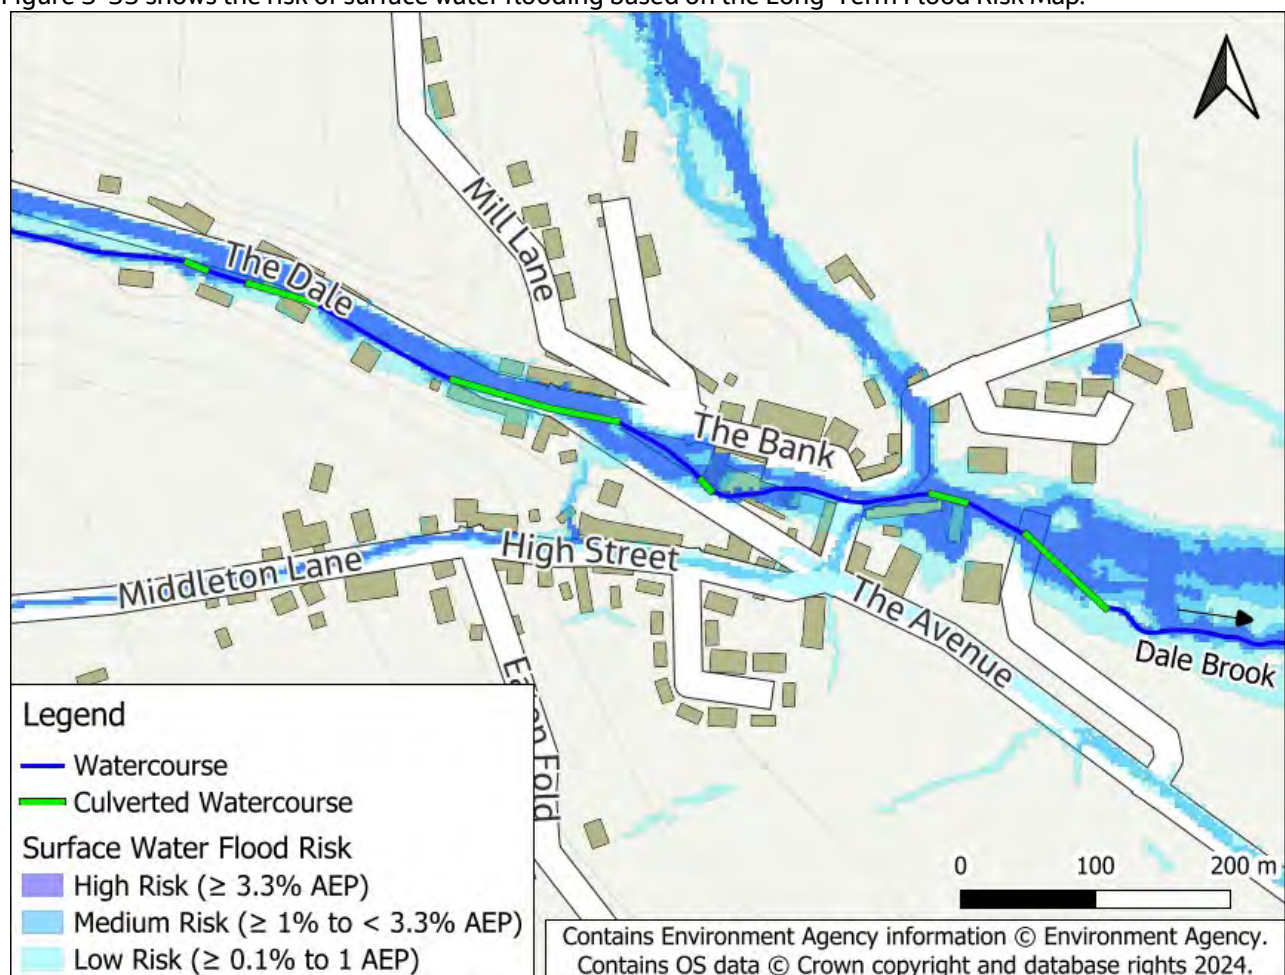
Figure 3-35: Map showing the chance in any given year of flooding from surface water at Stoney Middleton
(Source: Long Term Flood Risk Map)

Additionally, some homes are at risk of surface water flooding based on the Long Term Flood Risk Map (<https://check-long-term-flood-risk.service.gov.uk/postcode>). The properties that are located close to Dale Brook have a medium (between 1% and 3.3% AEP) to high (more than 3.3% AEP) risk of surface water flooding. This includes all the properties apart from the one on Denman Crescent. There are local accounts of a significant surface water flow route that flows from the northwest side of Castle Hill down to The Nook. Figure 3-35 shows the risk of surface water flooding based on the Long-Term Flood Risk Map.

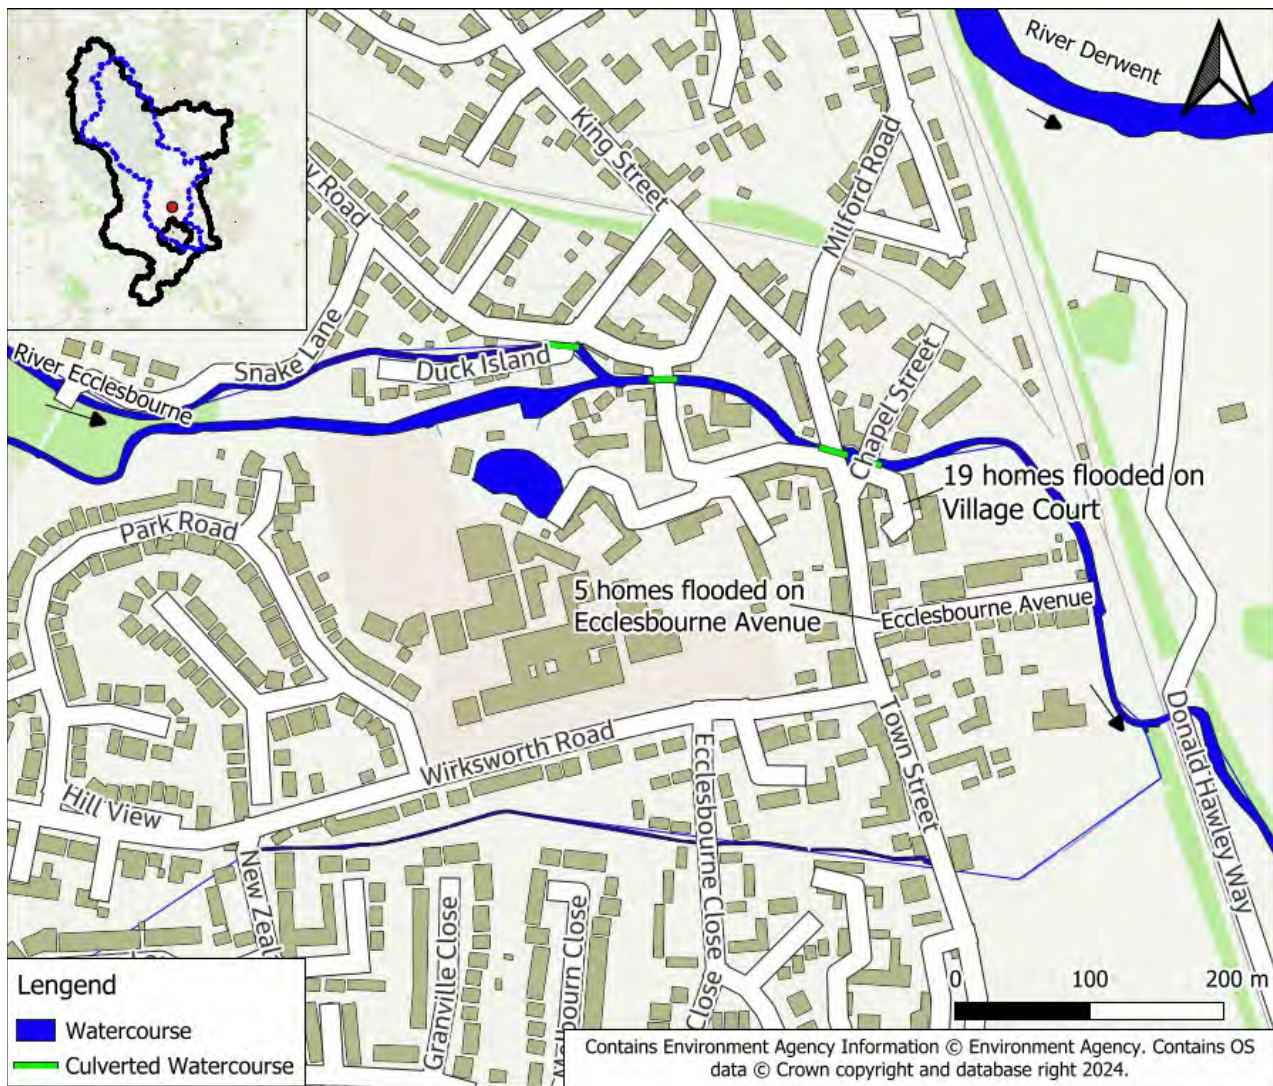
Figure 3-37: Overview map of Duffield.

Duffield is a village in the Amber Valley district of Derbyshire, five miles north of Derby and south of the Peak District National Park. Thirty-four properties were internally flooded during Storm Babet. Thirty-one were residential and three were non-residential properties including Duffield Meadows Primary School. Figure 3-37 shows the open and culverted watercourses within Duffield.

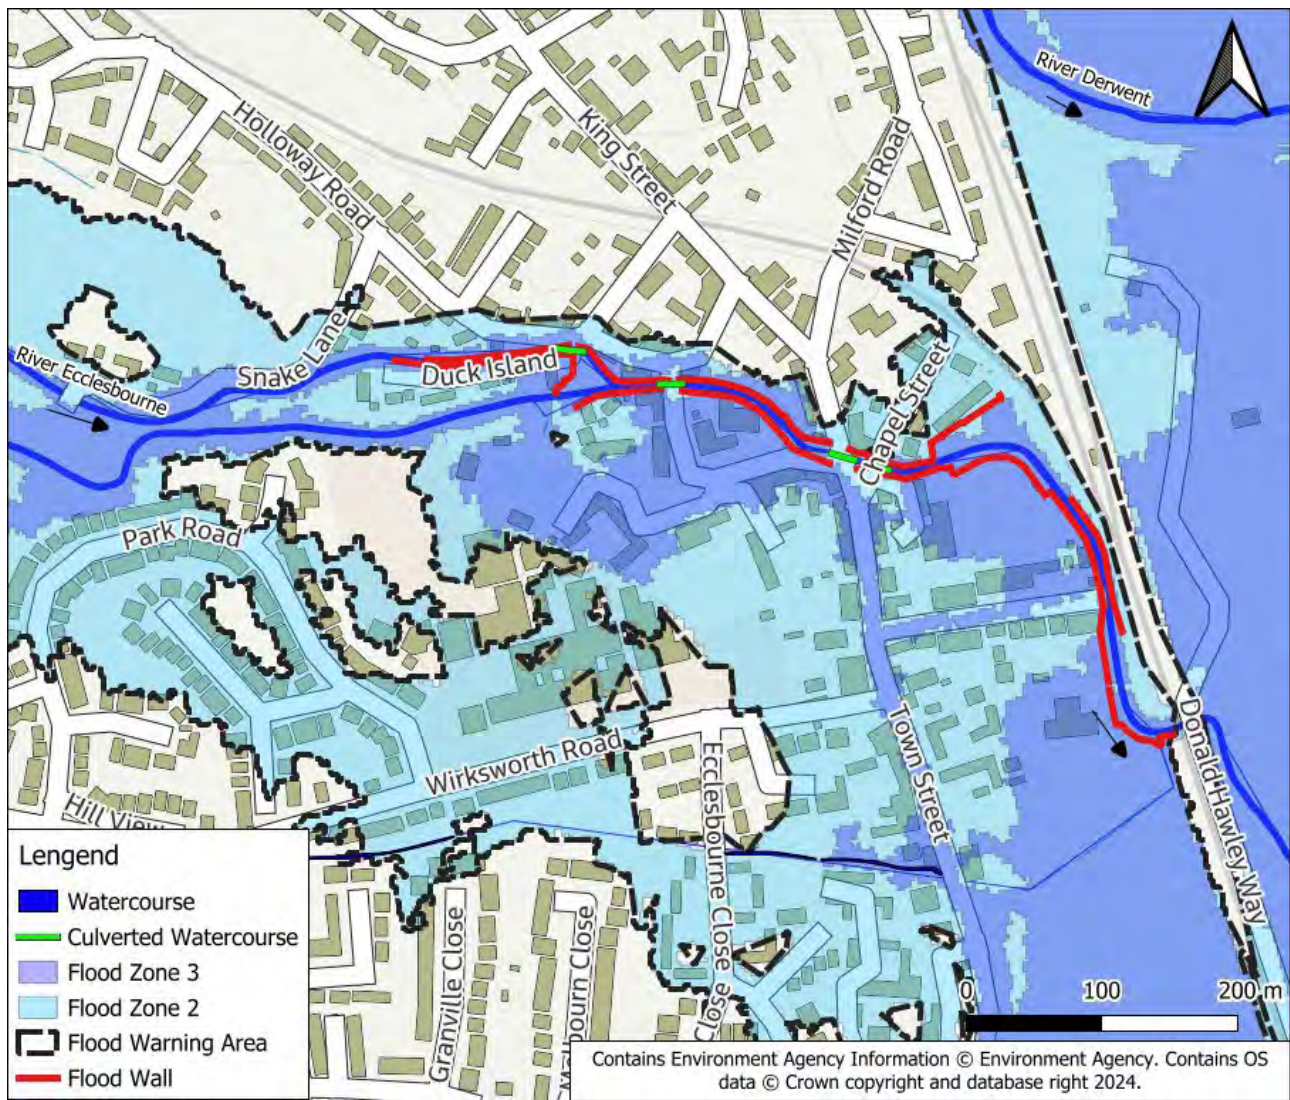
Figure 3-38: Flood zones and flood risk management arrangements at Duffield.

The Flood Map for Planning (<https://flood-map-for-planning.service.gov.uk/>) shows that thirty properties are located in Flood Zone 3, three properties are located in Flood Zone 2 and one property is located in Flood Zone 1. Flood Zone 3 means the properties have a greater than 1% AEP of flooding from rivers. Flood Zone 2 means the properties have between a 1% and 0.1% AEP of flooding from rivers. Flood Zone 1 means that properties have a very low chance of river flooding. Figure 3-38 demonstrates the Flood Zone extents.

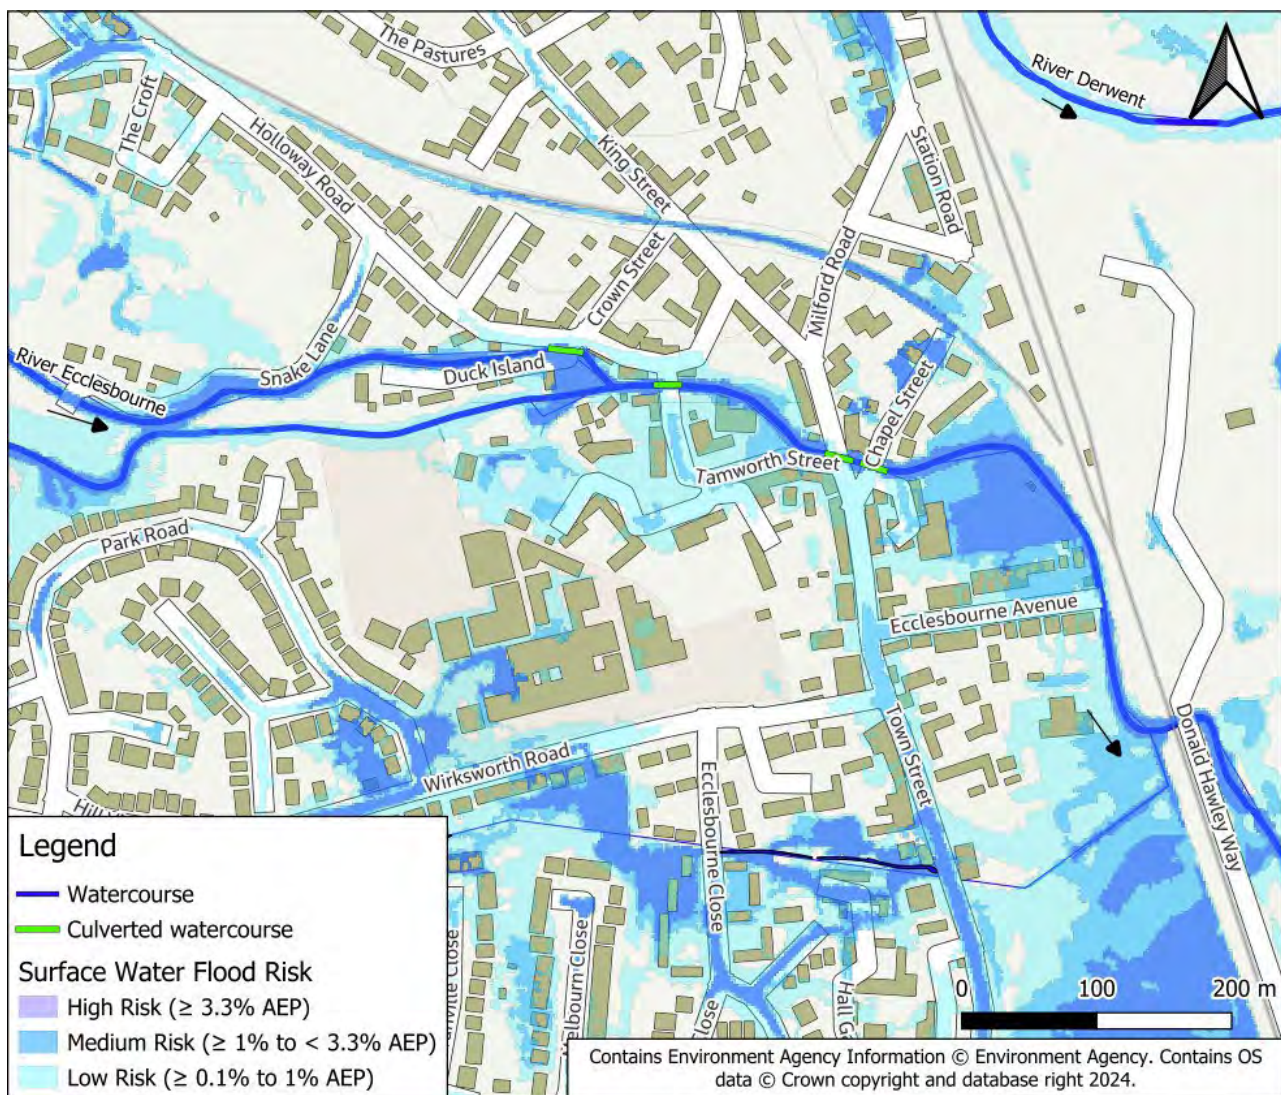
Figure 3-39: Map showing the chance in any given year of flooding from surface water at Duffield (Source: Long Term Flood Risk Map)

Additionally, some properties which flooded have a risk of surface water flooding based on the Long Term Flood Risk Map (<https://check-long-term-flood-risk.service.gov.uk/postcode>) See Figure 3-39. Properties on Village Court and Ecclesbourne Avenue having a medium chance (between 1% and 3.3% AEP) of surface water flooding. Many local roads, for example Town Street (A6), also have a high chance (more than 3.3% AEP) of surface water flooding.

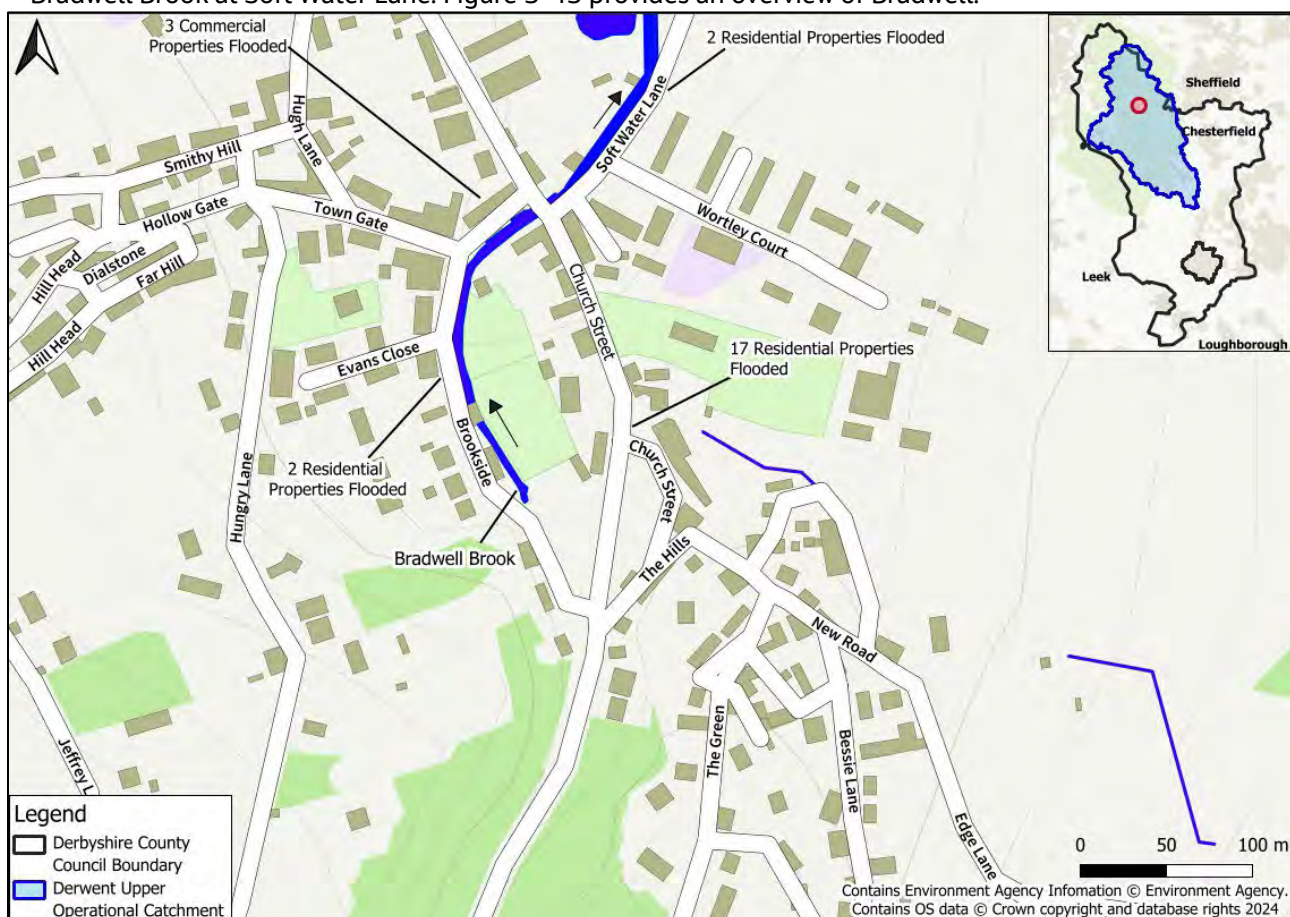
Figure 3-43: Overview map of Bradwell.

Twenty-six residential properties and three non-residential properties internally flooded as a result of Storm Babet in Bradwell. Bradwell is a village in the Peak District National Park and is part of the Derbyshire Dales District Council. It is to the south of the Hope Valley, situated less than 1km east of the Breedon Hope Cement Works. Bradwell Brook, designated as main river, flows through the village, and joins the River Noe approximately 1km to the north-east. There is an unnamed watercourse in the east of Bradwell that flows into Bradwell Brook at Soft Water Lane. Figure 3-43 provides an overview of Bradwell.

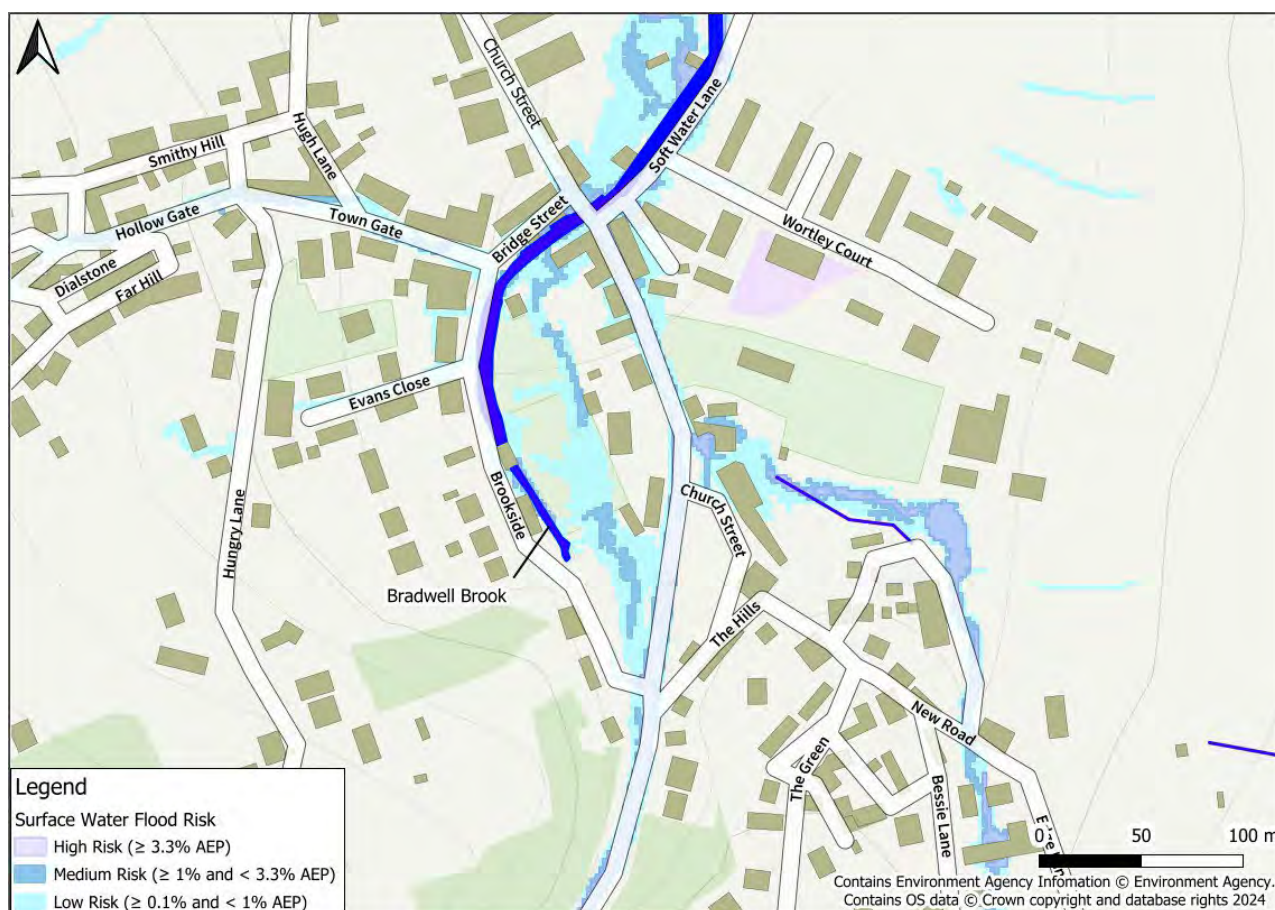
Figure 3-44: Map showing the chance in any given year of flooding from surface water at Bradwell (Source: Long Term Flood Risk Map)

Additionally, some properties are at risk of surface water flooding based on the Long Term Flood Risk Map (<https://check-long-term-flood-risk.service.gov.uk/postcode>) The B6049, Bridge Street and Soft Water Lane are all at high risk of surface water flooding with a 3.3% AEP. Several properties on the B6049 and Bridge Street are at medium risk of surface water flooding having between a 3.3% to 1% AEP. Further properties are at low surface water flood risk on Church Street, the B6049, Town Gate and Bridge Street. A low surface water flood risk means there is between a 1% to 0.1% AEP of surface water flooding. Figure 3-44 shows the surface water flood risk for Bradwell.

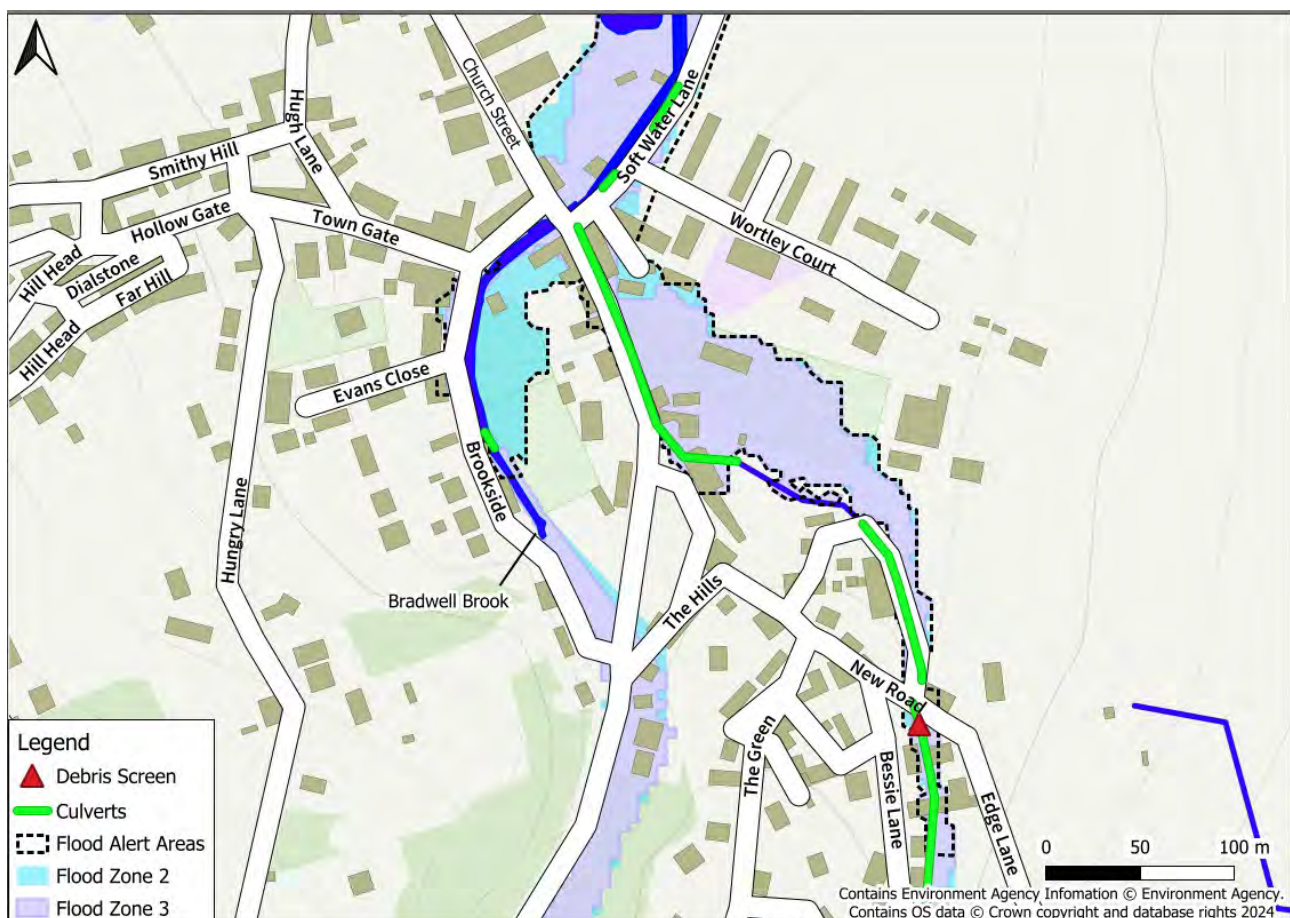
Figure 3-45: Flood risk management arrangements for Bradwell.

The Environment Agency reports that a site visit by ARUP conducted on the 29th of November 2023 found some properties to have Property Flood Resilience (PFR) measures.
