3. Derwent Catchment

3.1 Derwent Catchment Event Hydrology

3.2 Community Impacts - Lilac Way

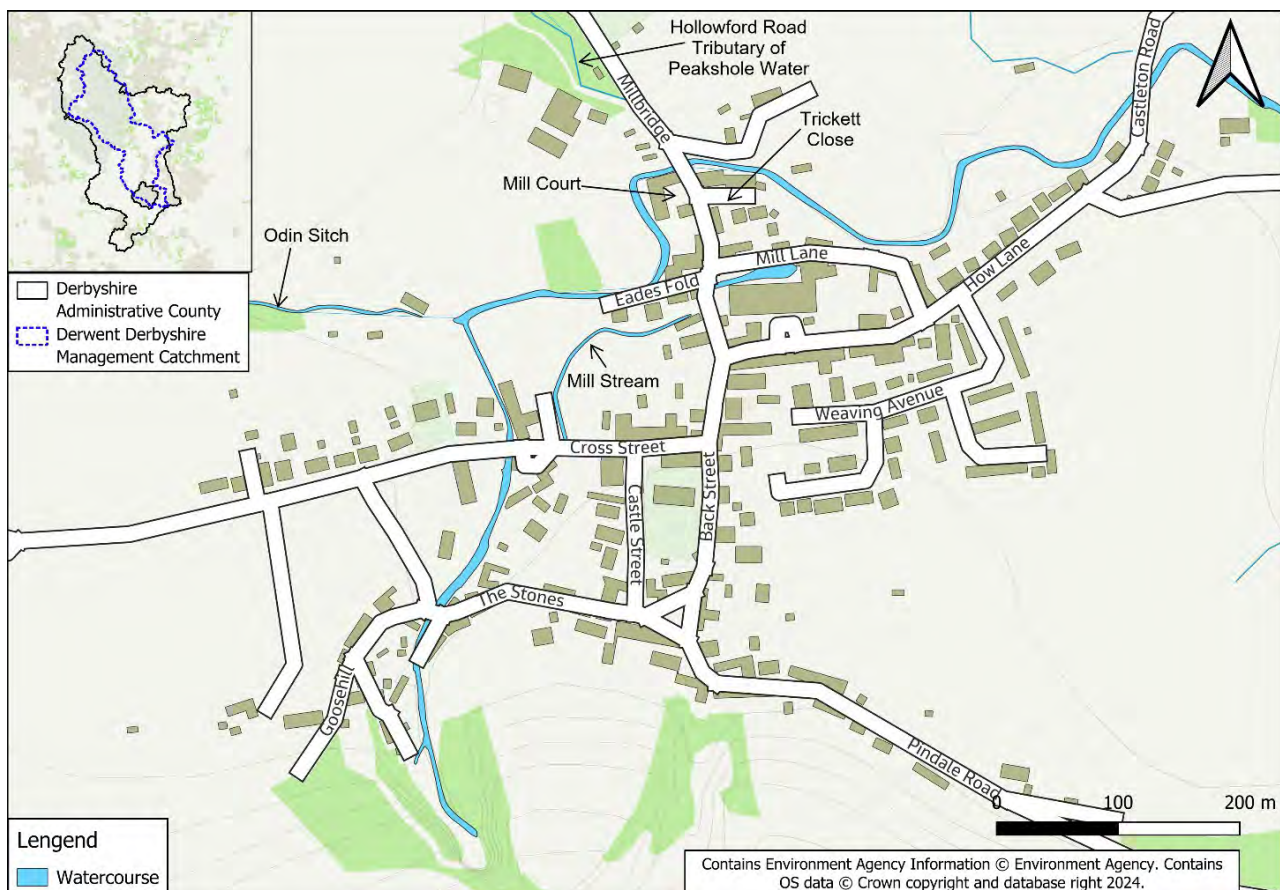
Figure 3-48: Overview map of Castleton.

Twenty-four residential properties and five non-residential properties internally flooded as a result of Storm Babet in Castleton. Castleton is a village in the Peak District National Park, Derbyshire, England. It is at the western end of the Hope Valley on the Peakshole Water, a tributary of the River Noe, between the Dark Peak to the northwest and the White Peak to the south. Both watercourses are designated main river. Figure 3-48 is an overview map of Castleton.

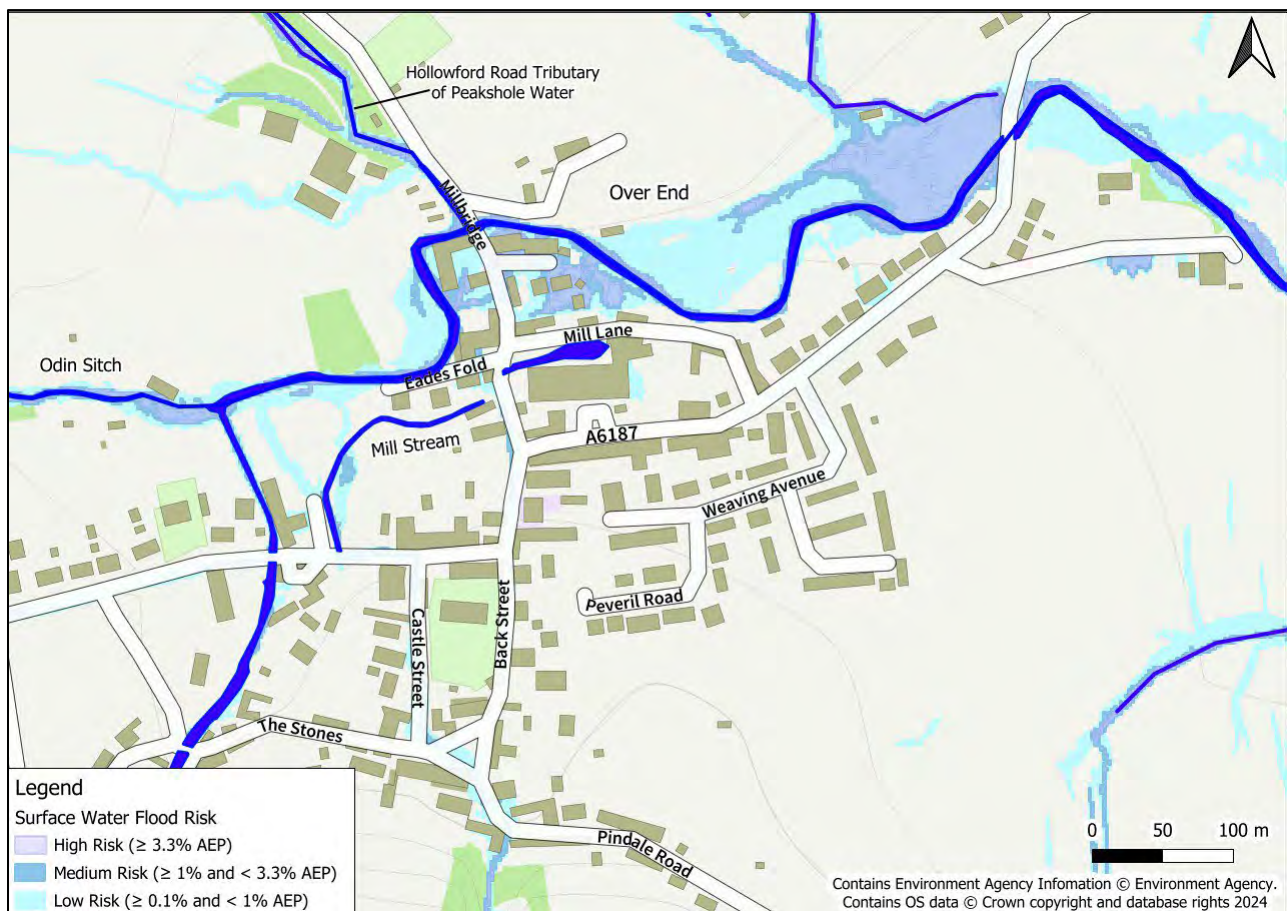
Figure 3-49: Map showing the chance in any given year of flooding from surface water at Castleton (Source: Long Term Flood Risk Map).

Based on the Long Term Flood Risk Map (<https://check-long-term-flood-risk.service.gov.uk/postcode>) most of the properties on Millbridge, Trickett Close and Mill Court, have a high (more than 3.3% AEP) chance of surface water flooding. There is up to a medium risk of surface water flooding in some additional low lying areas in the village. Figure 3-49 shows the surface water flood risk described.

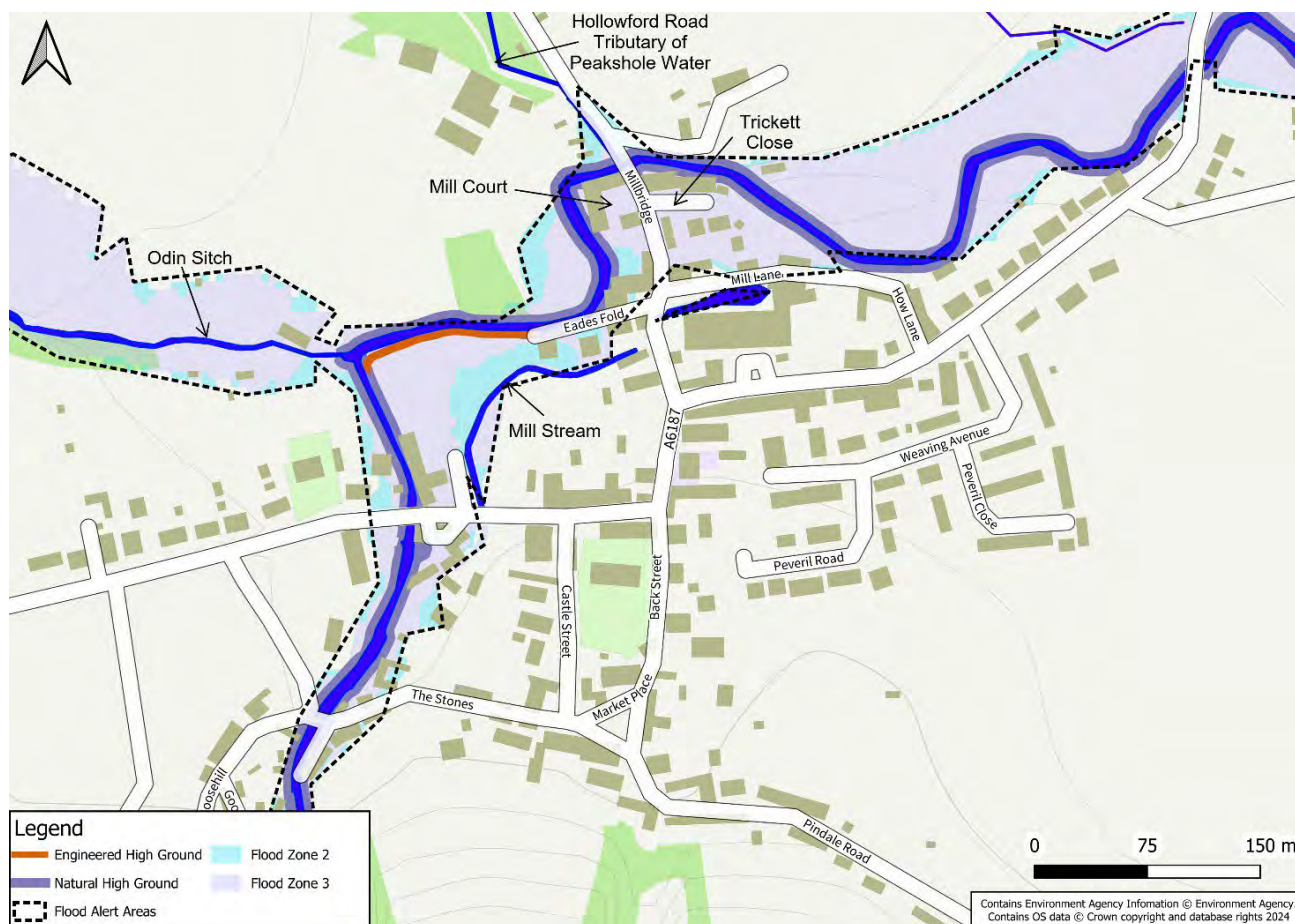
The Environment Agency's [Asset Information and Maintenance Programme \(data.gov.uk\)](https://environment.data.gov.uk/asset-management/) (<https://environment.data.gov.uk/asset-management/>) shows there are currently no formal flood defences in the community. The only asset in Castleton that the Environment Agency maintain is a flap valve in the visitor centre car park. The flap valve prevents water from Peakshole Water backing up into the surface water drainage network when river levels are high. There is a small wall that has been built on the Riverside Path to fill a gap between a drystone wall and the wall of a property. The drystone walls in Castleton are not flood defence walls or flood risk management assets. Figure 3-50 shows the flood risk management arrangements for Castleton.

Figure 3-50: Castleton flood risk management arrangements.

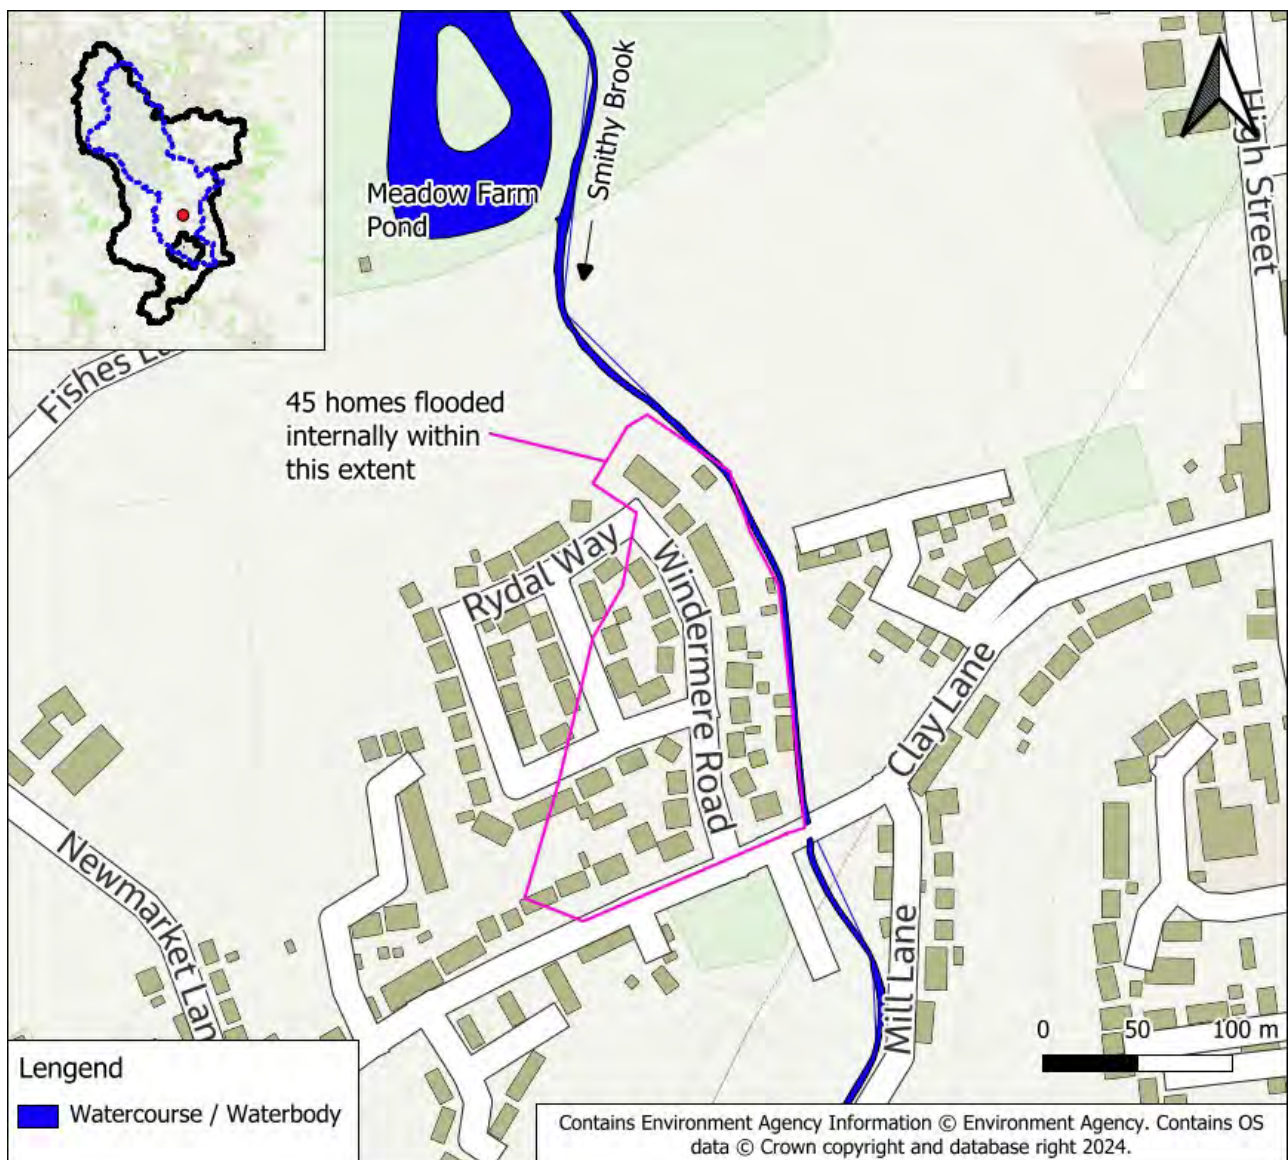
Forty-five residential properties flooded internally in Clay Cross as a result of Storm Babet. Clay Cross is a town in north-east Derbyshire, approximately 8km south of Chesterfield. The community sits to the west of Smithy Brook, also known as Press Brook. Smithy Brook is a tributary of the River Amber and is designated an ordinary watercourse. Figure 3-51 shows an overview of the community affected.

Figure 3-51: Overview map of Clay Cross community.

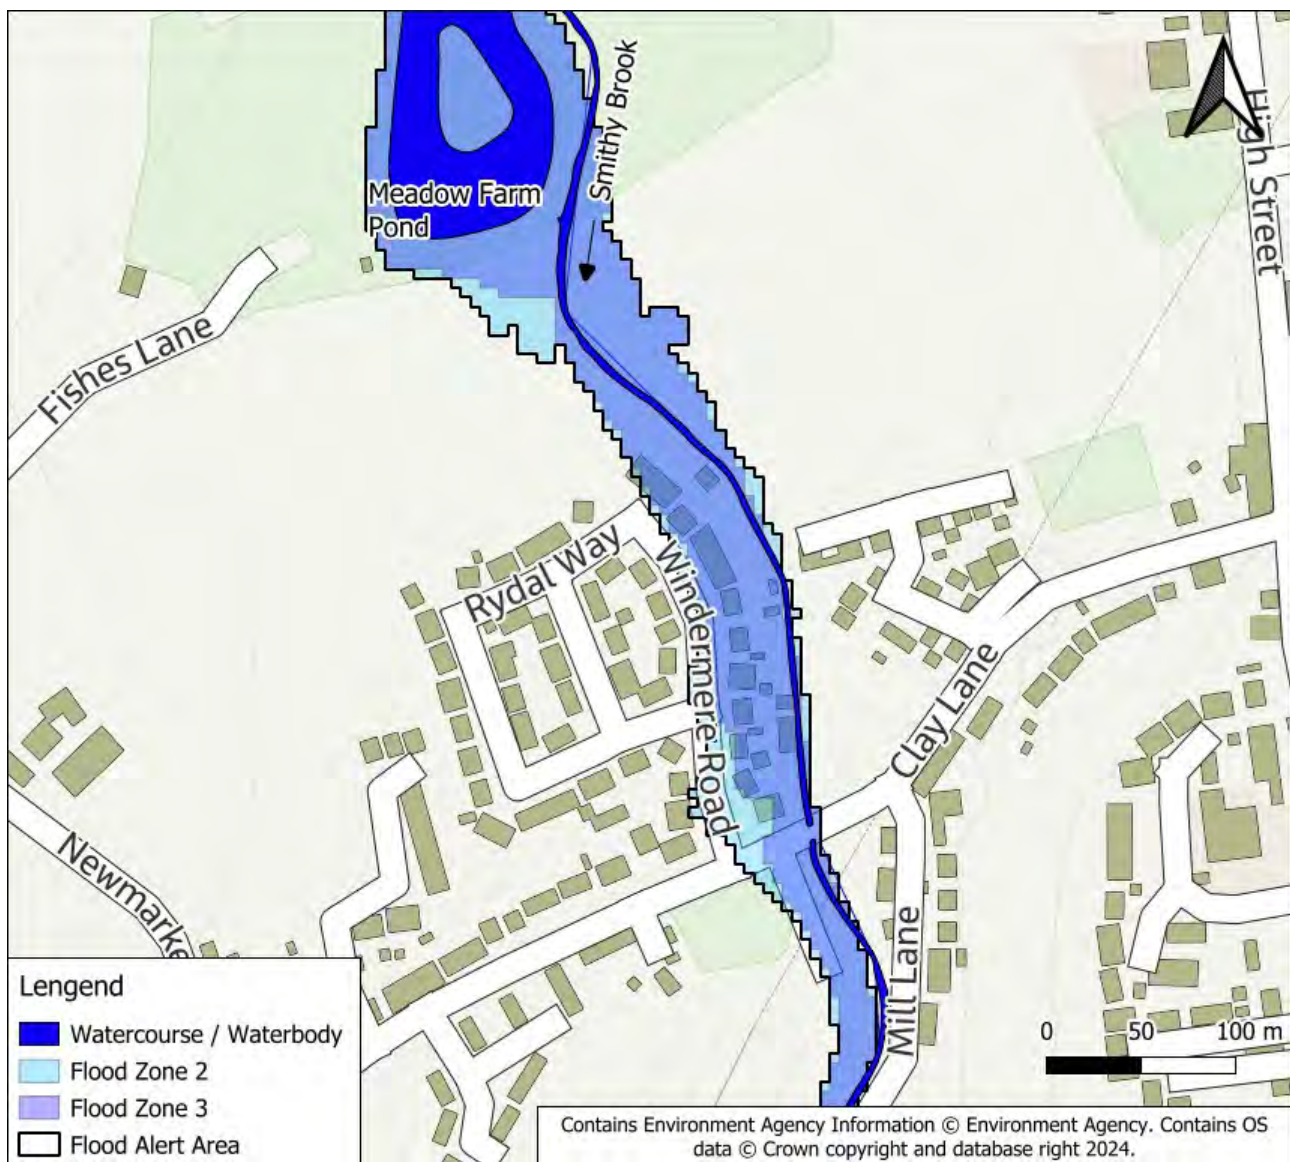
The Flood Map for Planning (<https://flood-map-for-planning.service.gov.uk/>) shows all properties that flooded were located in Flood Zone 2 or 3. Properties on the east of Windermere Road are within Flood Zone 3. Flood Zone 3 means the properties have a greater than 1% AEP of flooding from rivers. Flood Zone 2 extends across Windermere Road, to some of the properties on the west side of the road and on Clay Lane. Flood Zone 2 means properties have between a 1% and 0.1% AEP of river flooding. Figure 3-52 shows the Flood Zones described.

Figure 3-52: Flood Zones 2 and 3 at Clay Cross

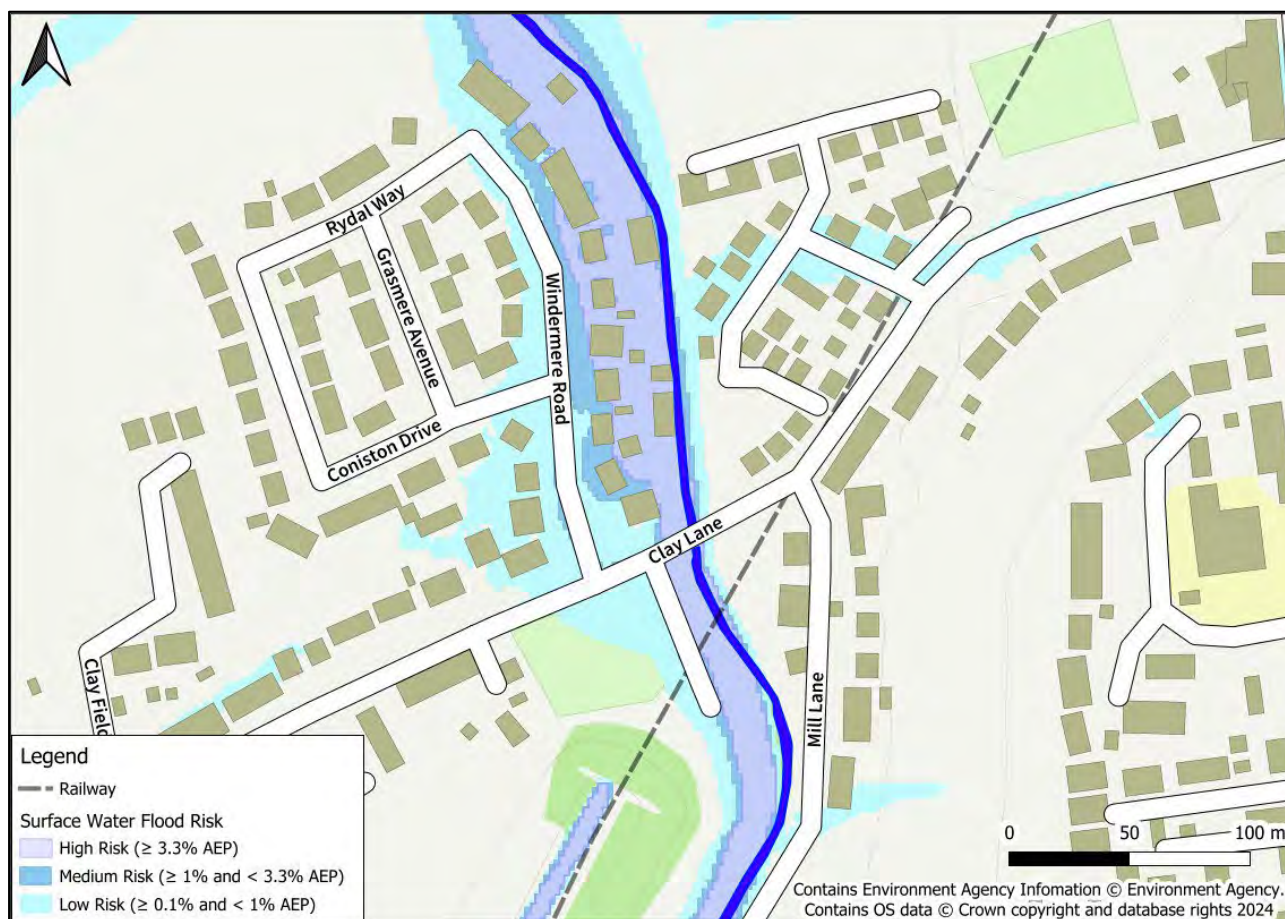
Additionally, the Long Term Flood Risk Map (<https://check-long-term-flood-risk.service.gov.uk/postcode>) shows the majority of the properties on the east side of Windermere Road have at least a medium (between 1% and 3.3% AEP) risk of surface water flooding, with some of the properties being at a high (more than 3.3% AEP) risk of surface water flooding. The majority of the properties internally flooded on the west side of Windermere Road are at low (between 0.1% and 1% AEP) risk of surface water flooding. Figure 3-53 shows the surface water flood risk described.

Figure 3-53: Map showing the chance in any given year of flooding from surface water at Clay Cross
(Source: Long Term Flood Risk Map).
