## 4. Don and Rother Catchment

### 4.1 Don and Rother Catchment Event Hydrology

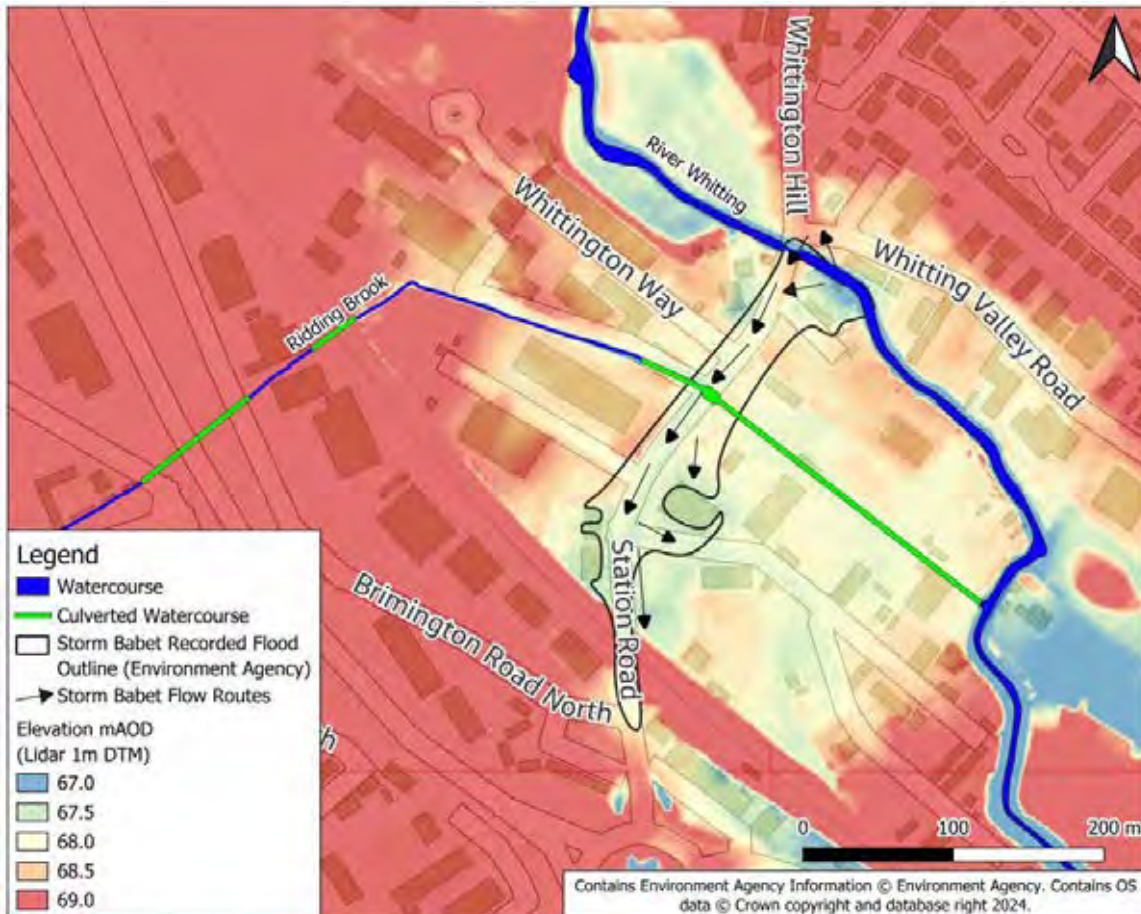
Figure 4-9: Ground level flow routes at Station Road, Whittington Moor.

Figure 4-9 shows the flow routes at this community, based on discussions with Chesterfield Borough Council. Hydrology data shows that on the 20th of October, the peak level recorded at the Sheepbridge River Whitting gauge, located approximately 0.9km from the community reached 2.56m; the highest level ever recorded. The gauge indicates that water levels in the River Whitting began to rise on the 20th of October at about midnight, reaching its peak at 2:00pm on the 20th of October.

The River Whitting initially overtopped a low spot on its east bank, directly south of the bridge over which Station Road crosses the river, flooding one business on Whitting Valley Road. Floodwater then inundated Station Road bridge, and flowed westwards, downslope, along Station Road for approximately 300m. Floodwater accumulated at a low spot on Station Road, directly east of the railway bridge, which Station Road passes beneath.

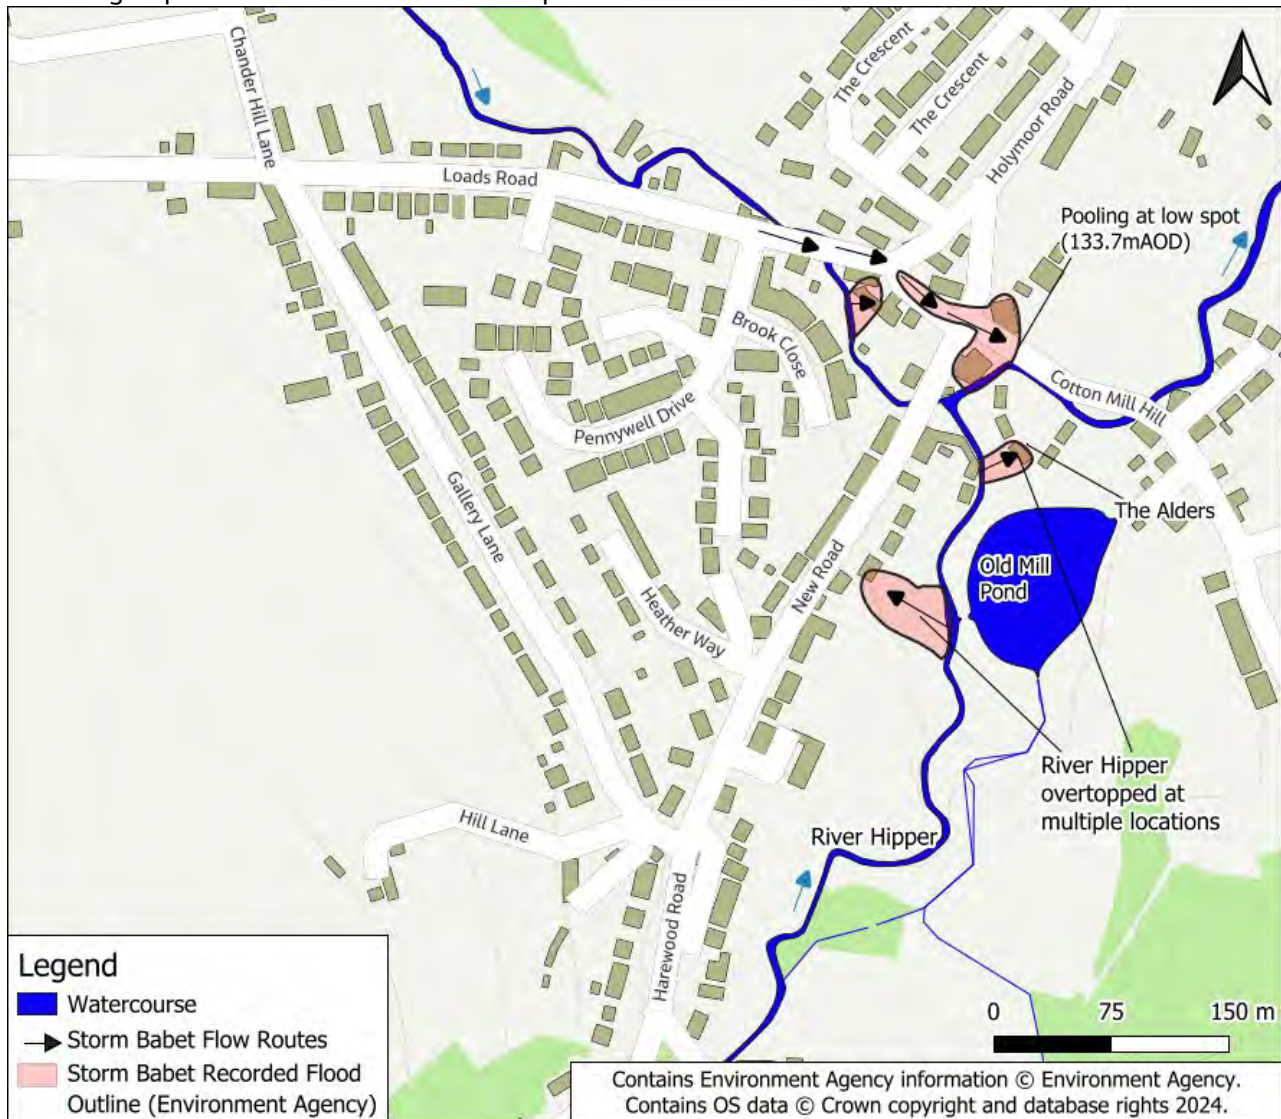
**Figure 4-14: Flood extent and flow routes at Holymoorside.**

Figure 4-14 shows the assumed flow routes and elevations which will have contributed to the flood extent. Hydrology data shows that on the 20th of October, the peak level recorded at the Holymoorside gauge downstream of Loads Road bridge on the River Hipper, reached 1.58m; the highest level ever recorded. The gauge indicates that water levels in the River Hipper began to rise on the 20th of October at about midnight, reaching its peak twelve hours later at 12:00pm.

Video evidence shows that the highway was flooded on the 20th of at 9:53am, although it is unclear when flooding commenced. Floodwater is reported to have entered the properties on New Road at approximately 12:00pm and to have receded by approximately 1:00pm.

The River Hipper is also understood to have overtopped its banks at multiple locations along the section near to Old Mill Pond and the middle of the village. Old Mill Pond was also reported to have overtopped local to a weir. The two internally flooded homes on the New Road and Loads Road junction were flooded from two sources; overtopping of the River Hipper which entered properties from the rear and Loads Road runoff entering properties from the front. The runoff accumulated at the Loads Road low spot located adjacent to The Alders, as shown in Figure 4-14. The Alders are on the inside of a bend in the Hipper and were flooded by water on multiple sides from the Hipper overtopping.

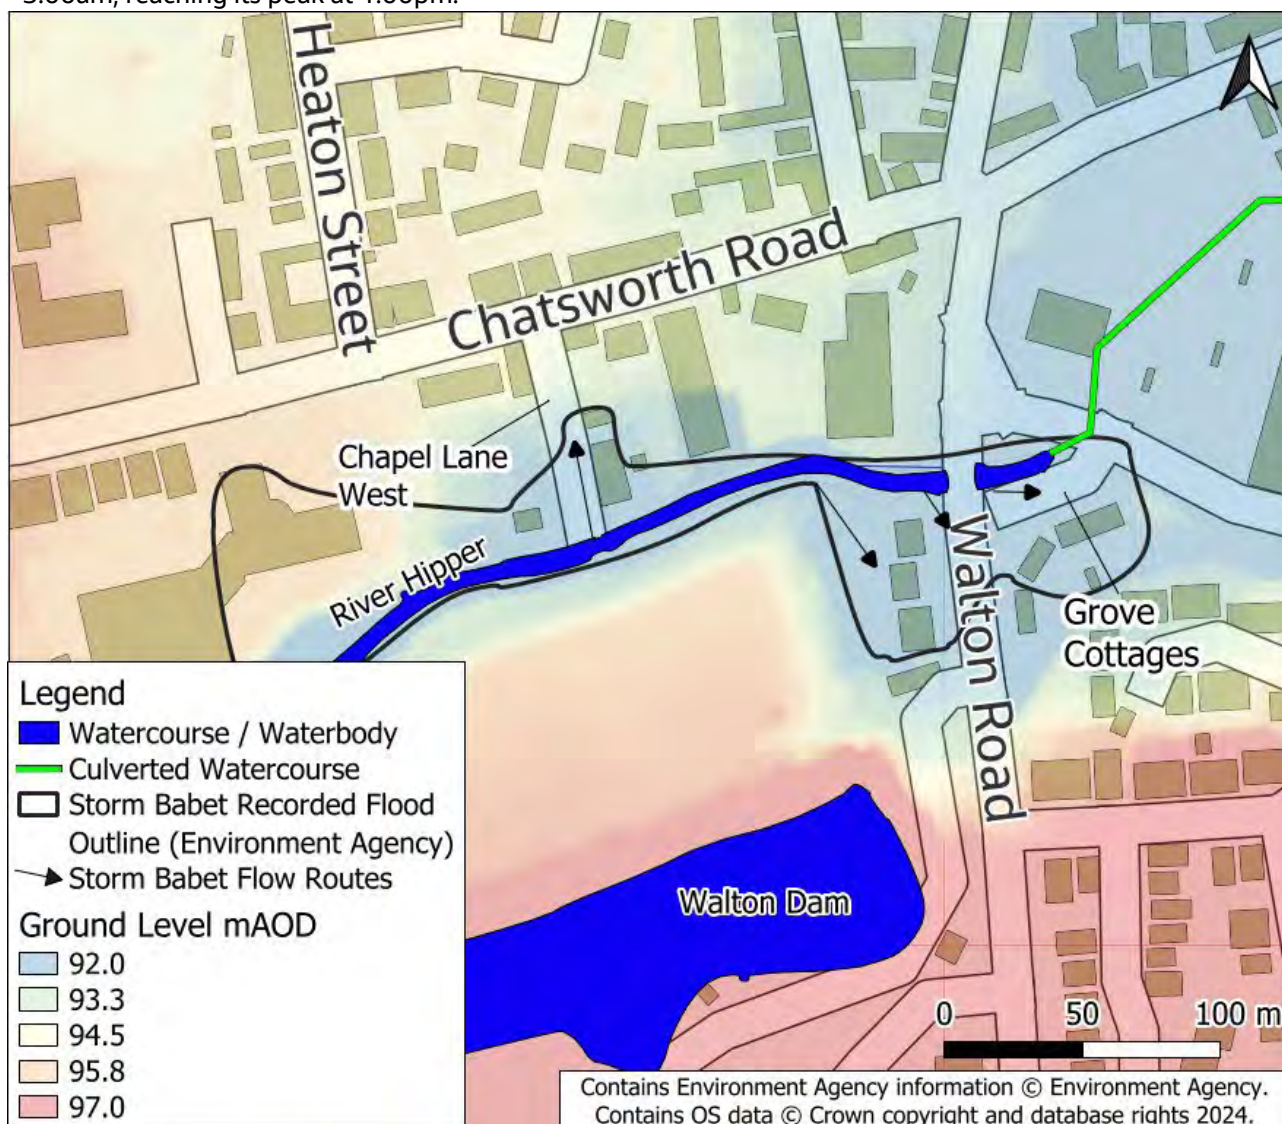
**Figure 4-18: Ground level and likely floodwater flow routes during Storm Babet at the Chatsworth Road West community.**

Figure 4-18 shows the assumed flow routes and elevations which will have contributed to the flood extent. Hydrology data shows that on the 20th of October, the peak level recorded at the Chesterfield Hipper gauge,

located approximately 20m upstream of Walton Road bridge, reached 3.59m; the highest level on record. The gauge indicates that water levels in the River Hipper began to rise on the 20th of October at about 3:00am, reaching its peak at 1:00pm.

The River Hipper exceeded the channel at several locations at this community. At Chapel Lane West, on the north bank of the River Hipper, the river breached its banks and flowed northward up the street to an elevation of approximately 92.7mAO. Although river water was the dominant flood source at Chapel Lane West, surface water runoff from Chatsworth Road is also understood to have contributed to the flooding. It is unclear whether this was rainfall runoff or related to the surface water network surcharging from road gullies. Residents have reported that floodwater reached waist height at the south end of Chapel Street West, adjacent to the River Hipper.

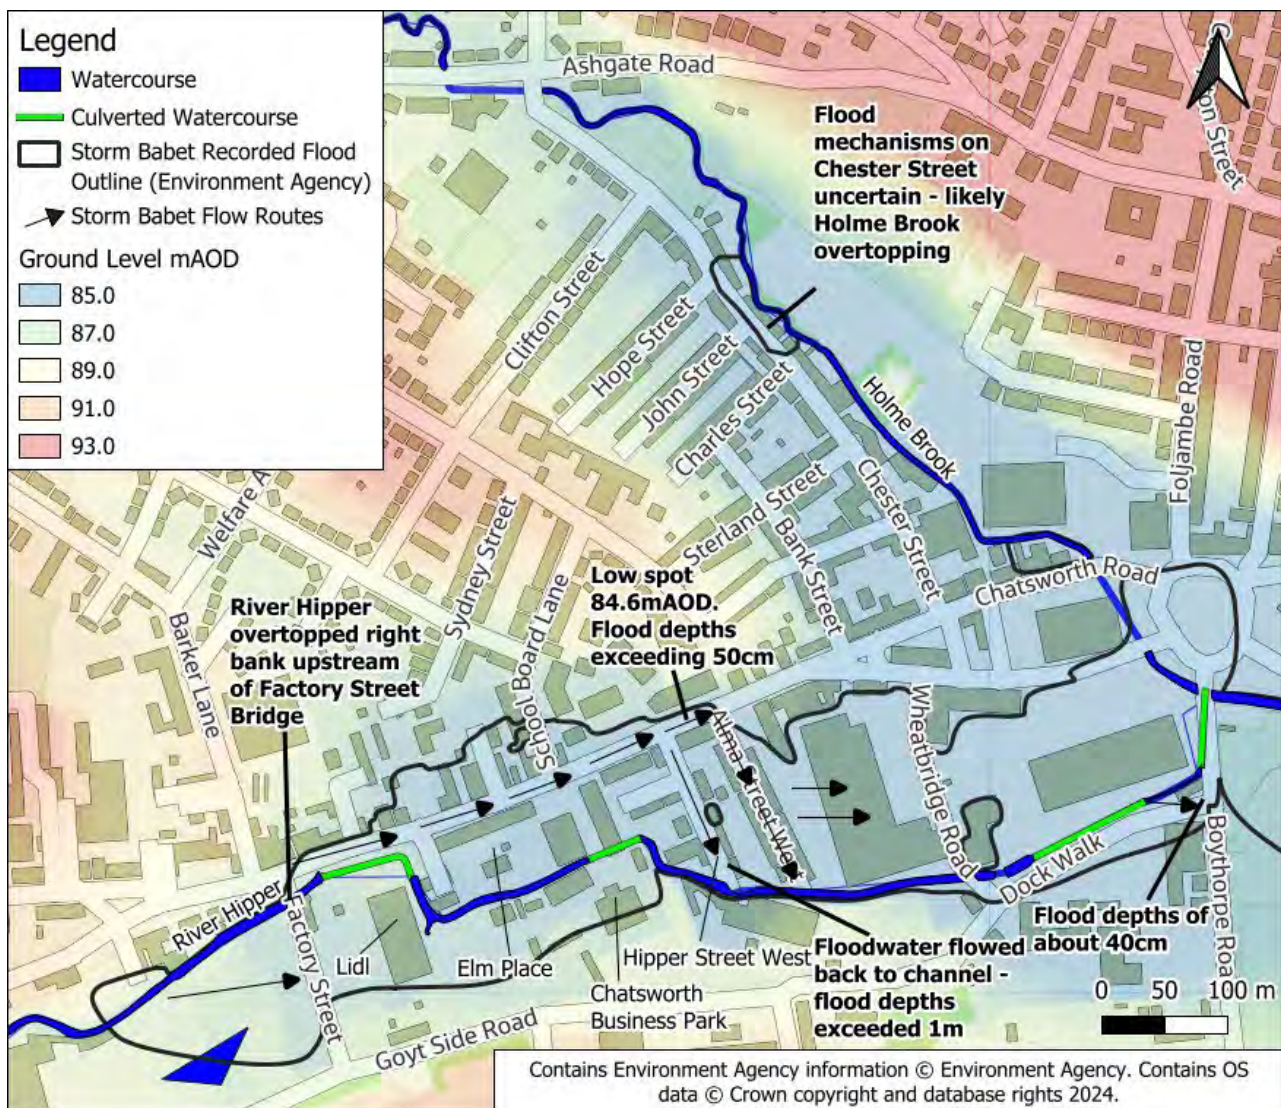
Figure 4-22: Ground level and Storm Babet flow routes at the Brompton community.

Figure 4-22 shows the flow routes which will have contributed to the flood extent. Hydrology data has been taken for two separate river level gauges in proximity of Brampton; the Chesterfield Hipper gauge, and the Chesterfield Ashgate gauge. The Chesterfield Hipper gauge shows that on the 20th of October, the peak level recorded reached 3.59m; the highest level ever recorded. The gauge indicated that water in the River Hipper began to rise on the 20th of October at about 3:00am, reaching its peak at 1:00pm.

The Chesterfield Ashgate gauge is located on Holme Brook by Purbeck Avenue bridge, approximately 1.5km upstream of where Holme Brook joins the Hipper and shows that on the 20th of October, the peak level recorded reached 1.6m; the second highest level ever recorded. The gauge indicated that water in Holme Brook began to rise on the 20th of October at about 2:00am, reaching its peak at 1:00pm.

Note that the following analysis is based on media and reports received during and after the event, some estimations have been made with regards to flood extents, depths and flow routes.

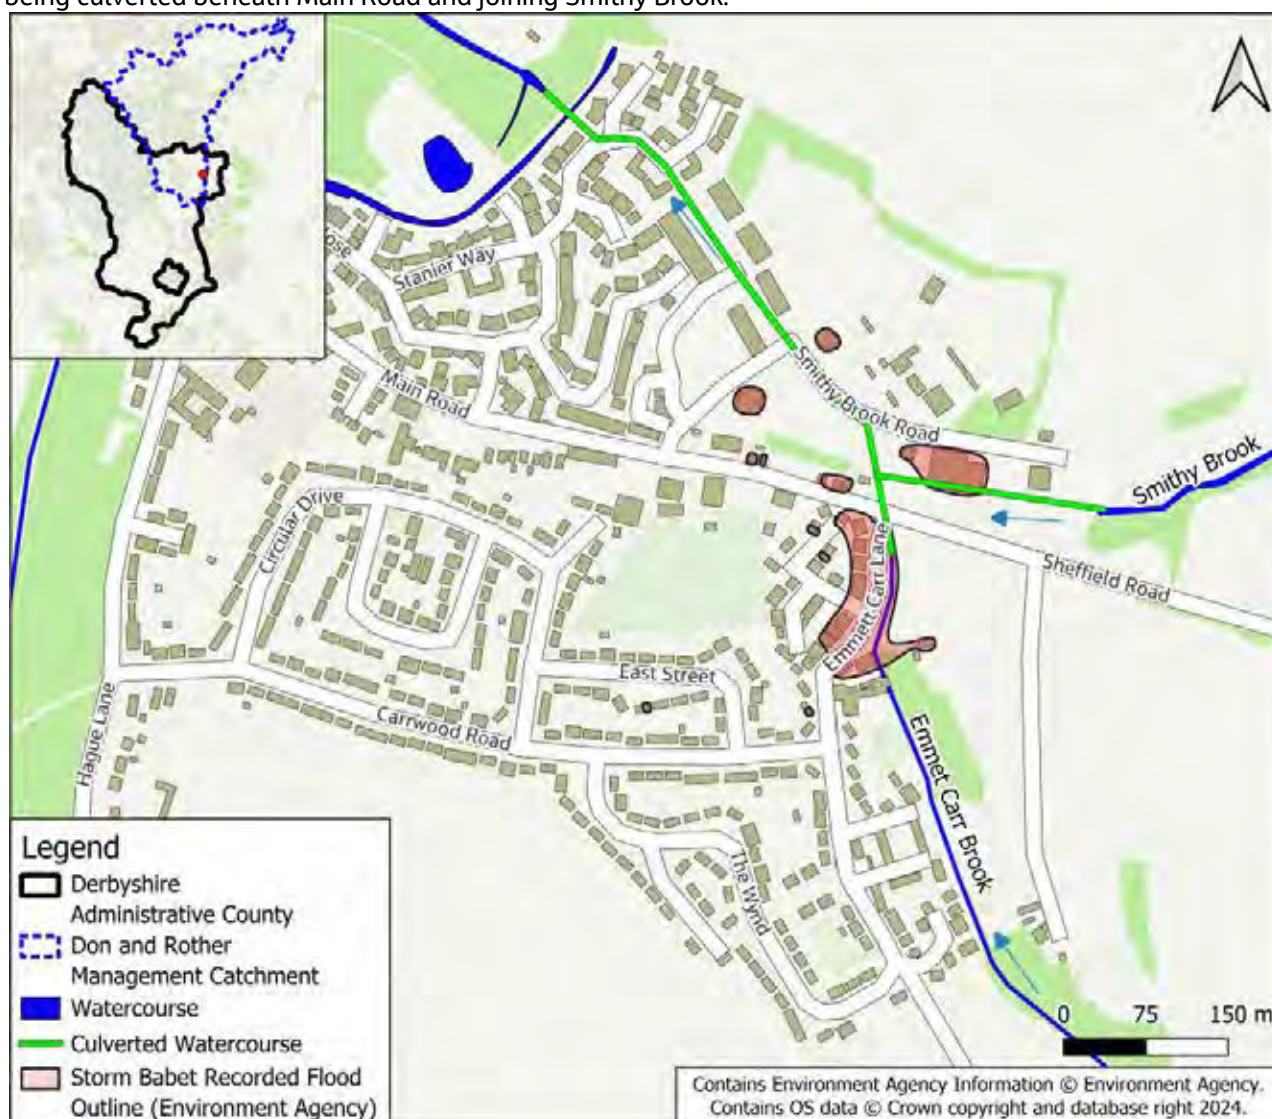
Figure 4-29: Overview map of Renishaw community.

Thirty-nine properties in the village of Renishaw, located about 2km to the south-east of Eckington, suffered internal flooding as a result of Storm Babet. Figure 4-29 shows the area where the main group of residential properties flooded. Renishaw is located within the North East Derbyshire District, bordering Bolsover District to its east. Smithy Brook, an ordinary watercourse, flows through the north of the village from east to west. The Smithy Brook catchment upstream of Renishaw is small, with its source 2km upstream near the M1. The watercourse takes drainage from the M1. Smithy Brook joins the River Rother approximately 0.4km downstream of the village boundary. Chesterfield Canal borders the village to the west and Emmett Carr Brook, an ordinary watercourse, borders the village to the east, representing the boundary between North East Derbyshire District and Bolsover District. Emmett Carr Brook flows parallel to Emmett Carr Lane before being culverted beneath Main Road and joining Smithy Brook.

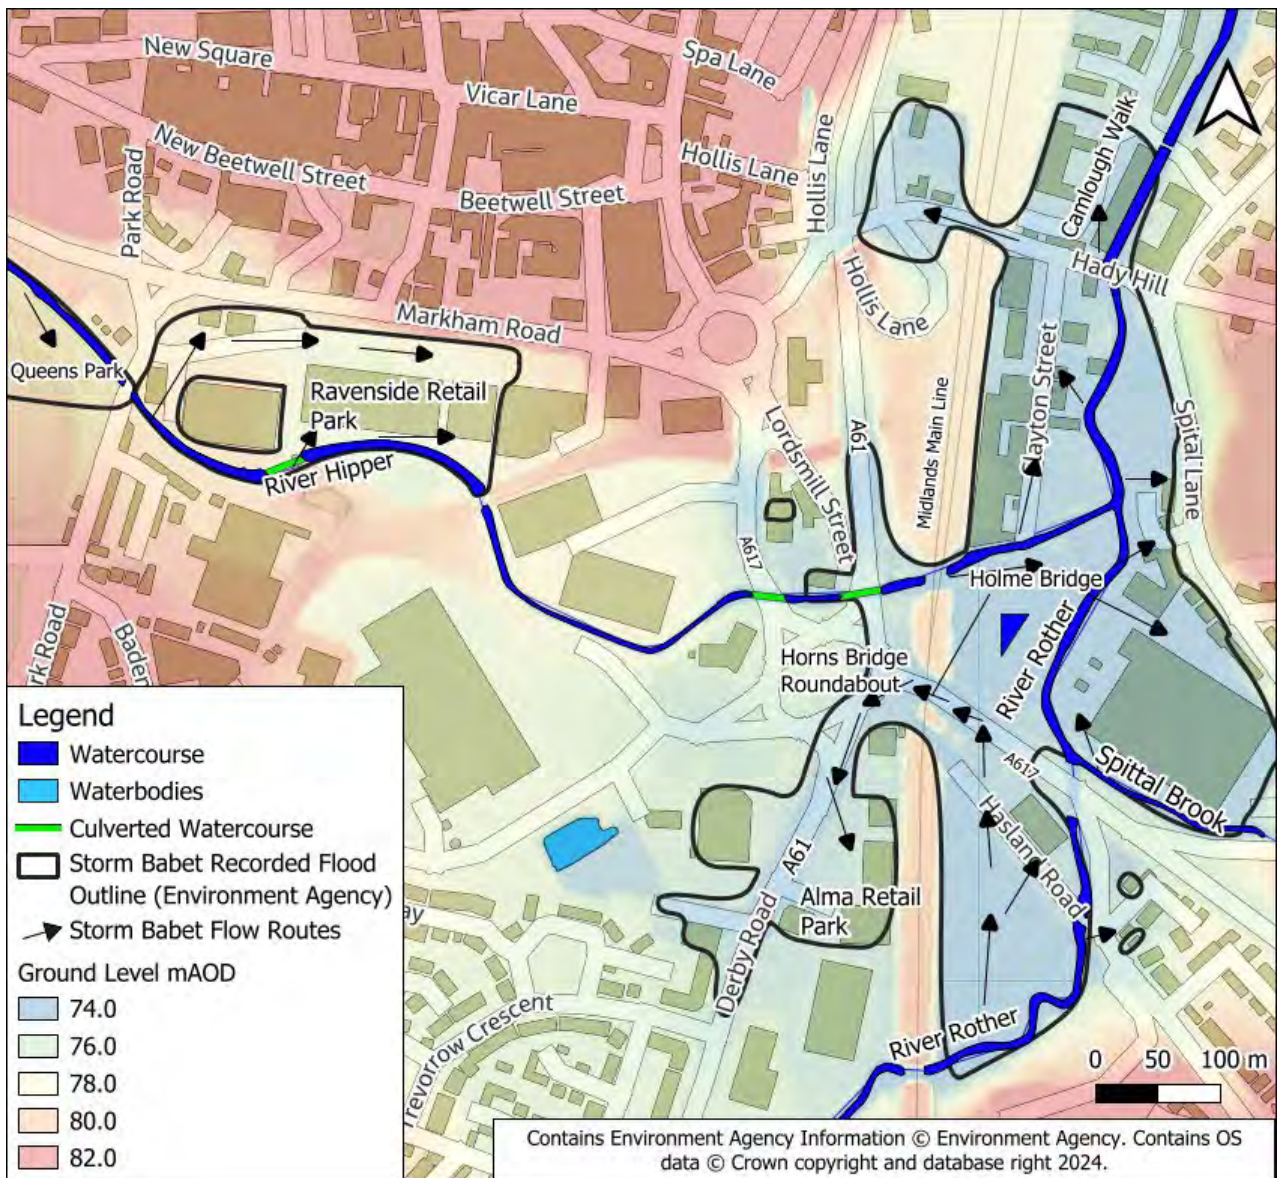
Figure 4-42: Ground level and Storm Babet flow routes at Central Chesterfield.

Flooding at this community was mainly caused by the River Rother, the River Hipper and Spital Brook exceeding their channel capacity. There is evidence to suggest that sewer systems were also overwhelmed in some areas of this community, which is likely to have contributed to flooding. Surface water runoff also likely exacerbated flooding in some areas, although the extent of floodwater contribution from sewer and surface water sources is unclear.

Figure 4-42 shows the assumed flow routes which contributed to the flood extent.

There are two river level gauges at this community. Hydrology data from the Hady Hill gauge, which is located on the River Rother at Hady Hill bridge, shows that on the 20th of October 2023, the peak reached 4.20m; the highest level ever recorded. The gauge indicates that water levels in the River Rother began to rise on the 20th of October at about 2:00am, reaching its peak at 5:30pm.

Hydrology data from the Chesterfield Park Road Bridge gauge, located on the River Hipper, at the upstream end of Ravenside Retail Park, shows that on the 20th of October, the peak reached 2.93m; the highest level ever recorded. The gauge indicates that water levels in the River Hipper began to rise on the 20th of October at about 2:00am, reaching its peak at 2:30pm.

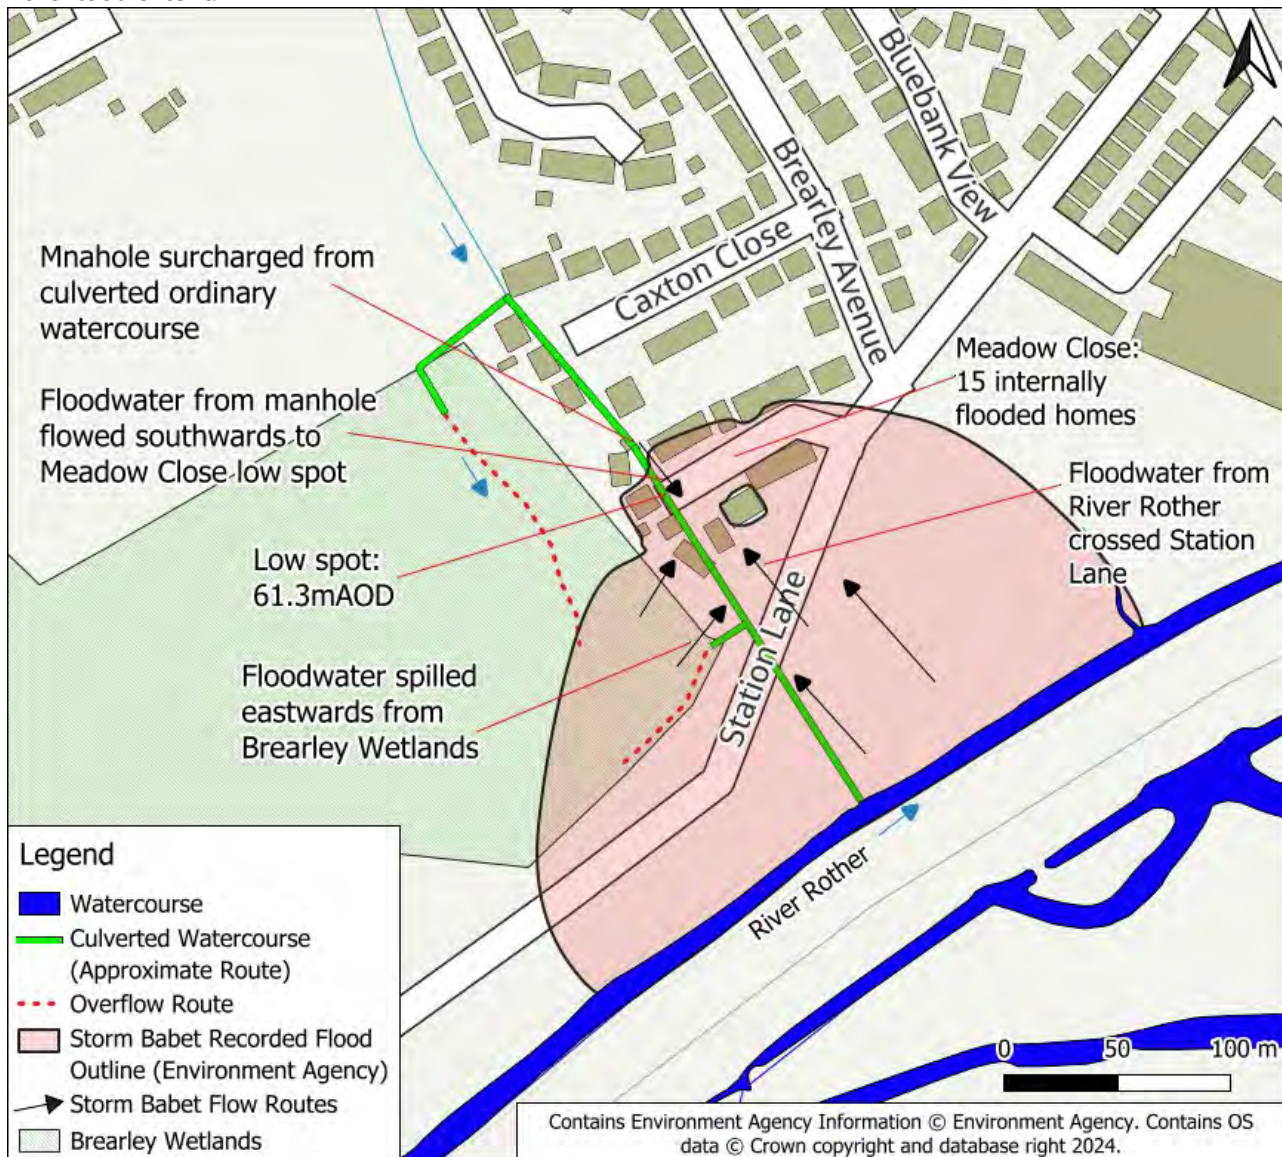
The initial flooding was from a double gully in the highway at the end of the driveway of 10 Meadow Close. This was then supplemented by flooding from the River Rother. The latter is likely to have been more dominant in causing the final flood extent, but this is not certain. Culvert exceedance is a known issue in this community; however, it has not previously resulted in flooding to this extent, which supports the hypothesis that the dominant flood source was the River Rother. Figure 4-50 shows the flow routes that contributed to the flood extent.

Figure 4-50: Flow pathways and annotated flood mechanisms of Storm Babet flooding in the vicinity of Meadow Close. Source: Derbyshire County Council Flood Team.

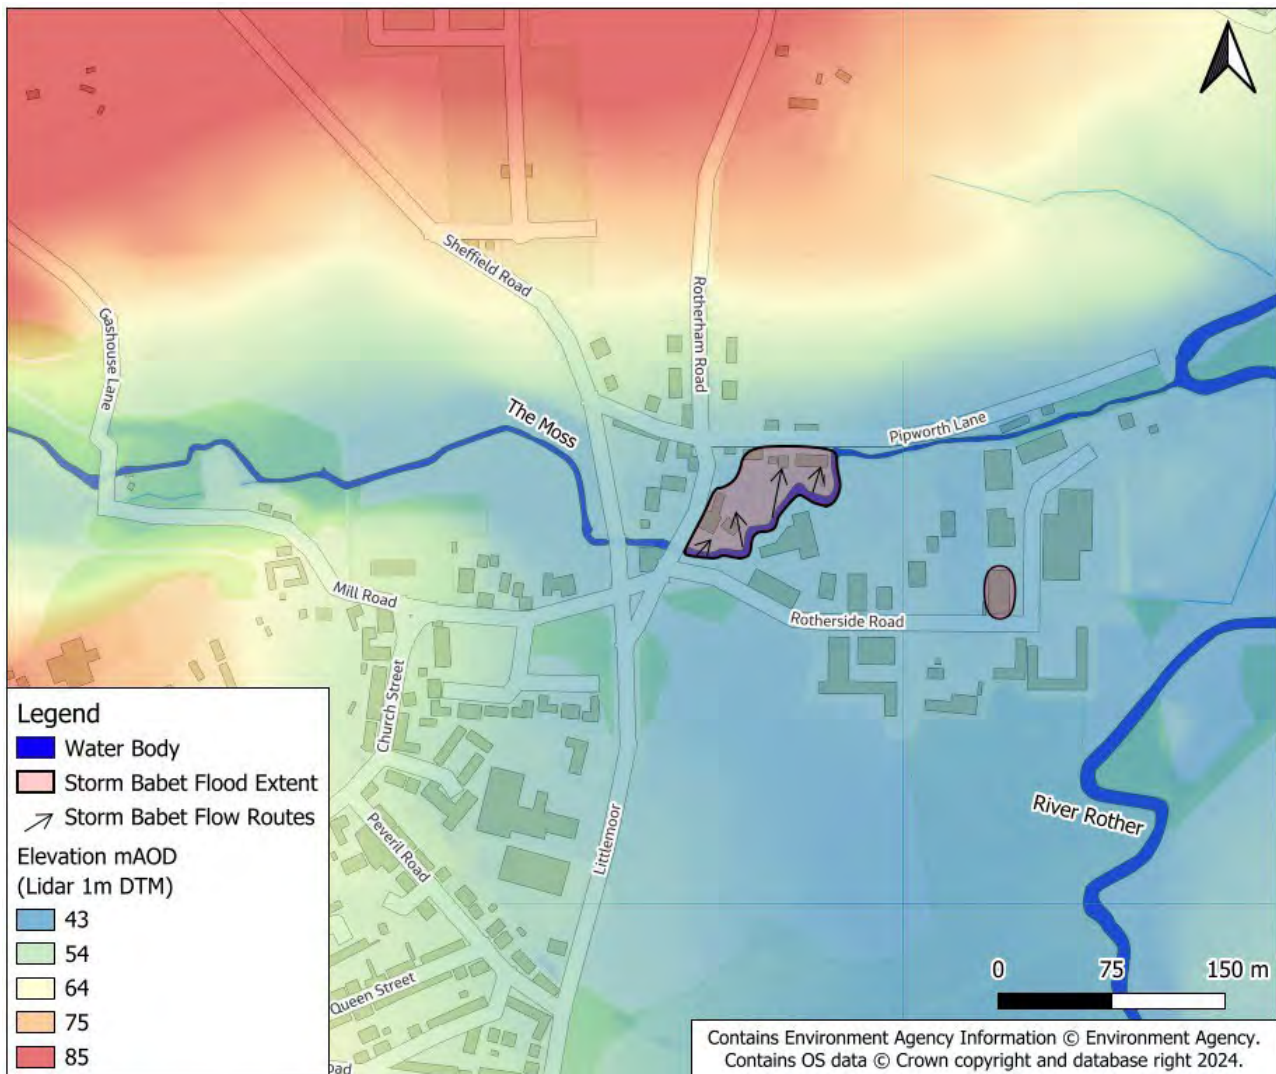
Figure 4-54 shows the flow routes and elevations which will have contributed to the flood extent.

Hydrology data shows that on the 20th of October, the peak level recorded at the Eckington Rotherham Road river gauge located on The Moss tributary at Rotherham Road bridge, reached 2.46m; the highest level ever recorded. The gauge indicates that water levels in The Moss began to rise on the 20th of October 2023 at about 4:00am, reaching its peak at 2:45pm.

Figure 4-54: Ground level and Storm Babet flow routes at Eckington.
