## 7. Trent Lower and Erewash Catchment

### 7.1 Trent Lower and Erewash Event Hydrology

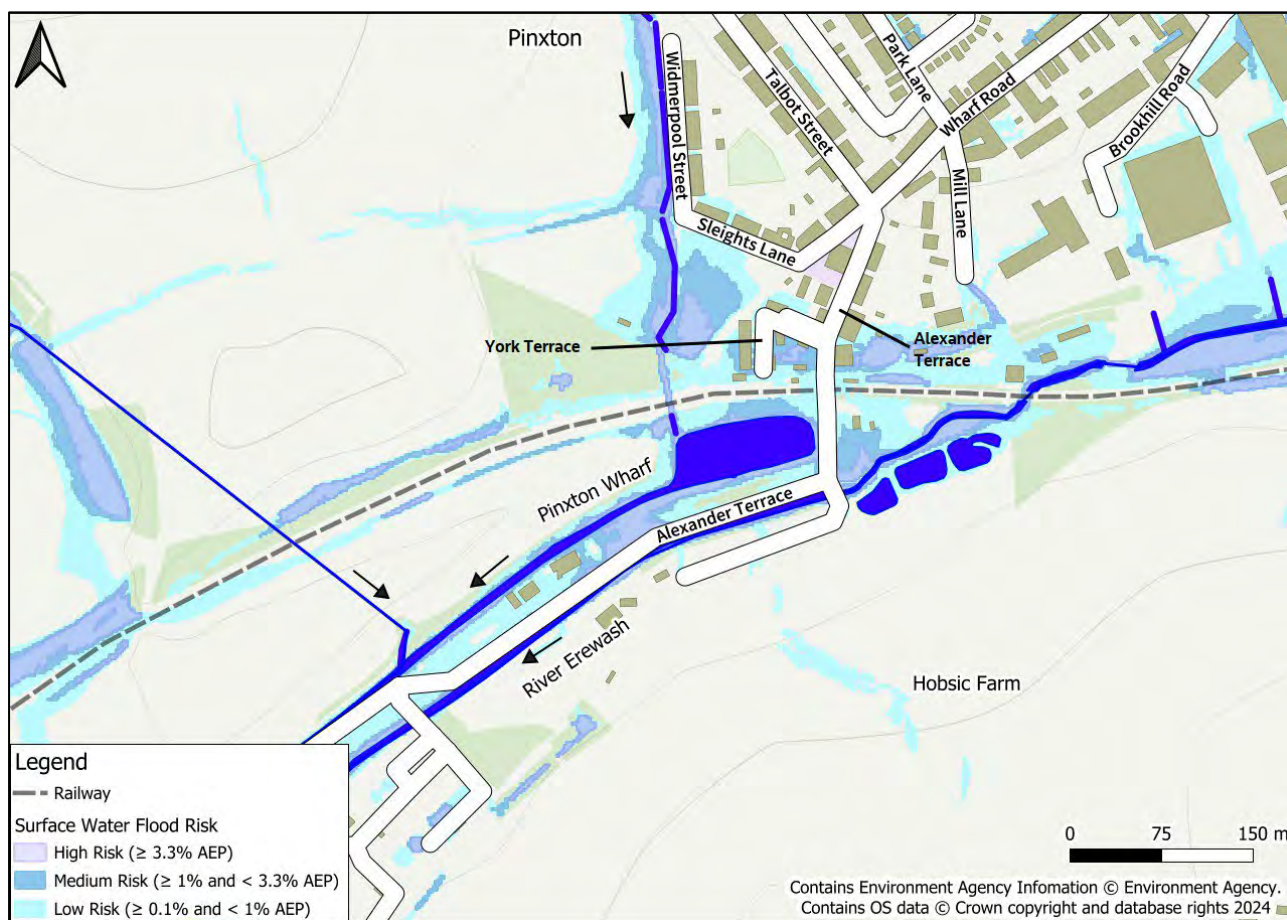
**Figure 7-28: Map showing the chance in any given year of flooding from surface water at Pinxton (Source: Long Term Flood Risk Map).**

The Environment Agency Long Term Flood Risk Map (<https://check-long-term-flood-risk.service.gov.uk/postcode>) indicates that all the properties flooded are at risk of flooding from surface water. Some properties on Alexander Terrace and York Terrace are at high risk of flooding from surface water, meaning more than 3.3% AEP. Figure 7-28 shows the surface water flood risk mentioned.

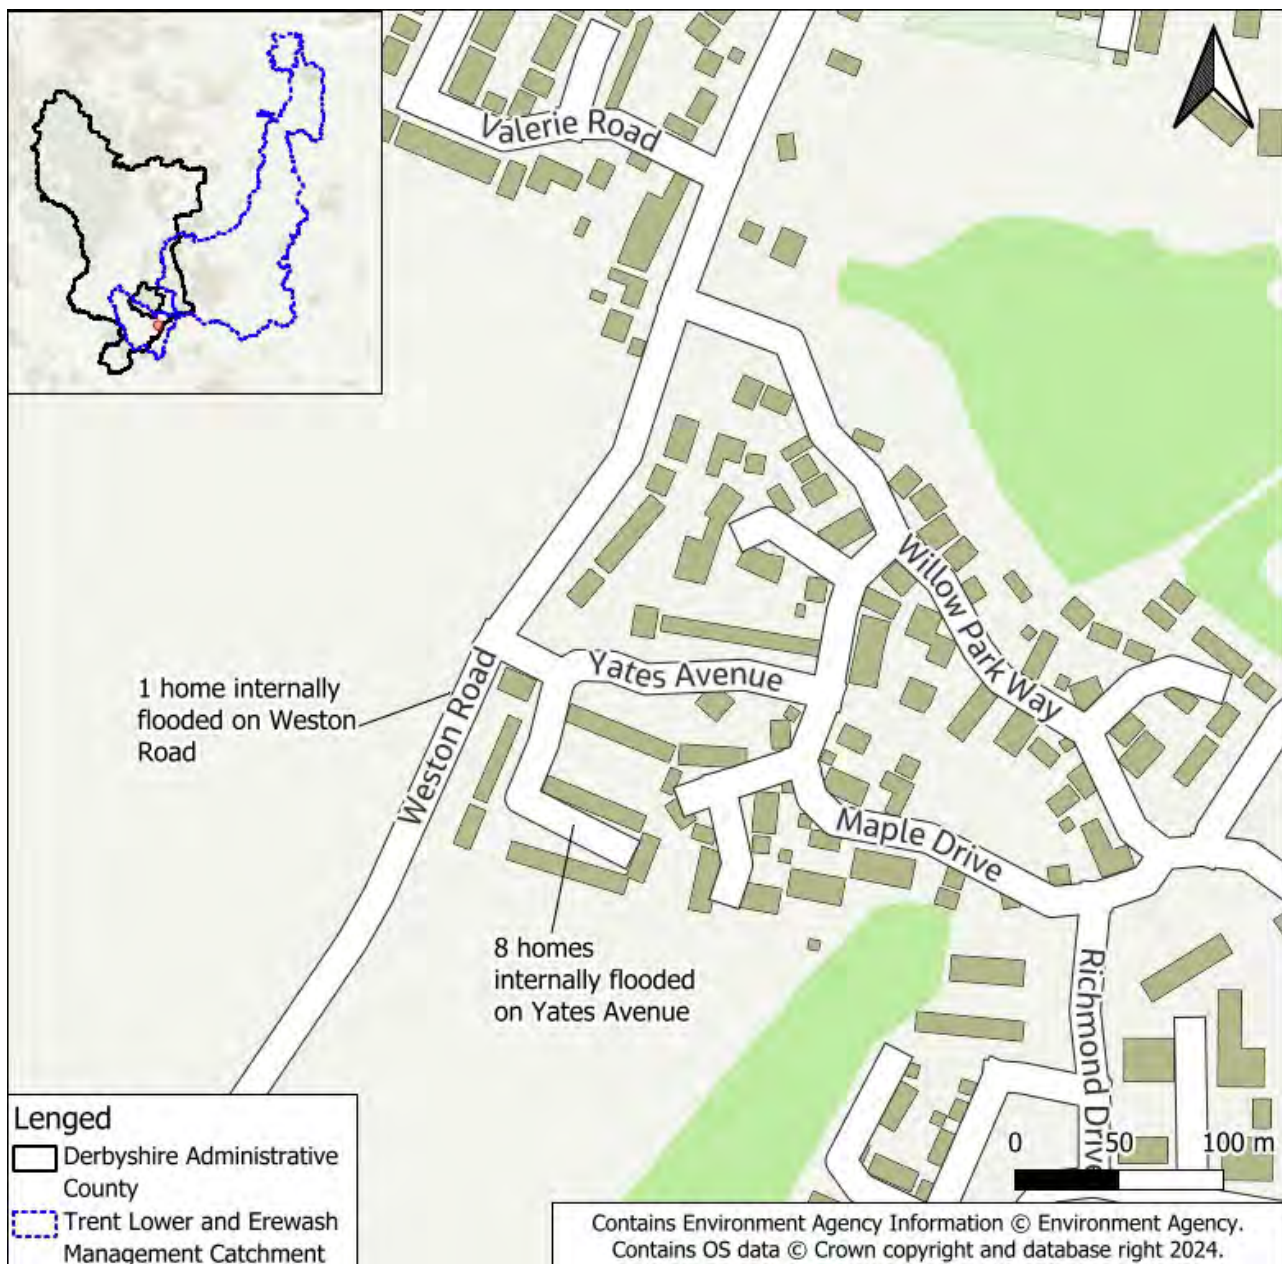
Figure 7-31: Local Flood Risk Management Assets and Flood Zones for the Langley Mill community.

Nine residential properties suffered from internal flooding in Aston-on-Trent as a result of Storm Babet. Aston-on-Trent is in South Derbyshire. Both the Trent and Mersey Canal and River Trent are located approximately 1 to 3km to the south and east of the village. The River Trent is designated as a main river. Figure 7-31 shows the Aston-On-Trent community.

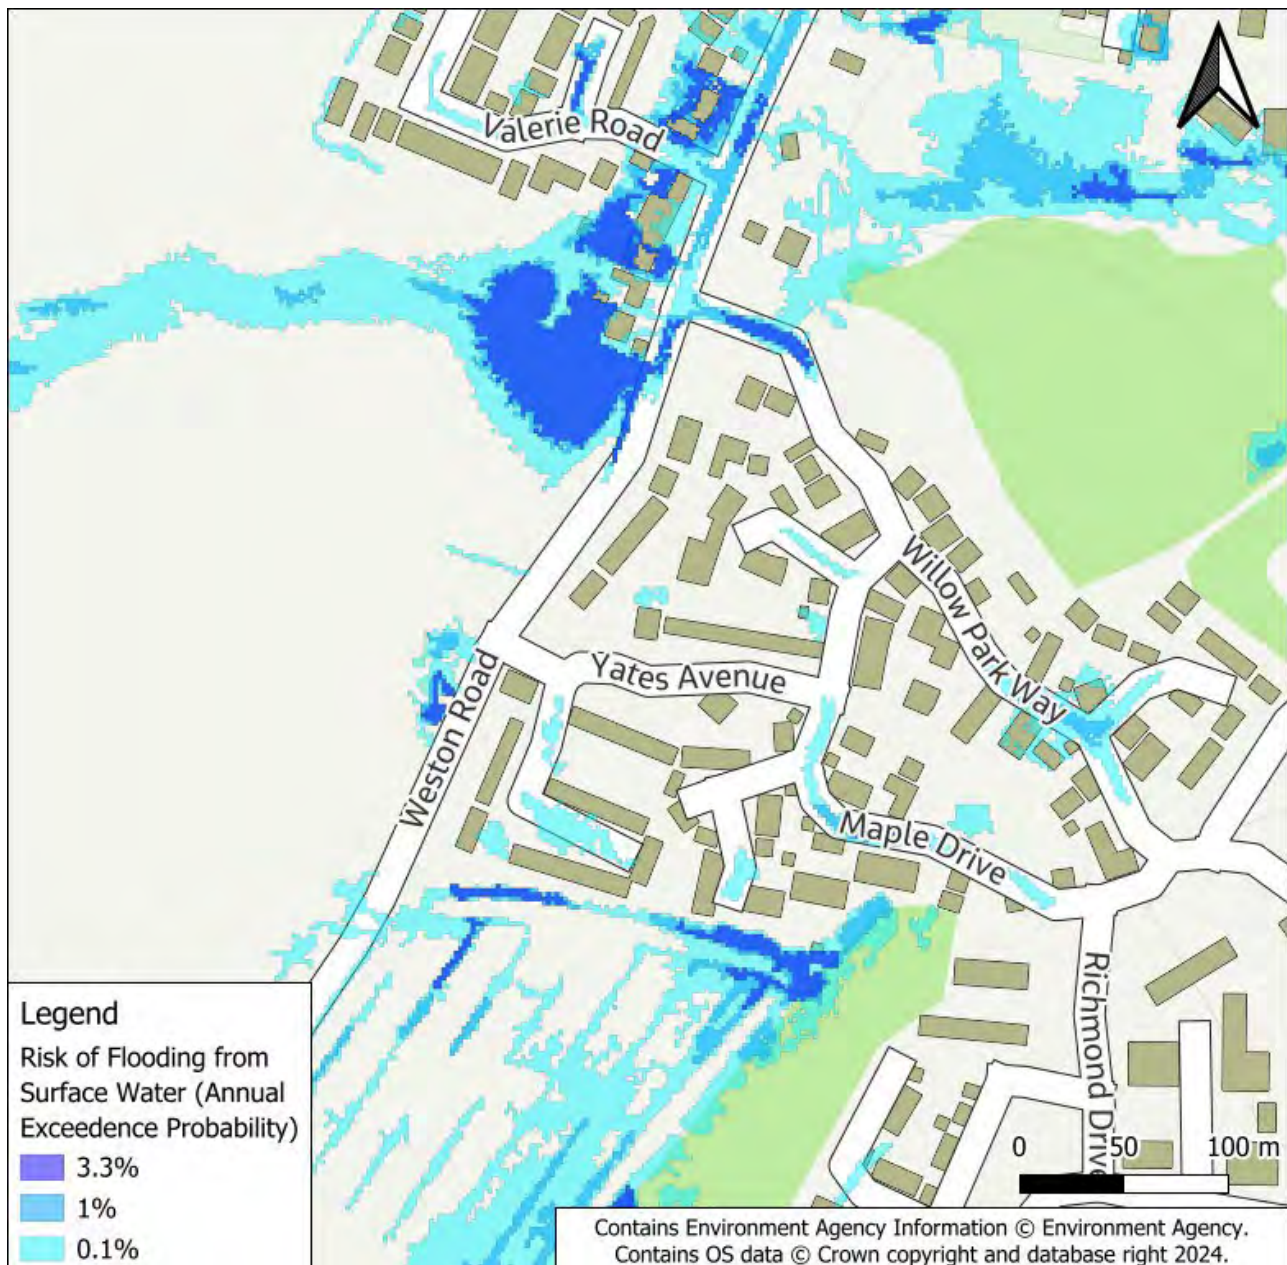
Figure 7-32: Map showing the chance in any given year of flooding from surface water at Aston-on-Trent (Source: Long Term Flood Risk Map).

The Long Term Flood Risk Map (<https://check-long-term-flood-risk.service.gov.uk/postcode>) shows a high likelihood of surface water flood risk to areas of Weston Road, Yates Avenue and Valerie Road with some properties having a more than 3.3% Annual Exceedance Probability (AEP) of surface water flood risk. This is shown in Figure 7-32 below.
